Five-Year Review Report (Third) Five-Year Review United Chrome Products Site Corvallis, Oregon March 2003

**Five-Year Review Report
(Third) Five-Year Review Report**

United Chrome Products

March 2003

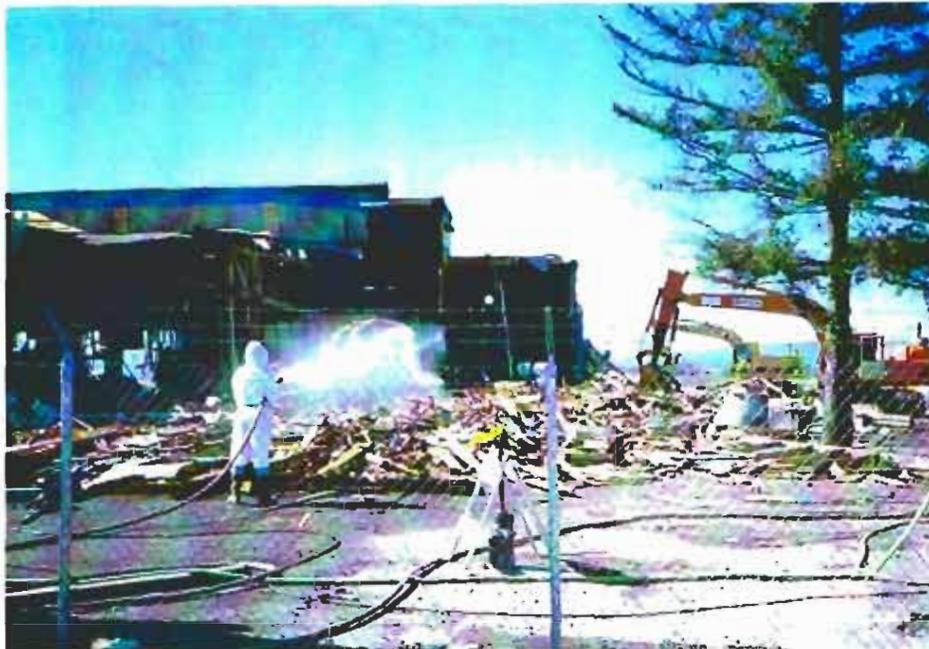
Photograph 1 – Demolition of the United Chrome Products building.

- Decontamination and demolition of the vacant United Chrome Products building (Photograph 1). Decontamination water was collected and stored in a temporary storage tank for treatment in the onsite treatment system. Demolition debris was transported to Valley Landfill's Coffin Butte facility in Corvallis, Oregon.

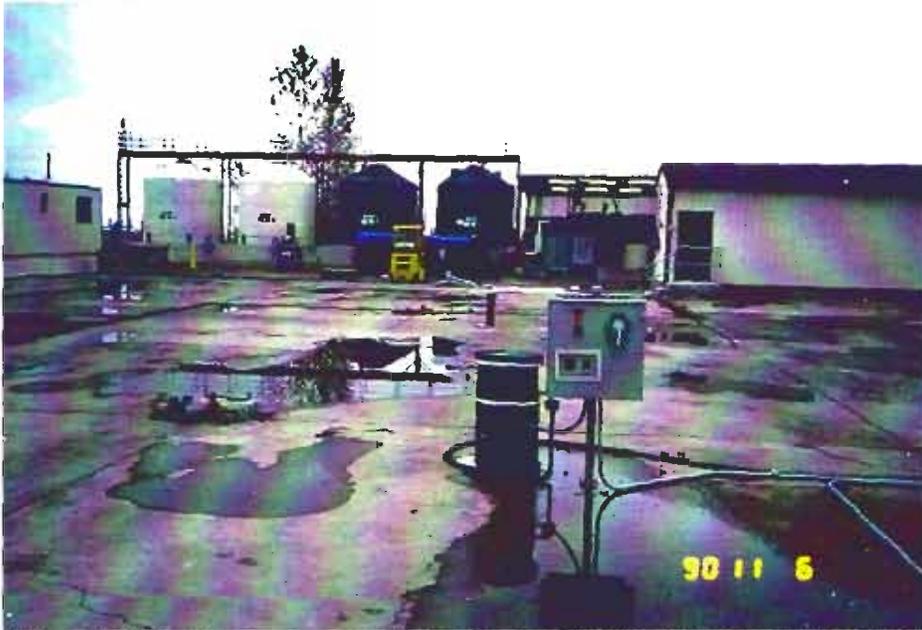
Photograph 2- Typical upper zone groundwater extraction well and onsite treatment system. Black tanks used for influent (groundwater) storage and white tanks for effluent (treated groundwater) storage.

- Installation of 23 extraction wells (versus the 15 proposed in the ROD) and associated conveyance piping and well controls (Photograph 2) to pump contaminated groundwater from the upper zone to the onsite pretreatment system. Six piezometers and six monitor wells (non-pumping extraction wells) were also installed to allow for monitoring of remedial action progress.

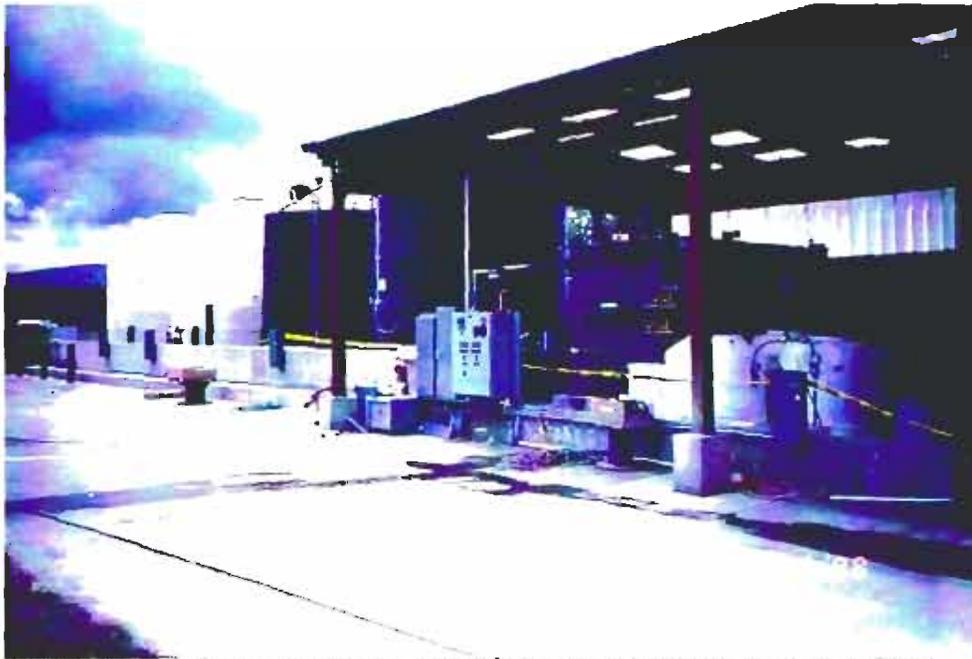
Photograph 3 - Chemical reduction and precipitation treatment tank with totes containing treatment chemicals.

- Construction of extracted groundwater influent and effluent holding tanks, installation of a skid-mounted chemical reduction and precipitation pretreatment system (Photograph 3), and setup of an office/laboratory trailer for use by operations and maintenance (O&M) staff. The City of Corvallis later modified the treatment system to add two 6,000-gallon sludge thickening tanks.

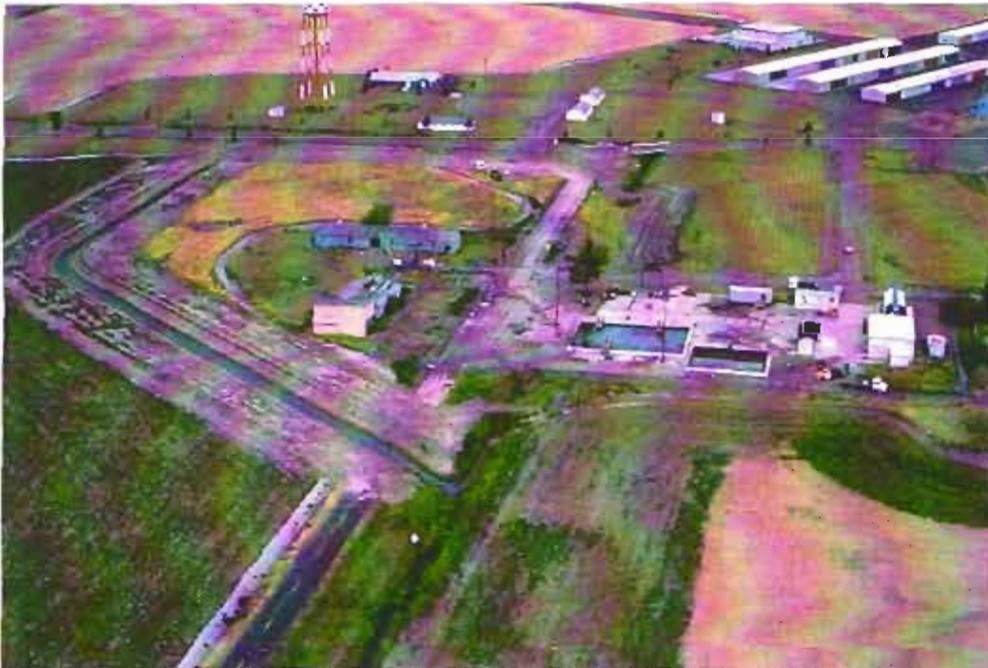
Photograph 4 – Surface drainage bypass ditch shown on left. Infiltration basins at right-center of photograph.

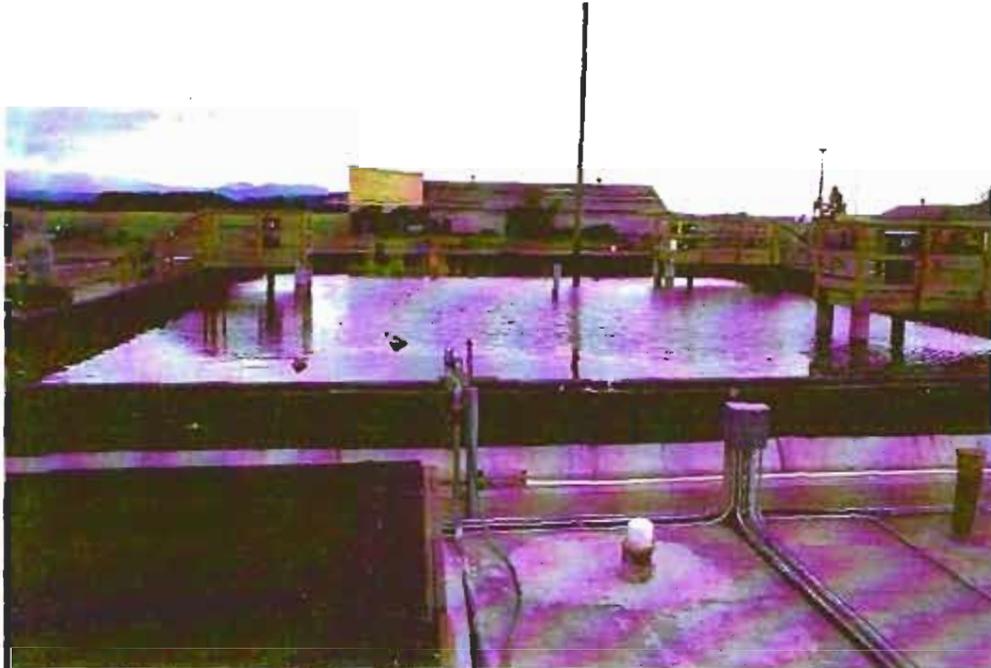
The basin walls (Photograph 5) were constructed of 30-inch-high concrete curbing lined with geotextile. The curbing was glued to a concrete footing, resulting in a leak-proof construction. Tap water was pumped into the basins through a 2-inch spigot and the water level maintained by a float valve. The water level inside the basins was initially maintained at a height 2 feet above ground surface but was subsequently lowered to a ground surface level to reduce vertical gradients between the upper zone and deep aquifer.

Photograph 5 – Upper zone infiltration basin Number 1.

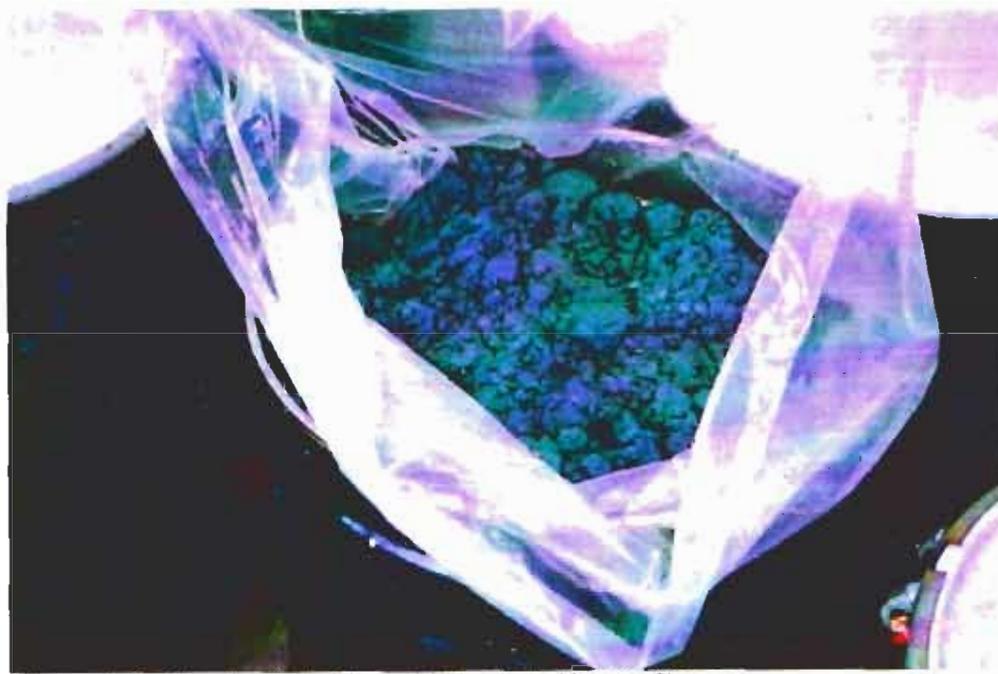
Photograph 6 – Chromium hydroxide precipitate collected from the filter press.

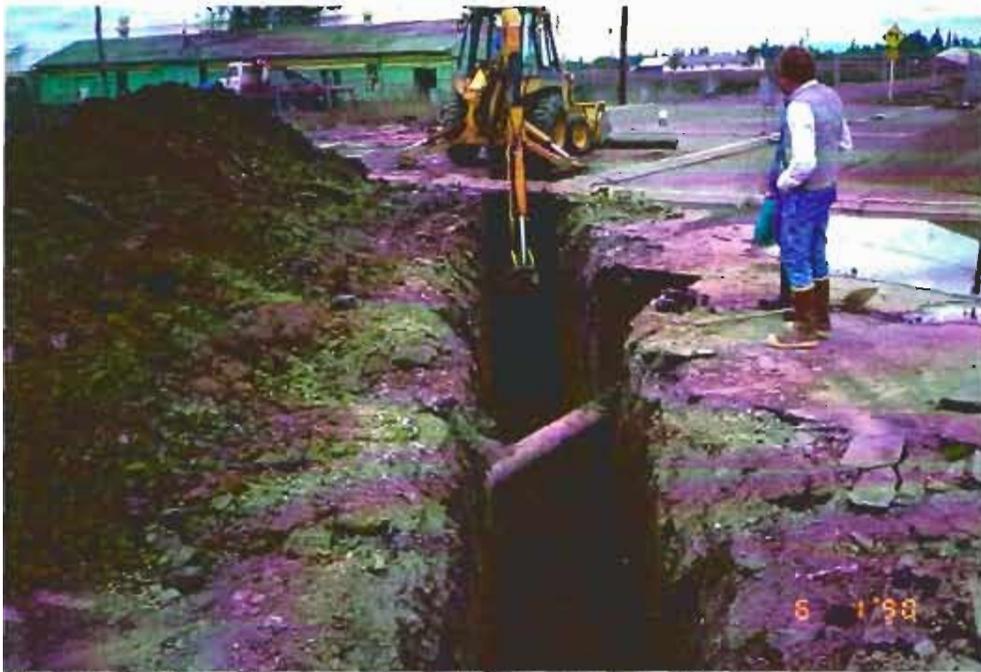
Photograph 7 – Construction of upper zone infiltration trench in June 1990 by the City.

- Construction of a 100-foot-long infiltration trench in 1990 to deliver additional recharge to the upper zone northeast of Basin 1 (Photograph 7).

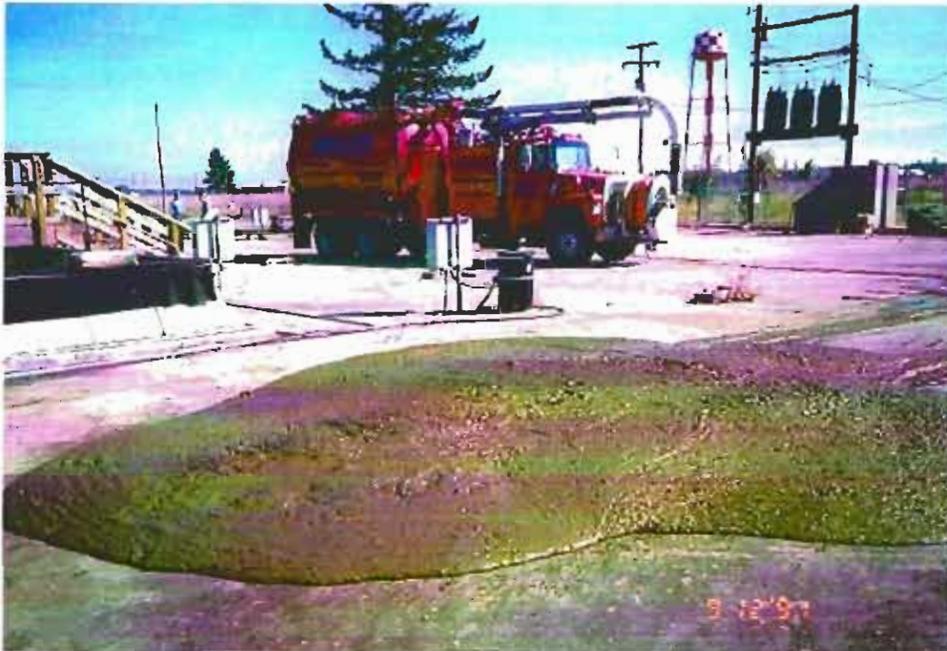
Photograph 8 – Chromium-contaminated sediment removed from onsite culvert in September 1991. The City attempted to stabilize the sediment with concrete to permit disposal at Subtitle D (nonhazardous) landfill, but was unable to blend the concrete and sediment into a stable solid.

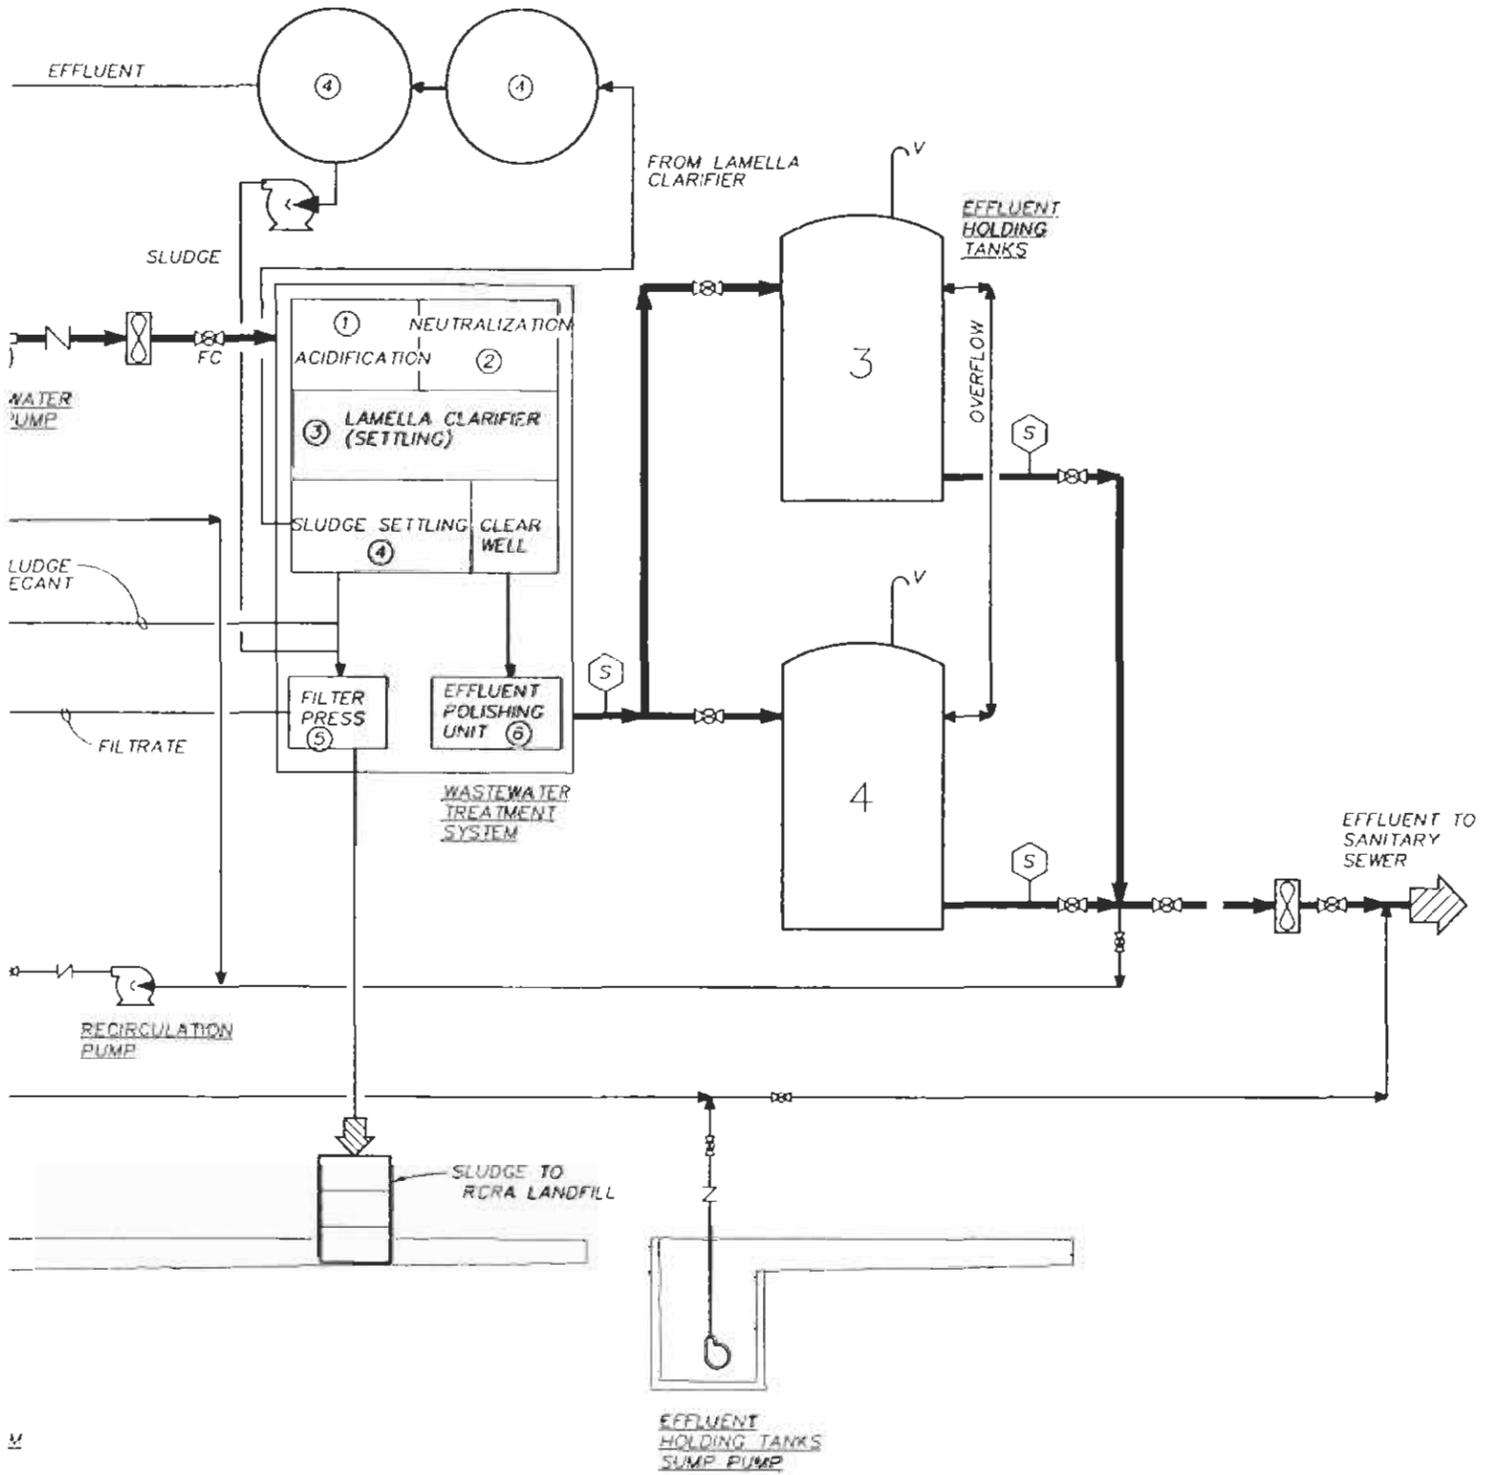
FIGURE 4-5
GROUNDWATER TREATMENT SYSTEM[®]
UNITED CHROME PRODUCTS SITE
CORVALLIS, OREGON

SLUDGE THICKENING TANKS
AUGUST 1990 PROCESS MODIFICATION

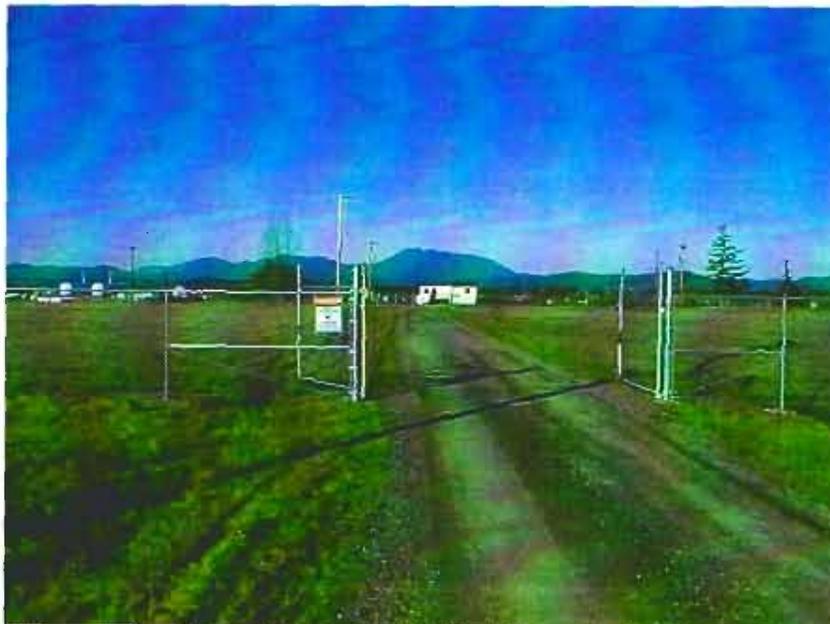
Two security fences (Photograph 10) enclose the United Chrome site, with access obtained through gates located off Airport Place. The outer fence, maintained by the Federal Aviation Administration, encloses the Corvallis Airport and is labeled with no trespassing and warning signs approximately every 100 feet along its entire length. The inner fence encloses the United Chrome and CoEnergy sites (Figure 6-1), which lie within the Corvallis Airport property. A third fence separates the United Chrome and CoEnergy sites from one another, and separate locking gates control entry and egress from each. CoEnergy also uses two guard dogs to patrol their facility.

Photograph 10 – FAA security fence outside United Chrome site fence.

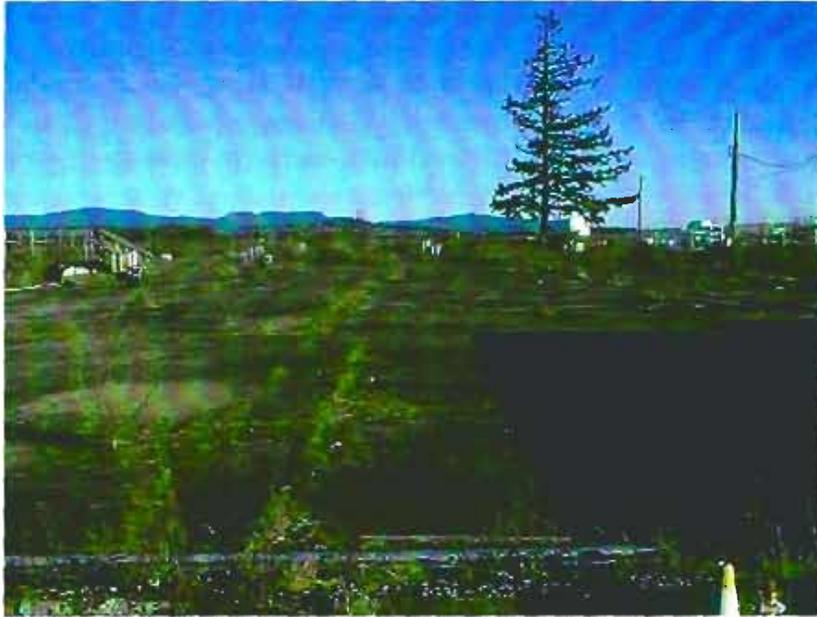
Photograph 11 – Concrete cover and floor of former United Chrome Products building.

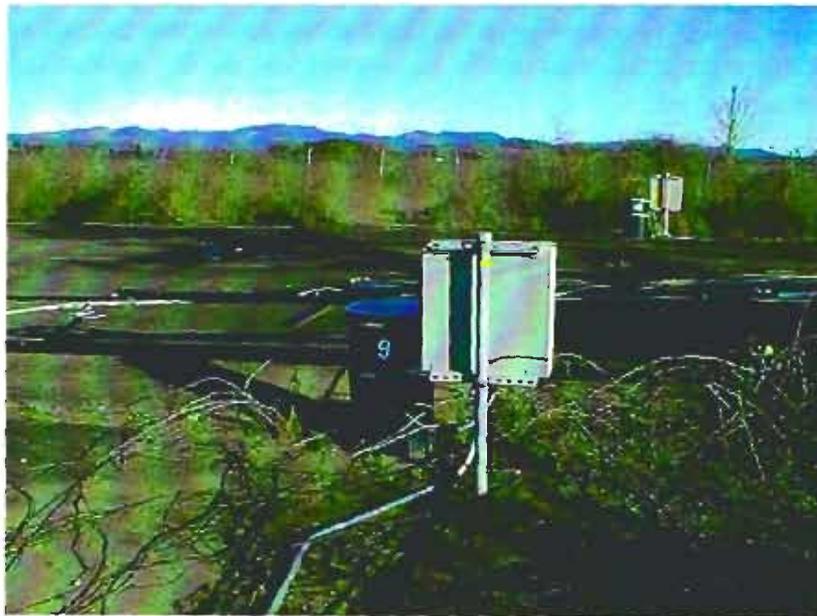
The only extraction wells still in operation are upper zone well EW-9 and deep aquifer wells DW-8 and DW-9 (Photographs 12a and 12b). All other extraction wells have been converted to monitor wells, or have met the ROD performance standard and been abandoned per EPA approval. The status of all wells present at the start of the remedial action in 1988 is shown in Table 6-1. Wells still present at the site are shown on Figure 6-1. At the time of the inspection, wells EW-9, DW-8, and DW-9 were operating satisfactorily.

Photograph 12a – Upper zone extraction well EW-9.

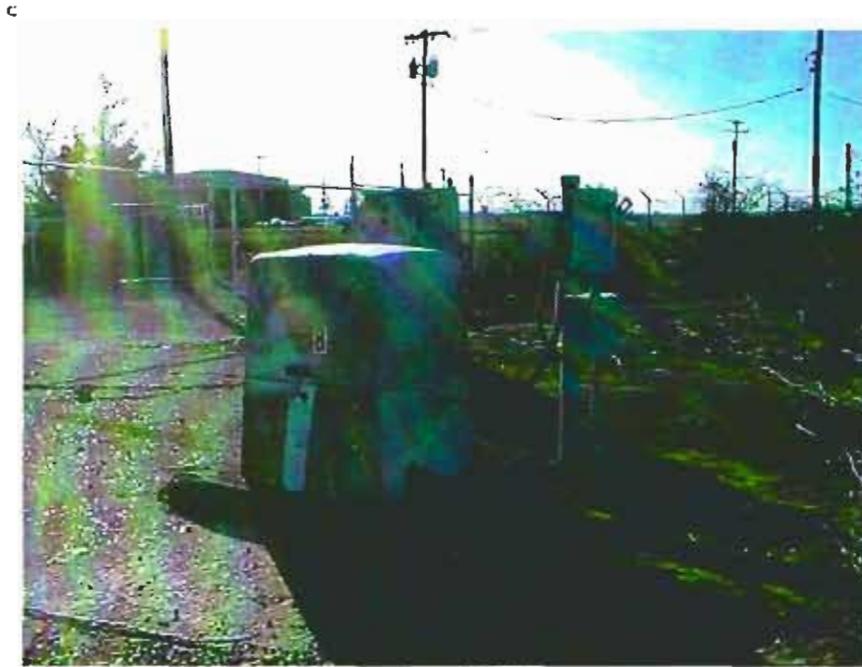
Photograph 12b – Deep aquifer extraction well DW-8.

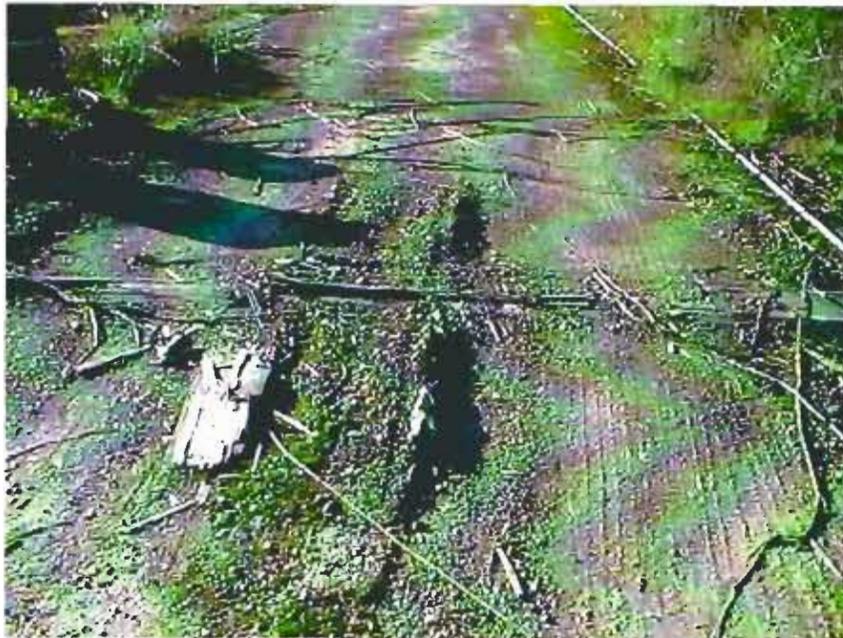
The above ground piping that conveys groundwater from extraction wells EW-9, DW-8, and DW-9 to the discharge point is in good shape. However, the bridge near wells EW-5 and DW-1 (Photograph 13), which allows vehicles to drive safely over the pipe, is in poor condition and should be repaired if future vehicle traffic through this area is required. The bridge was damaged by heavy truck traffic during the October 2000 upper zone source removal project.

Photograph 13 – HDPE aboveground pipe bridge near DW-1.

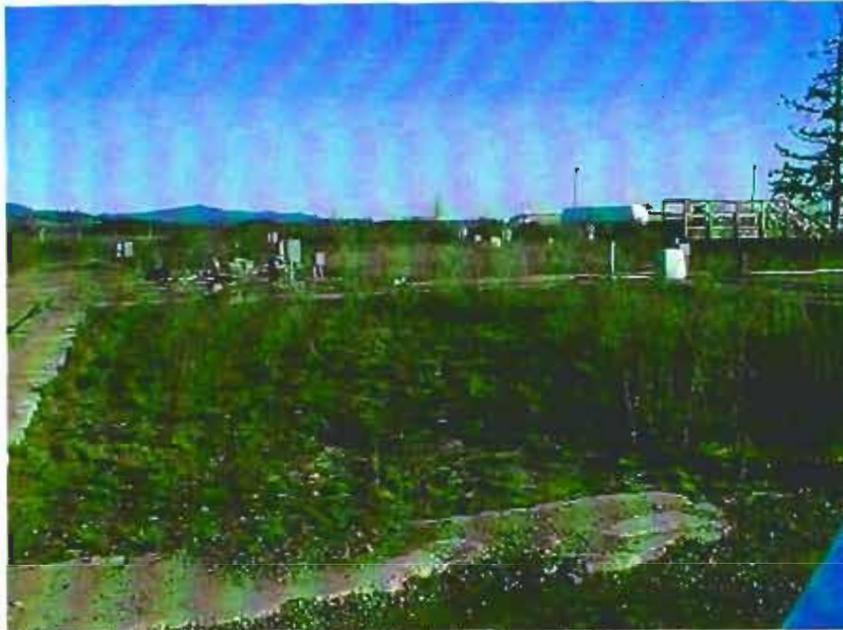
The infiltration basins (Basin 1 and Basin 2) were decommissioned in August 2000 in conjunction with the upper zone source removal work (Photograph 14). The decommissioning effort included removal of geotextile material, above-grade concrete walls, plumbing and valve controls. The infiltration trench is still operational but has not been used since January 1993, except for a short trial between August and October 2001. Given the limited nature of current upper zone pumping operations, it is unlikely the trench will be required in the future.

Photograph 14 – Footprint of former infiltration basin number 2.

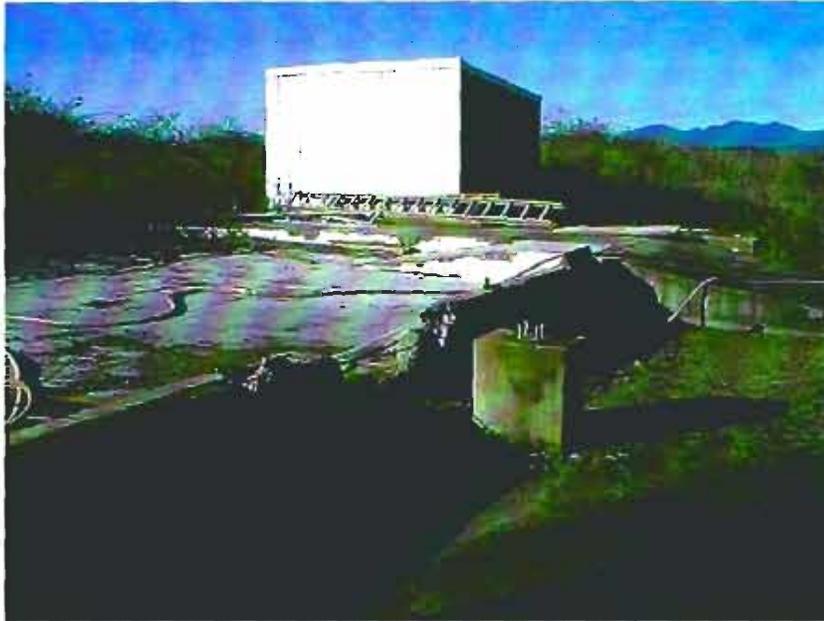
The groundwater treatment system was removed between March and April 1999. The only components remaining are the secondary containment wall that enclosed the influent tank storage and treatment system areas, the partially enclosed shop, the electrical control panel, the decontamination pad, and the containment cell for the sludge thickening tanks. The secondary containment wall has been intentionally breached (Photograph 15) along the north side to prevent accumulation of large amounts of rainwater. The metered discharge point where extracted groundwater is discharged to the sanitary sewer is in satisfactory condition (Photograph 16).

Photograph 15 – Breach of secondary containment wall at site of former wastewater treatment system.

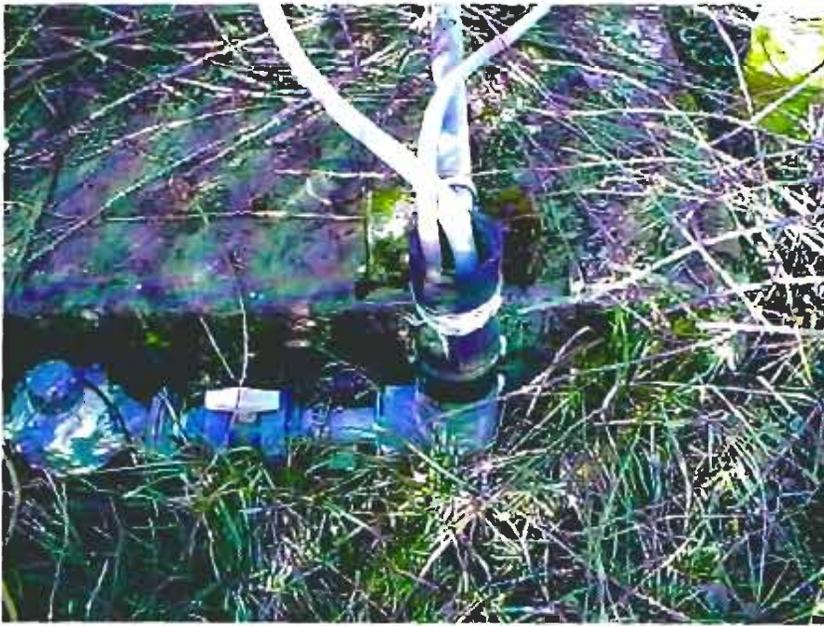
Photograph 16 – Upper zone and deep aquifer extracted groundwater discharge point.

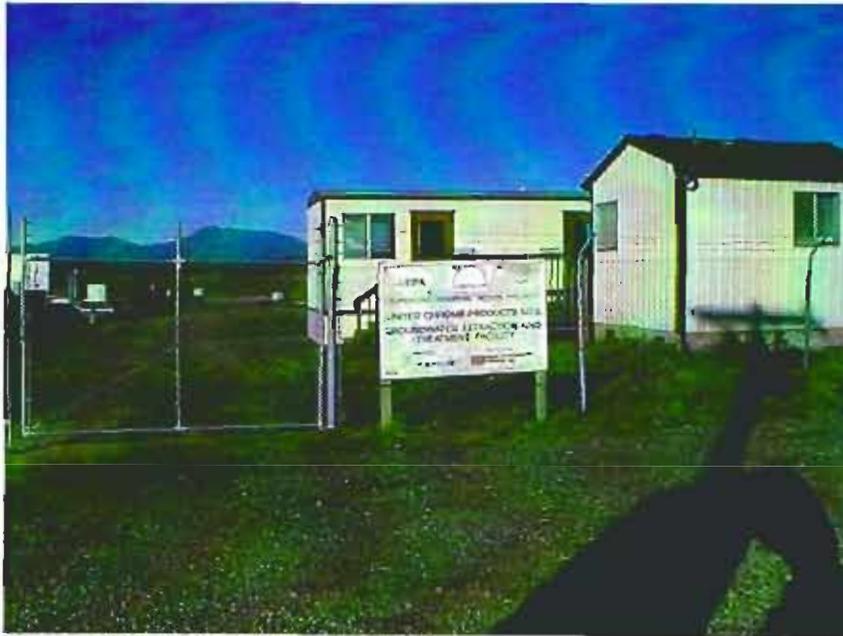
An office and laboratory trailer and locker room trailer, constructed as part of the groundwater remedial construction effort, are still maintained by the City of Corvallis (Photograph 17). All onsite testing is done in the laboratory trailer, but most document/data management is performed at the City of Corvallis POTW. The laboratory equipment appeared to be in good working condition, and the City provides copies of all calibration and quality assurance checks with the quarterly progress reports. Copies of the O&M manuals, health and safety plan, and historical site-related documents are also kept onsite. The O&M manual has not been updated since the treatment system was decommissioned in April 1999. However, to support an update to the site Health and Safety Plan, the City prepared a summary of significant site events (see Attachment 4 in Appendix A).

Photograph 17 – Office and laboratory trailer.

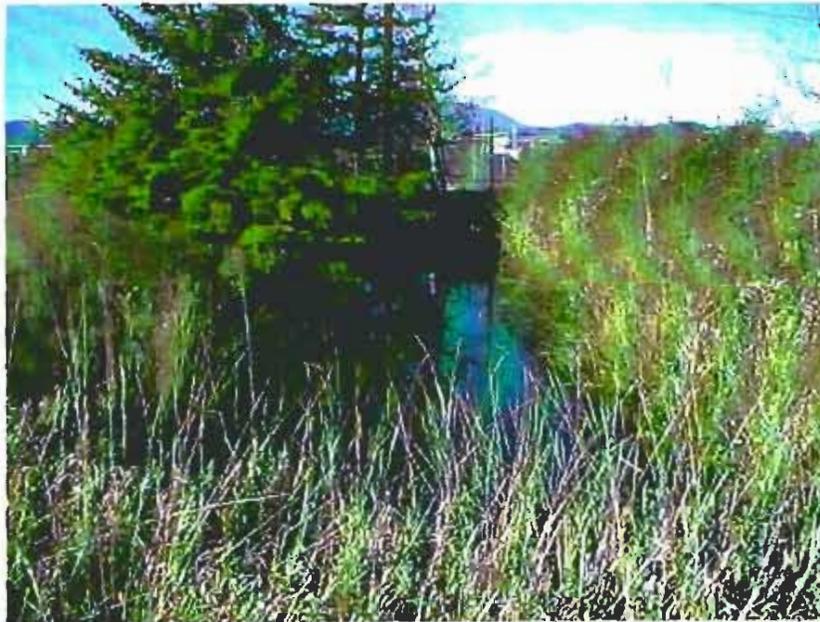
Photograph 18 – Isolated portion of former site drainage ditch near United Chrome site.

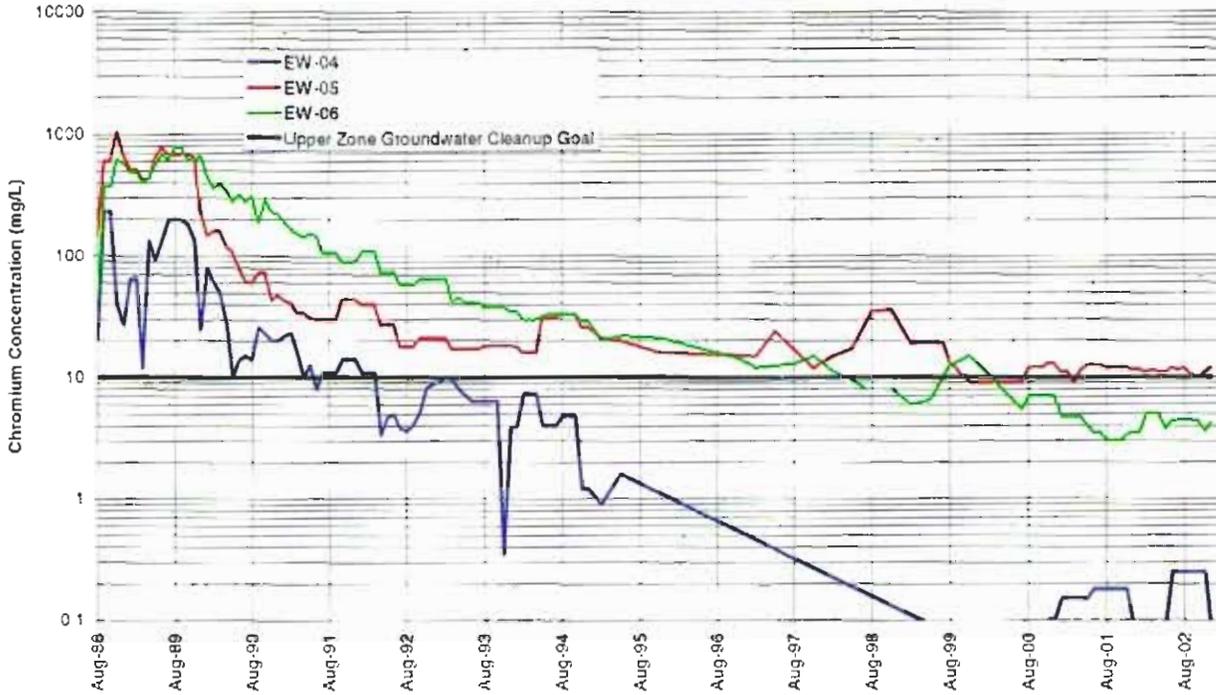
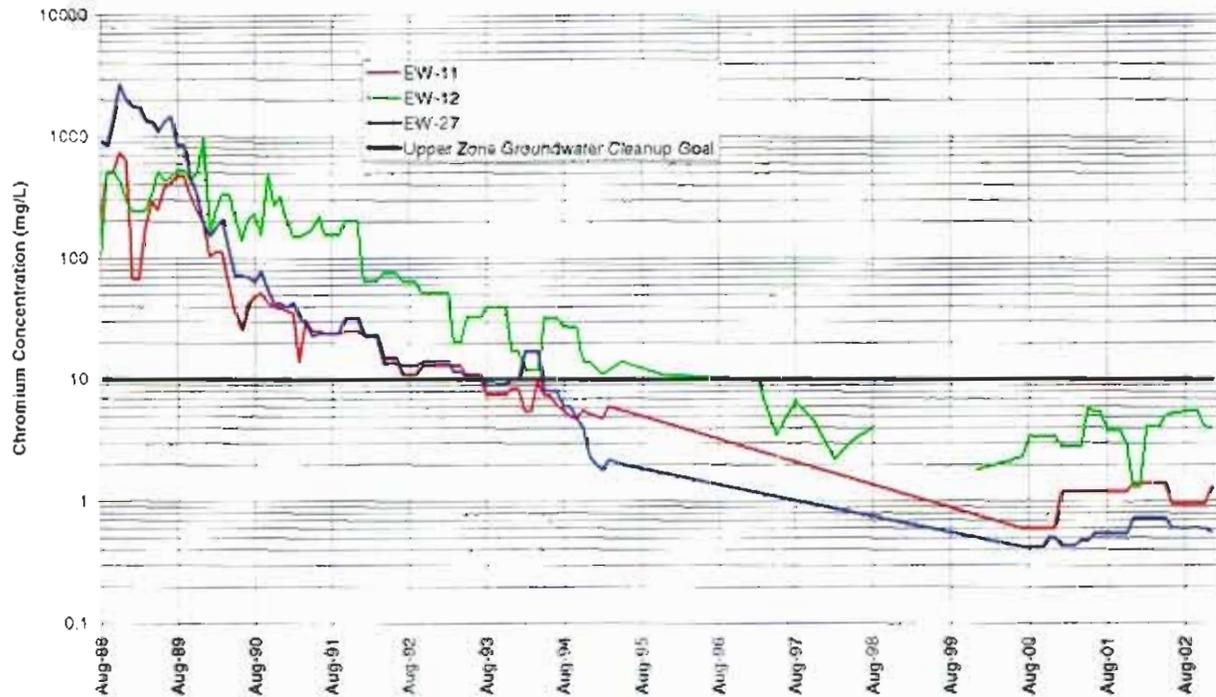
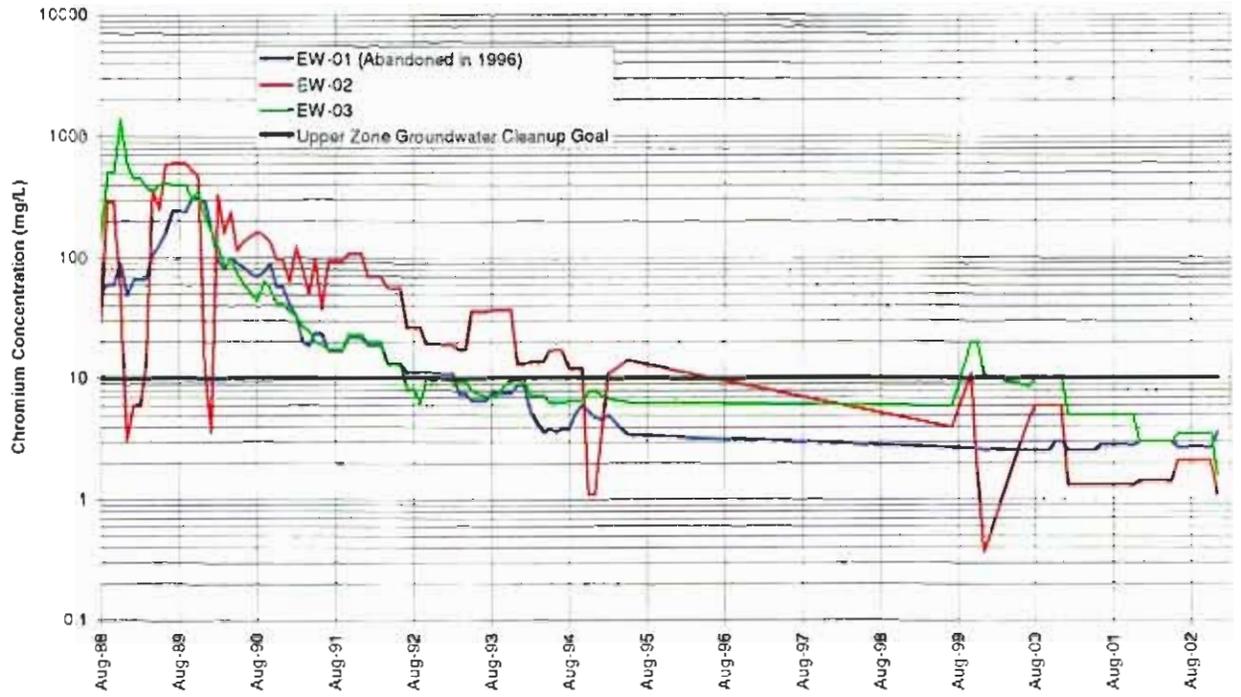
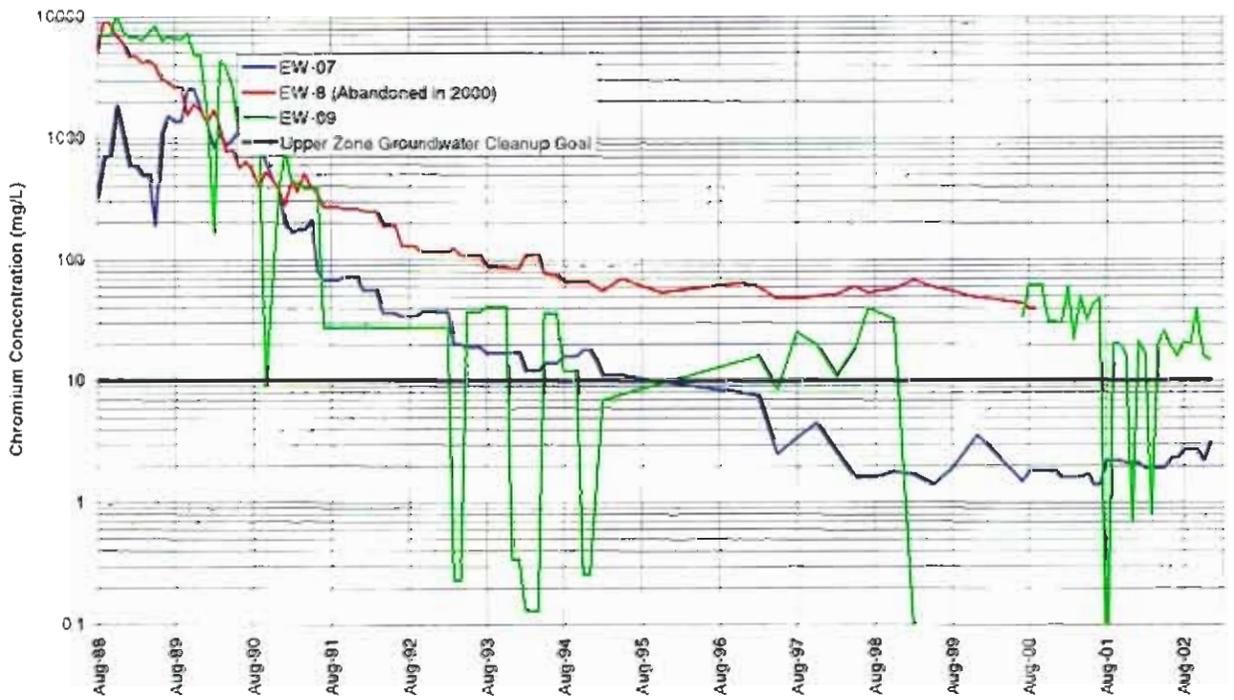
Figure 7-2a
Upper Zone Groundwater Chromium Concentration Trends
United Chrom Products Site
Corvallis, Oregon

Chromium Concentration Trends at Interior Wells

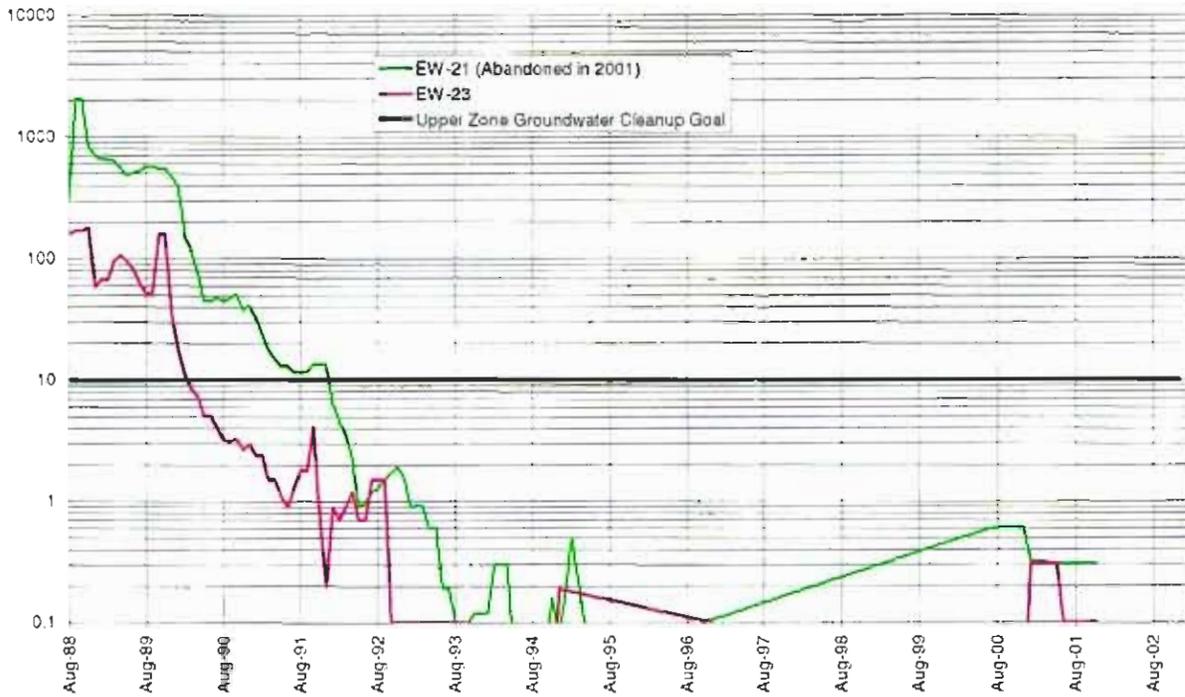
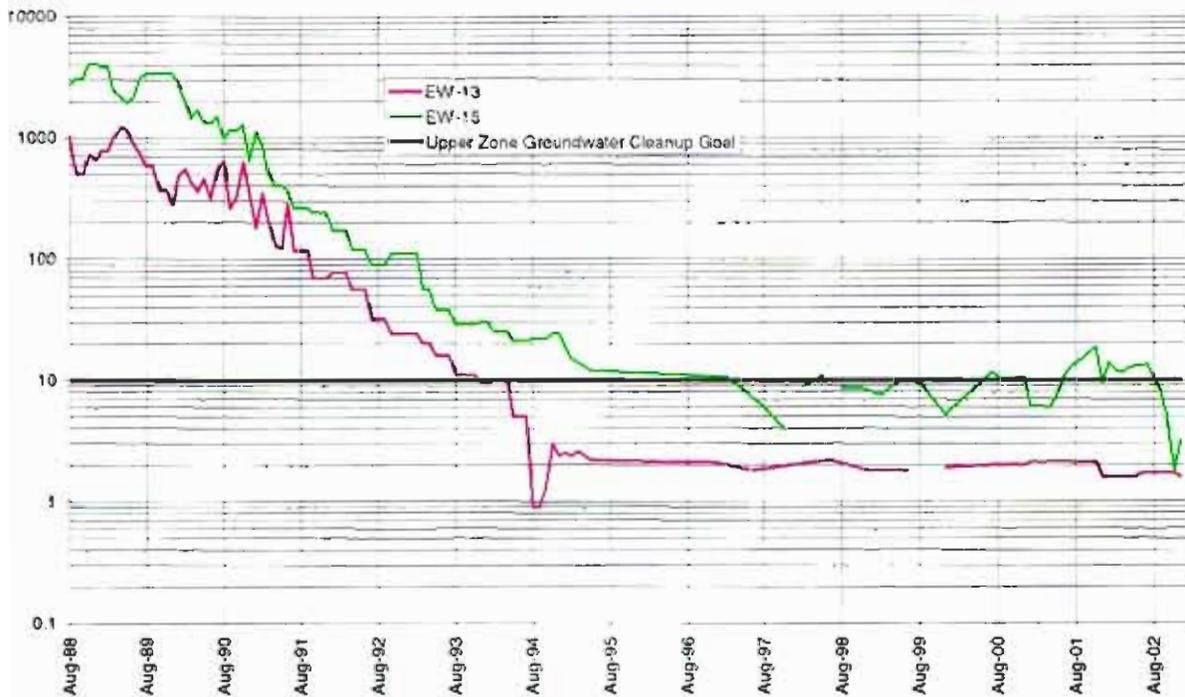
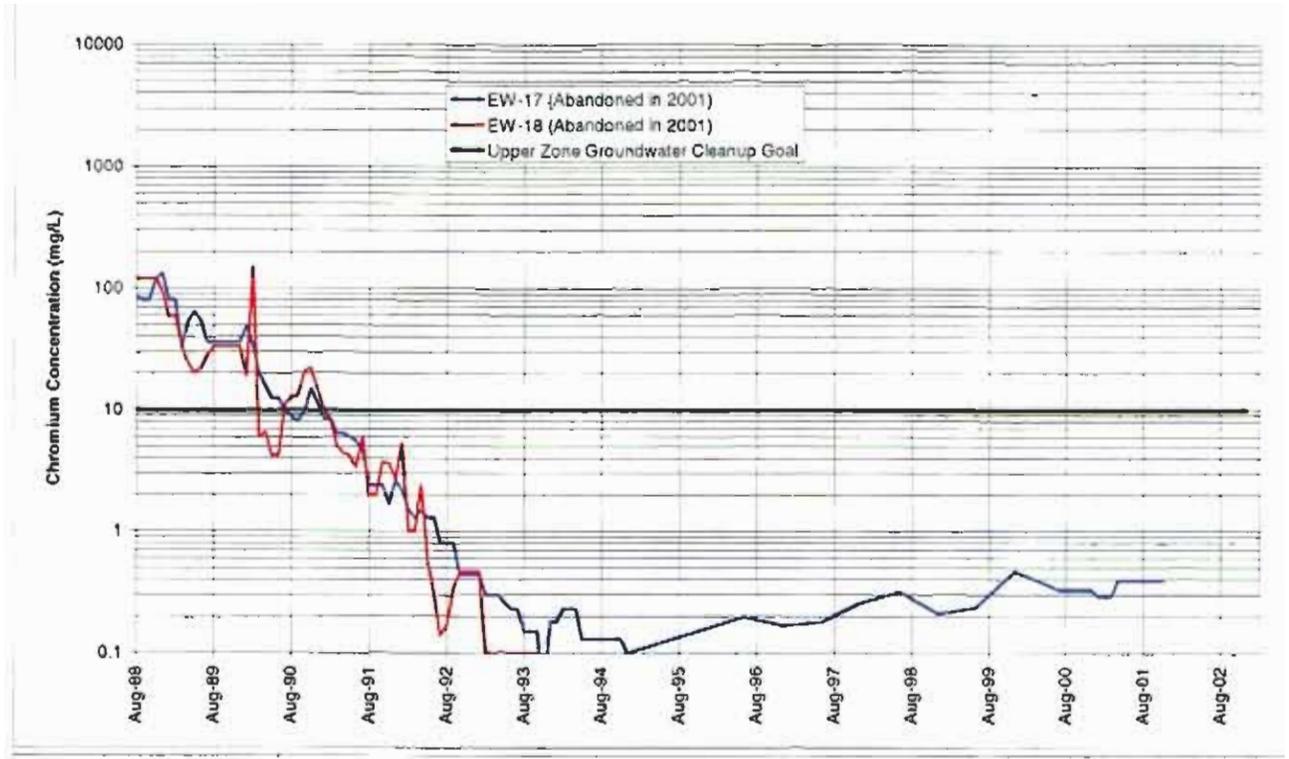
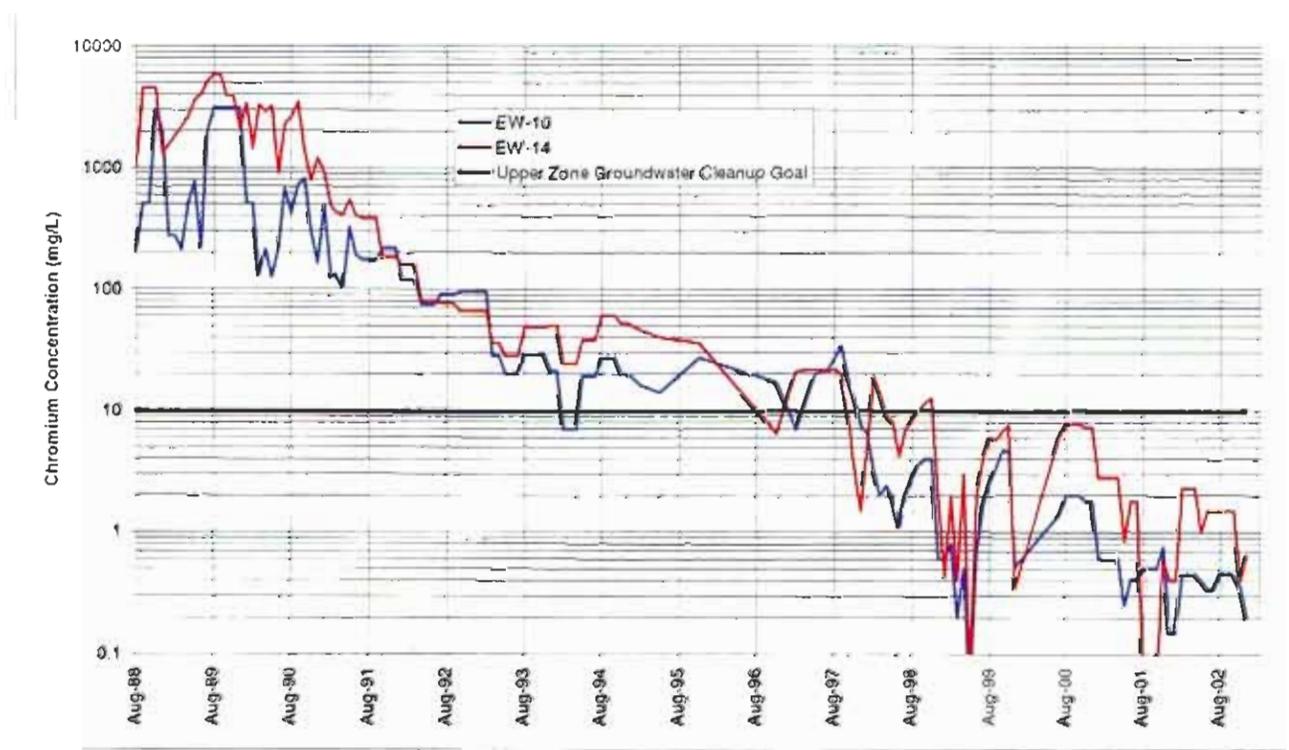
Figure 7-2b
Upper Zone Groundwater Chromium Concentration Trends
United Chrome Products Site
Gervais, Oregon

Chromium Concentration Trends at Year 1992 to 2000 Boundary Wells
