Five-Year Review Report (Third) Five-Year Review United Chrome Products Site Corvallis, Oregon March 2003

**Five-Year Review Report
(Third) Five-Year Review Report**

United Chrome Products

March 2003

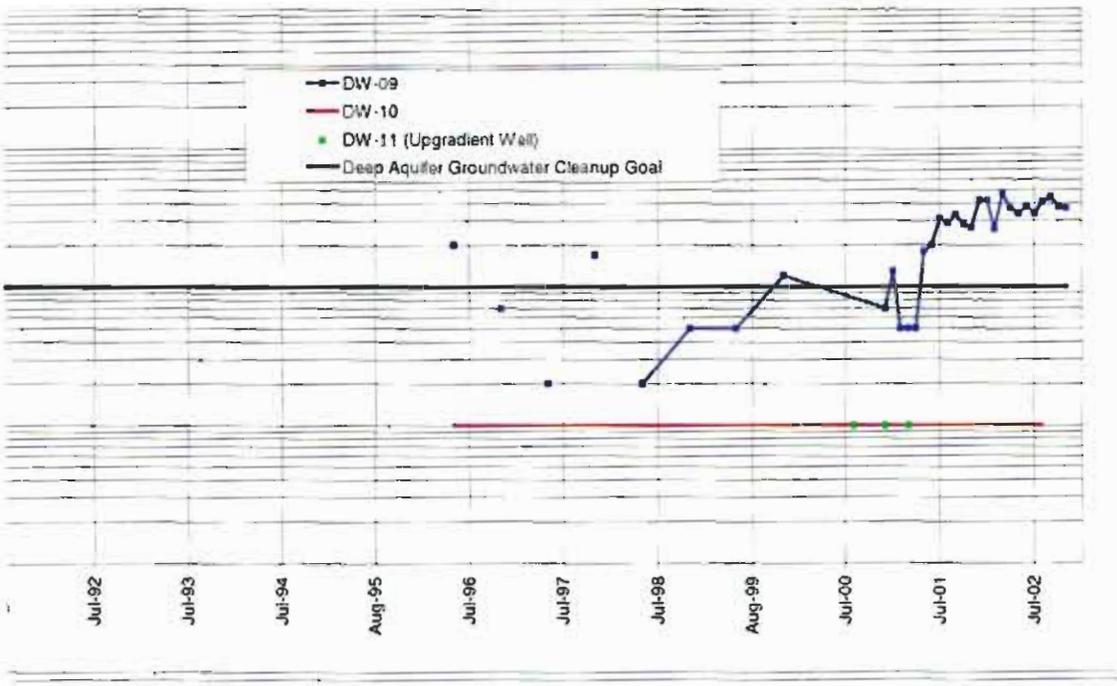
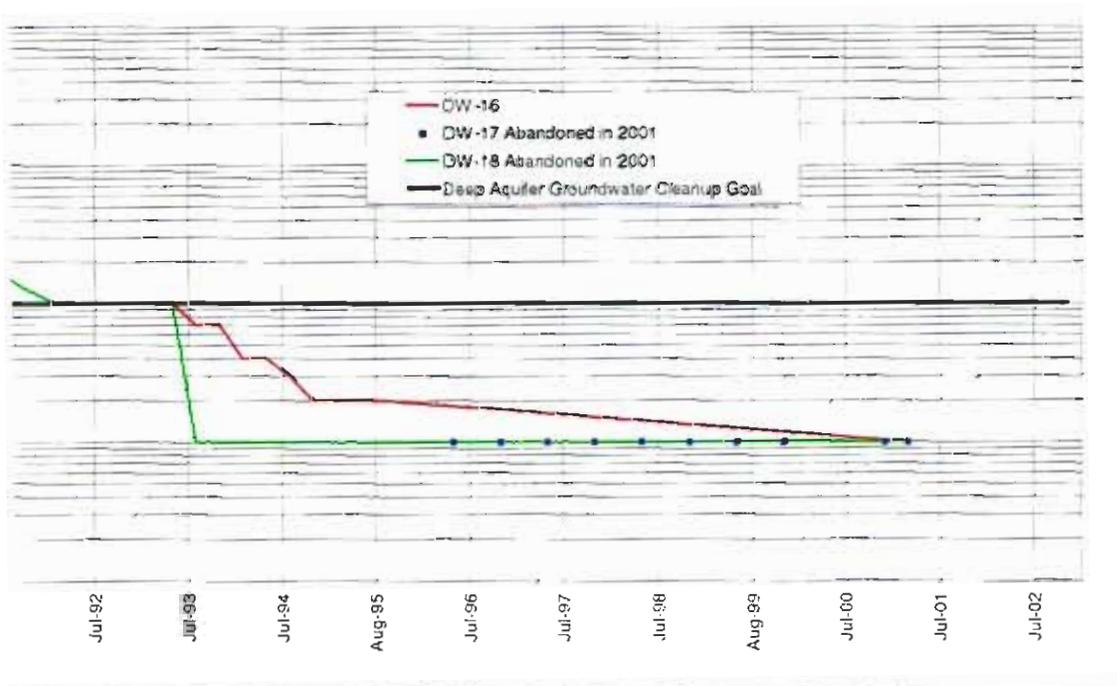
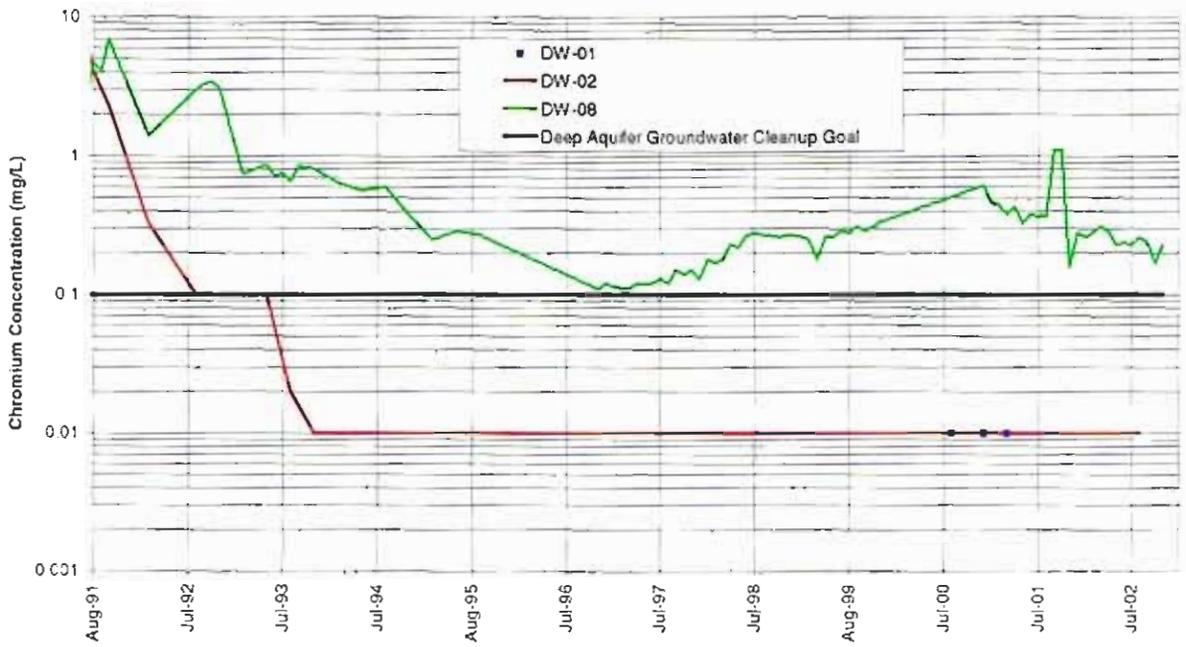
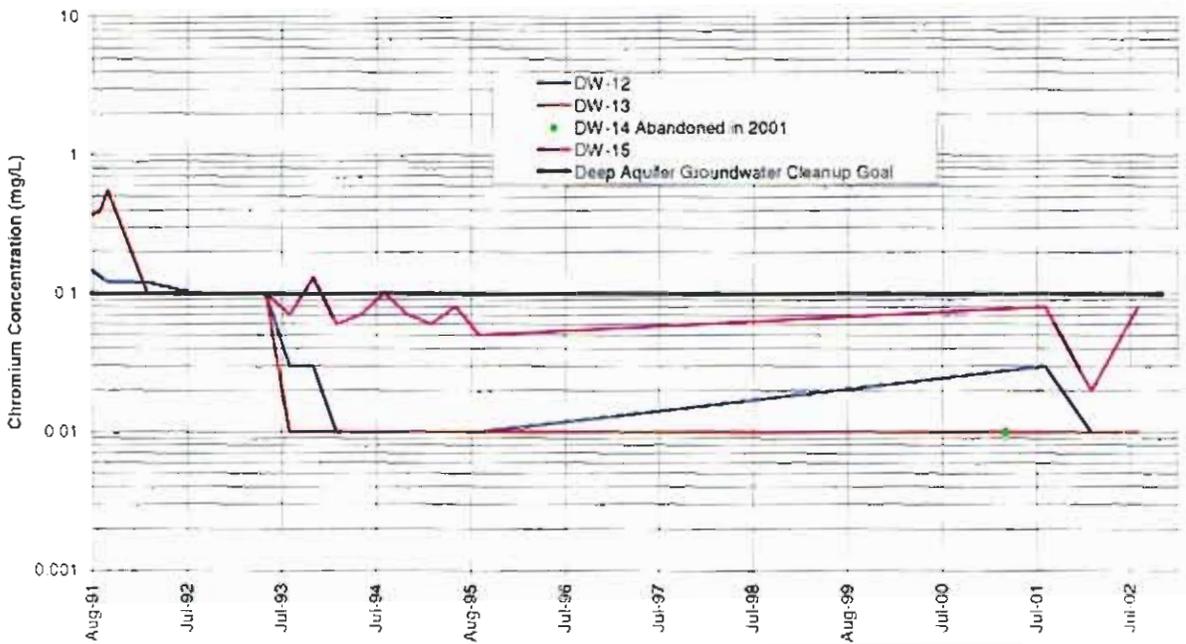
Figure 7-5
Deep Aquifer Groundwater Chromium Concentration Trends
United Chrome Products Site
Corvallis, Oregon

Chromium Concentration Trends

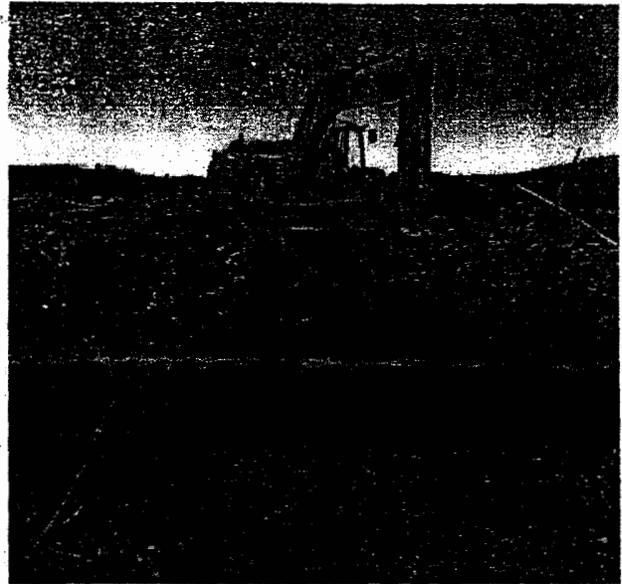
Soil is excavated from the location of former plating tanks, September 18, 2000.

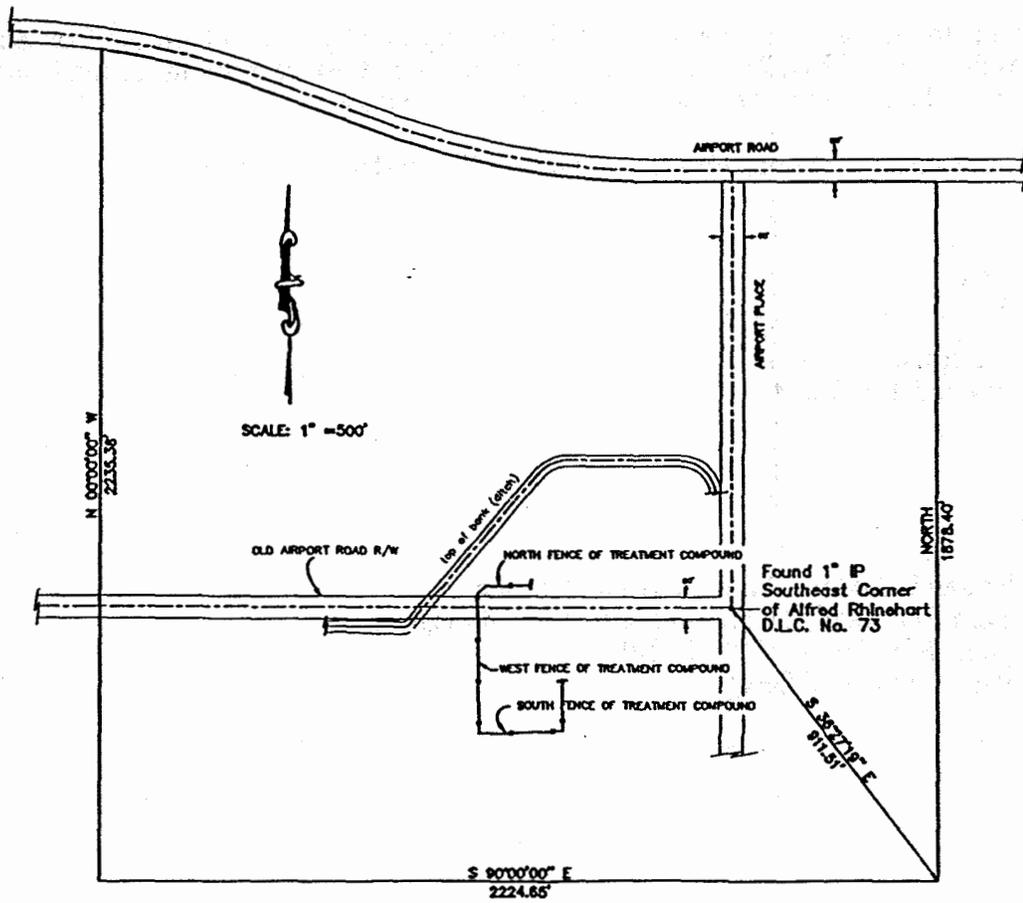
**CITY OF CORVALLIS AIRPORT CHROME TREATMENT SITE
OFFSITE GROUNDWATER USE RESTRICTION EASEMENT**

Beginning at the southeast corner of the Alfred Rhinehart Donation Land Claim No. 73, located in Township 12 South, Range 5 West of the Willamette Meridian, Benton County, Oregon; thence S 36°27'19"E, 911.51 feet to the TRUE POINT OF BEGINNING; thence WEST, 2224.65 feet; thence NORTH, 2235.38 feet to the south right of way of Airport Road; thence along said south right of way in and easterly direction to a point that is NORTH of the TRUE POINT OF BEGINNING; , thence SOUTH, 1878.40 feet to the TRUE POINT OF BEGINNING.
