FIGURE 1
SITE VICINITY MAP
TAYLOR LUMBER AND TREATING SUPERFUND SITE
SHERIDAN, OREGON

FIGURE 2
GENERAL LOCATION OF
WEST AND EAST FACILITIES
TAYLOR LUMBER AND TREATING
SUPERFUND SITE

FIGURE 8
KEY ELEMENTS OF SELECTED REMEDY
TAYLOR LUMBER AND TREATING
SUPERFUND SITE

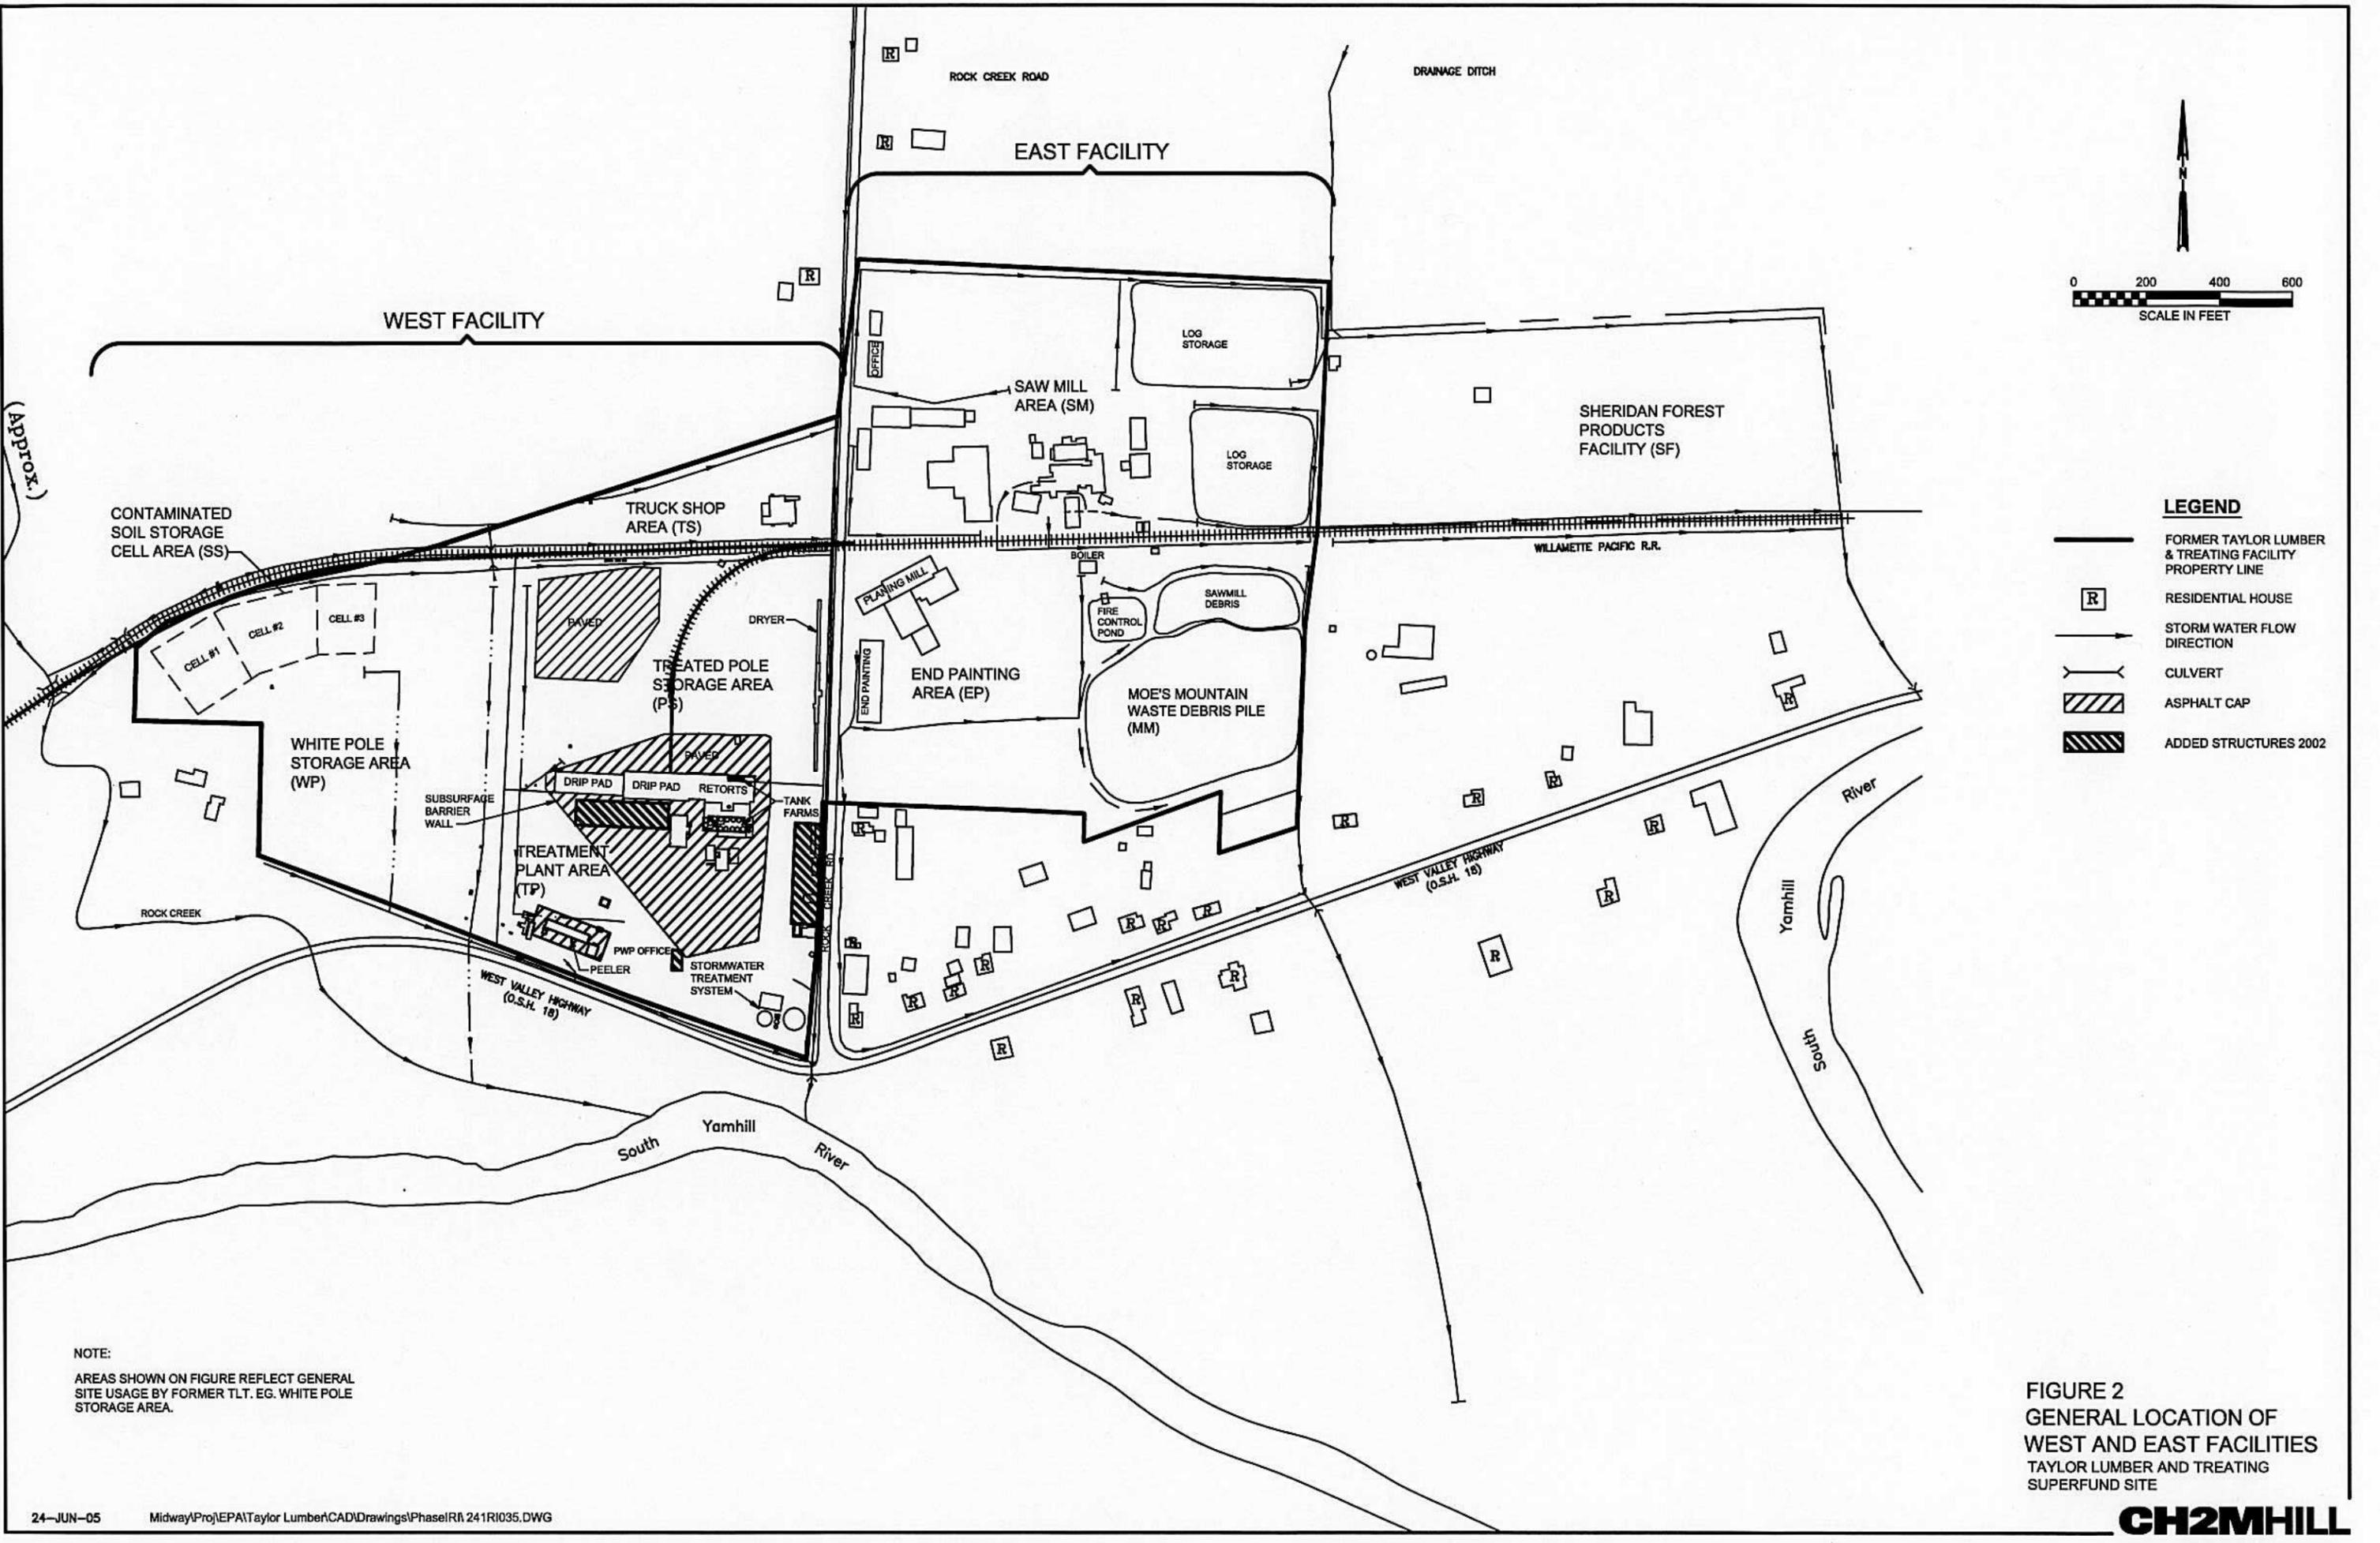
NOTE:
AREAS SHOWN ON FIGURE REFLECT GENERAL SITE USAGE BY FORMER TLT. EG. WHITE POLE STORAGE AREA.

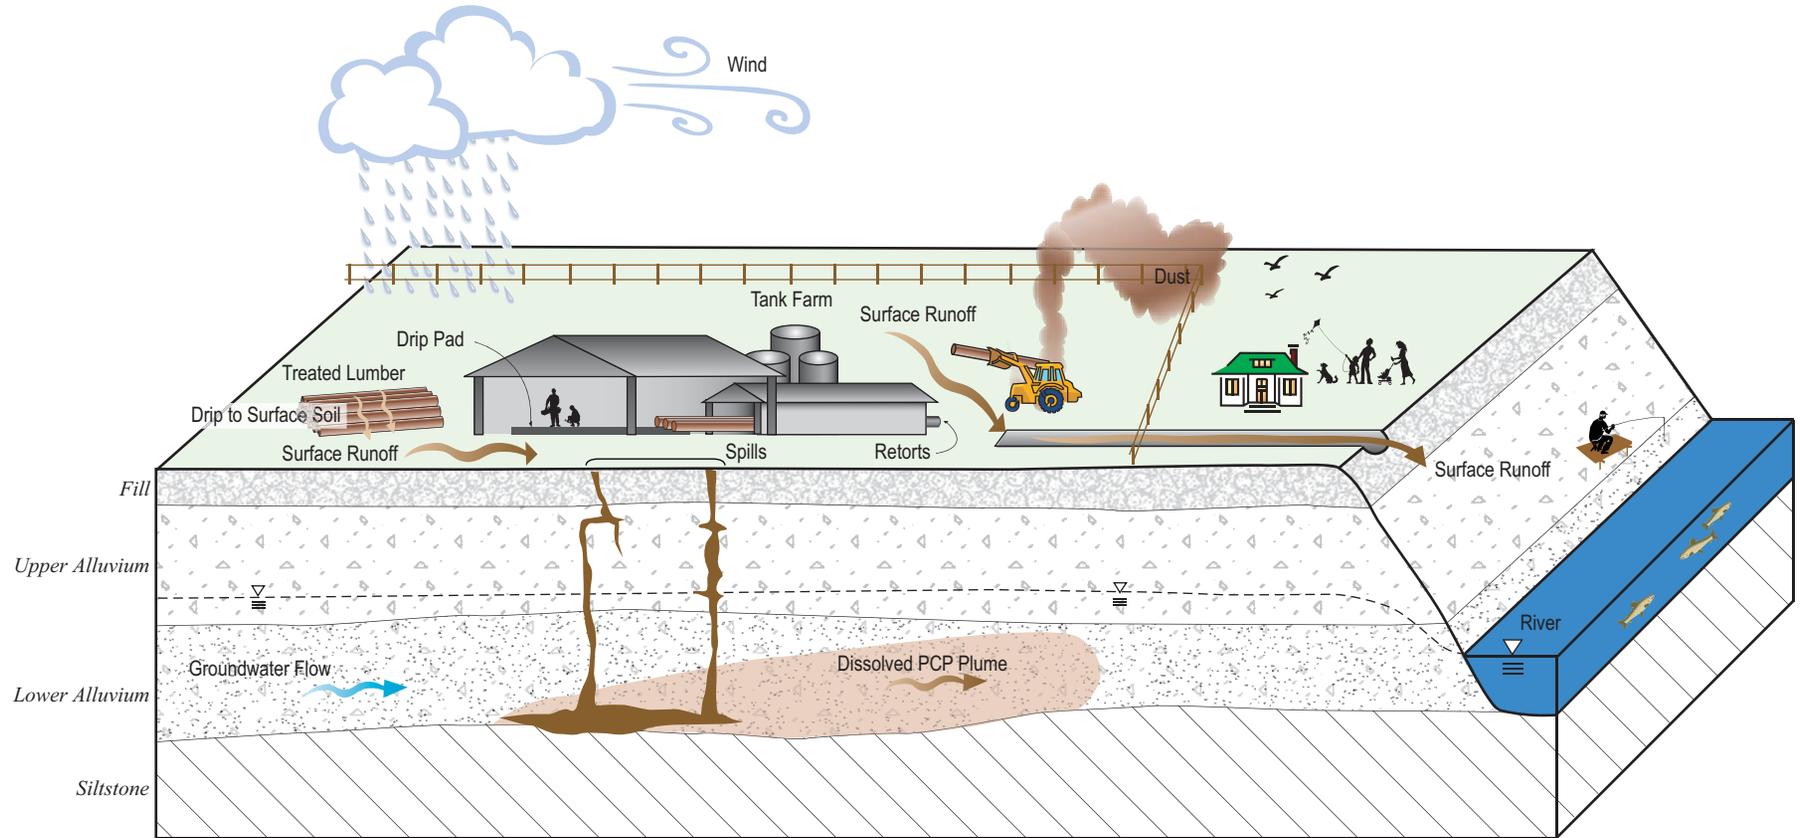
FIGURE 3
CONCEPTUAL SITE MODEL BEFORE 2000
TAYLOR LUMBER AND TREATING
SUPERFUND SITE

Before 2000

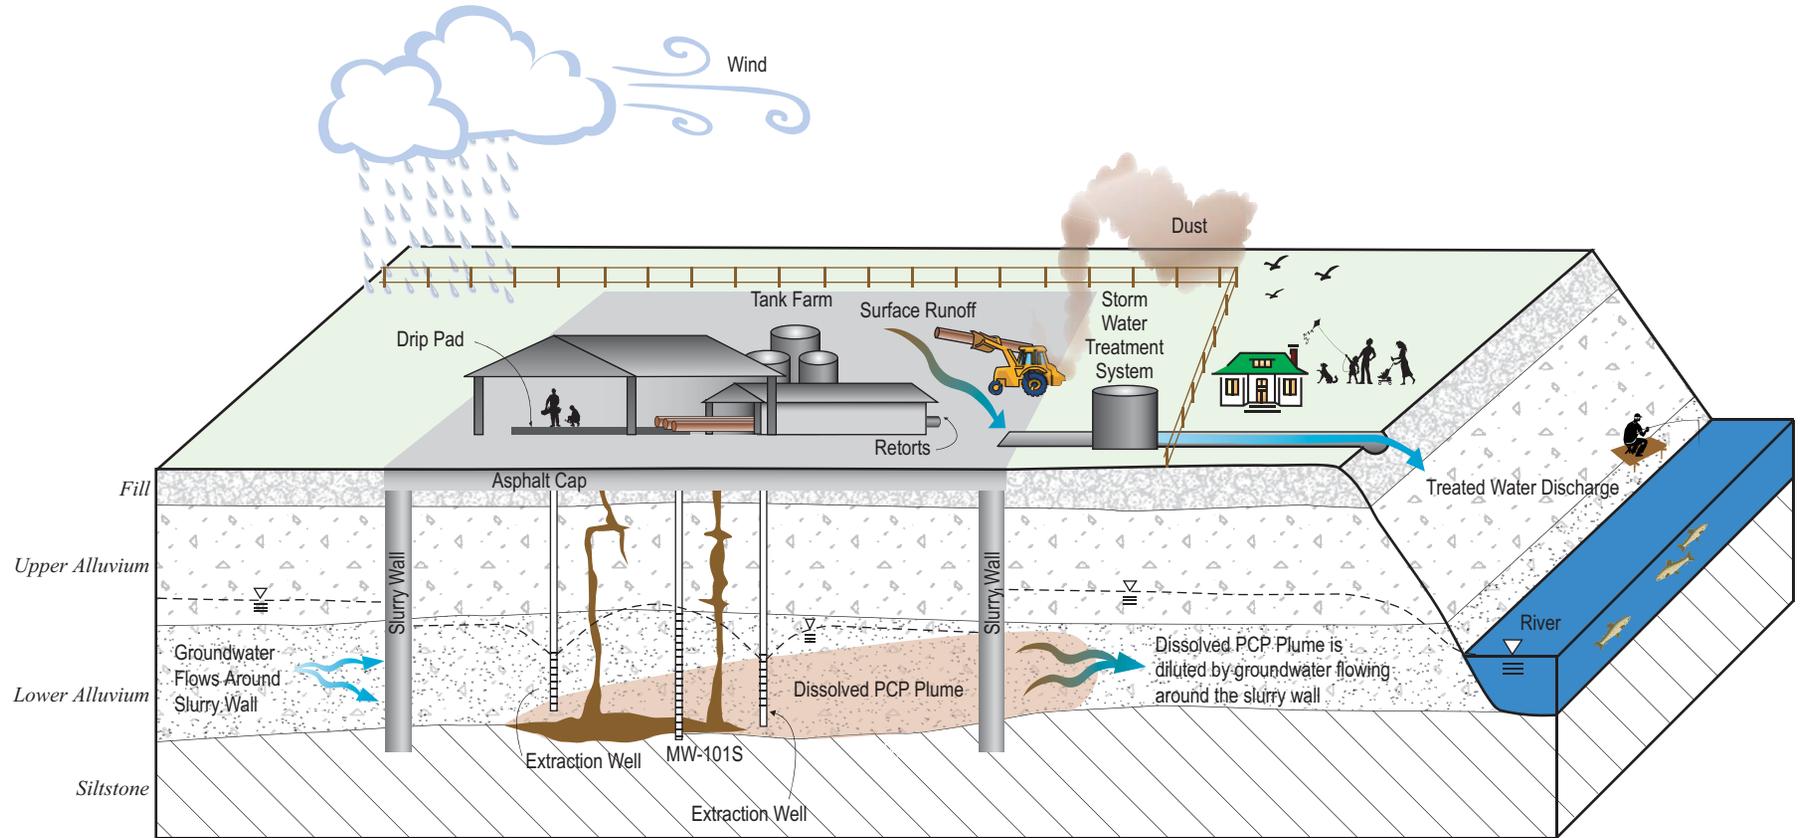
FIGURE 4
CONCEPTUAL SITE MODEL AFTER 2000
TAYLOR LUMBER AND TREATING
SUPERFUND SITE

After 2000

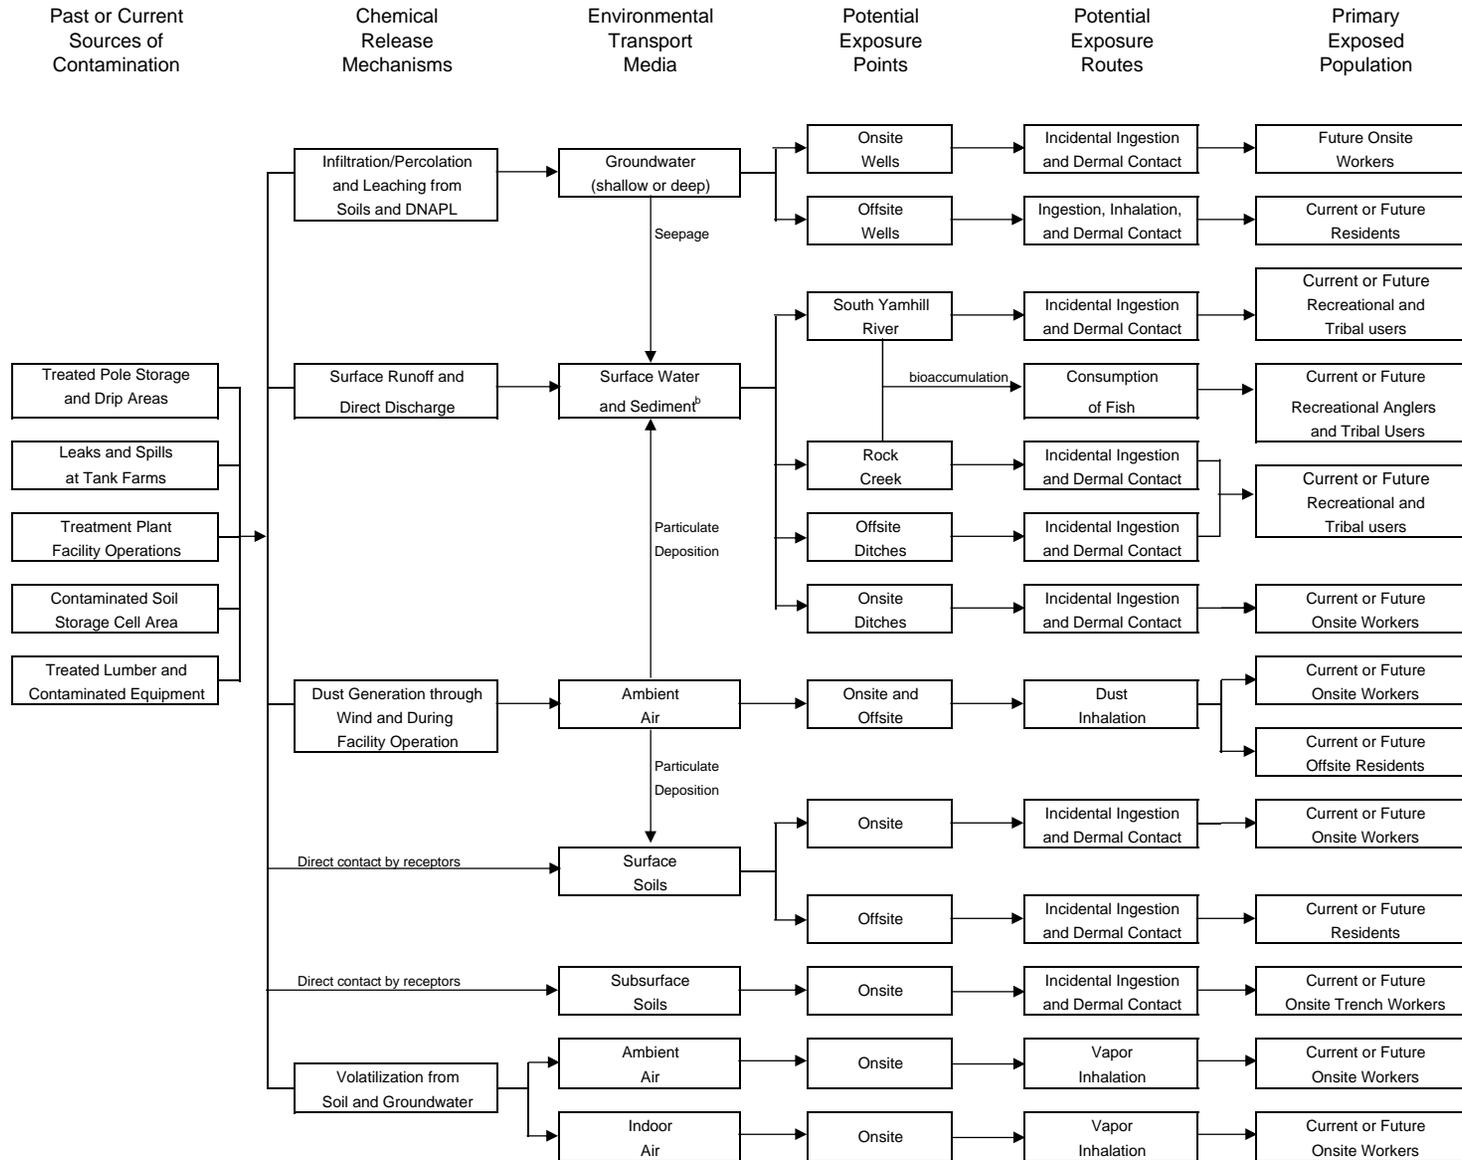
FIGURE 5

Sitewide Conceptual Site Model for Potential Human Exposures^a
Taylor Lumber and Treating Superfund Site

^a All of the exposure pathways depicted in this conceptual exposure model will be quantitatively evaluated during the baseline risk assessment

^b Includes river/creek sediment and sediment in onsite and offsite ditches termed "ditch soil" in the baseline risk assessment because the ditches are dry most of the year.

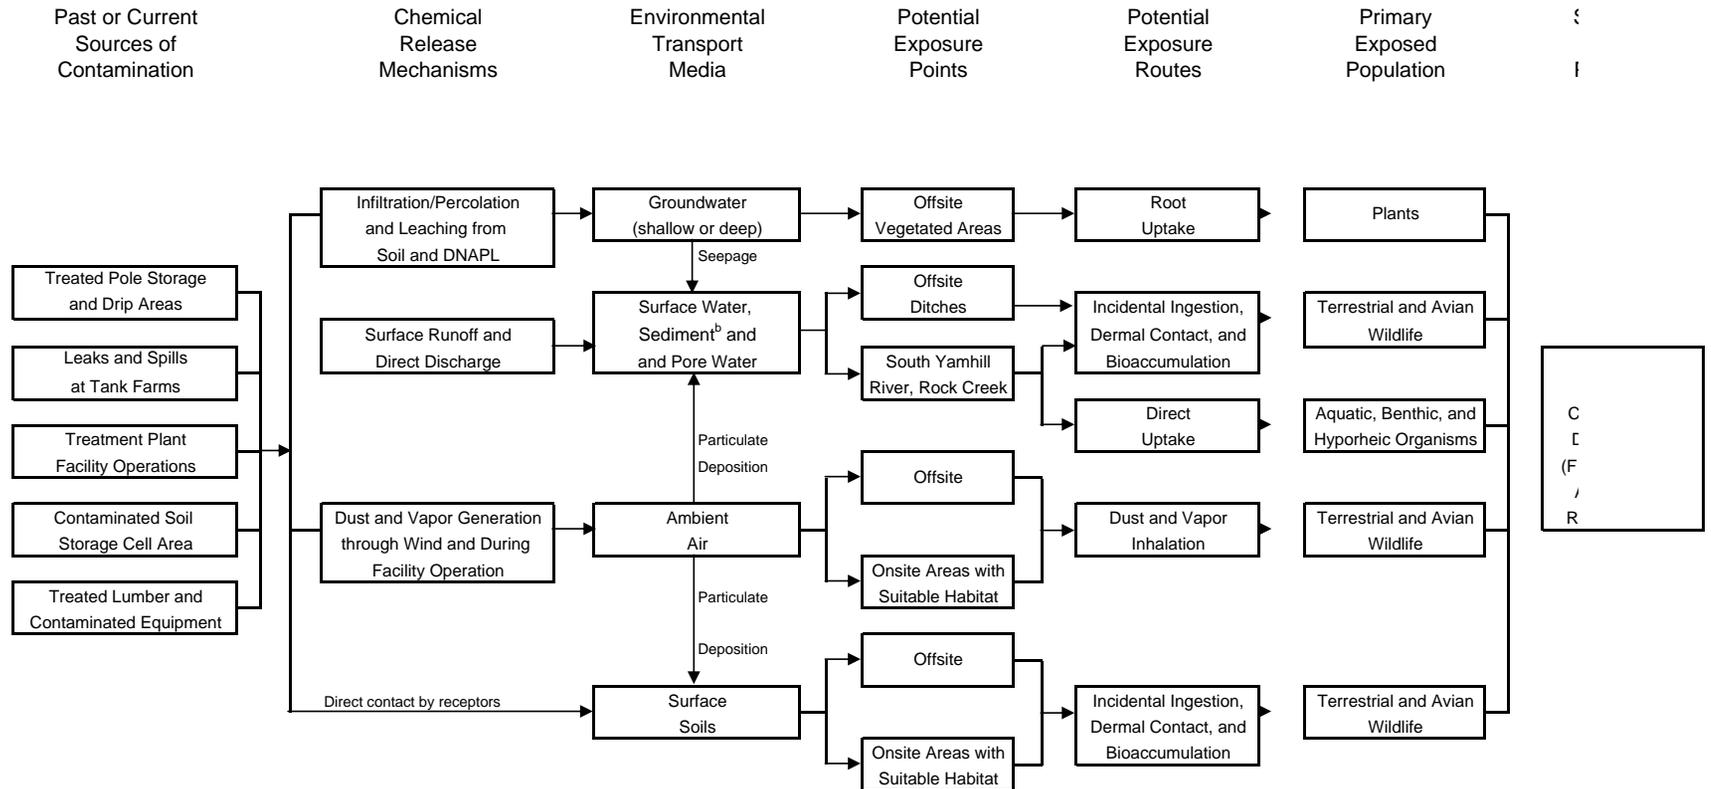
FIGURE 6
 Sitewide Conceptual Site Model for Potential Ecological Exposures^a
Taylor Lumber and Treating Superfund Site

^a All of the exposure pathways depicted in this conceptual exposure model will be quantitatively evaluated during the baseline risk assessment with the exception of dermal contact, dust inhalation, and vapor inhalation; these pathways will be qualitatively addressed in the uncertainty discussion.

^b Includes river/creek sediment and sediment in onsite and offsite ditches termed "ditch soil" in the baseline risk assessment because the ditches are dry most of the year.

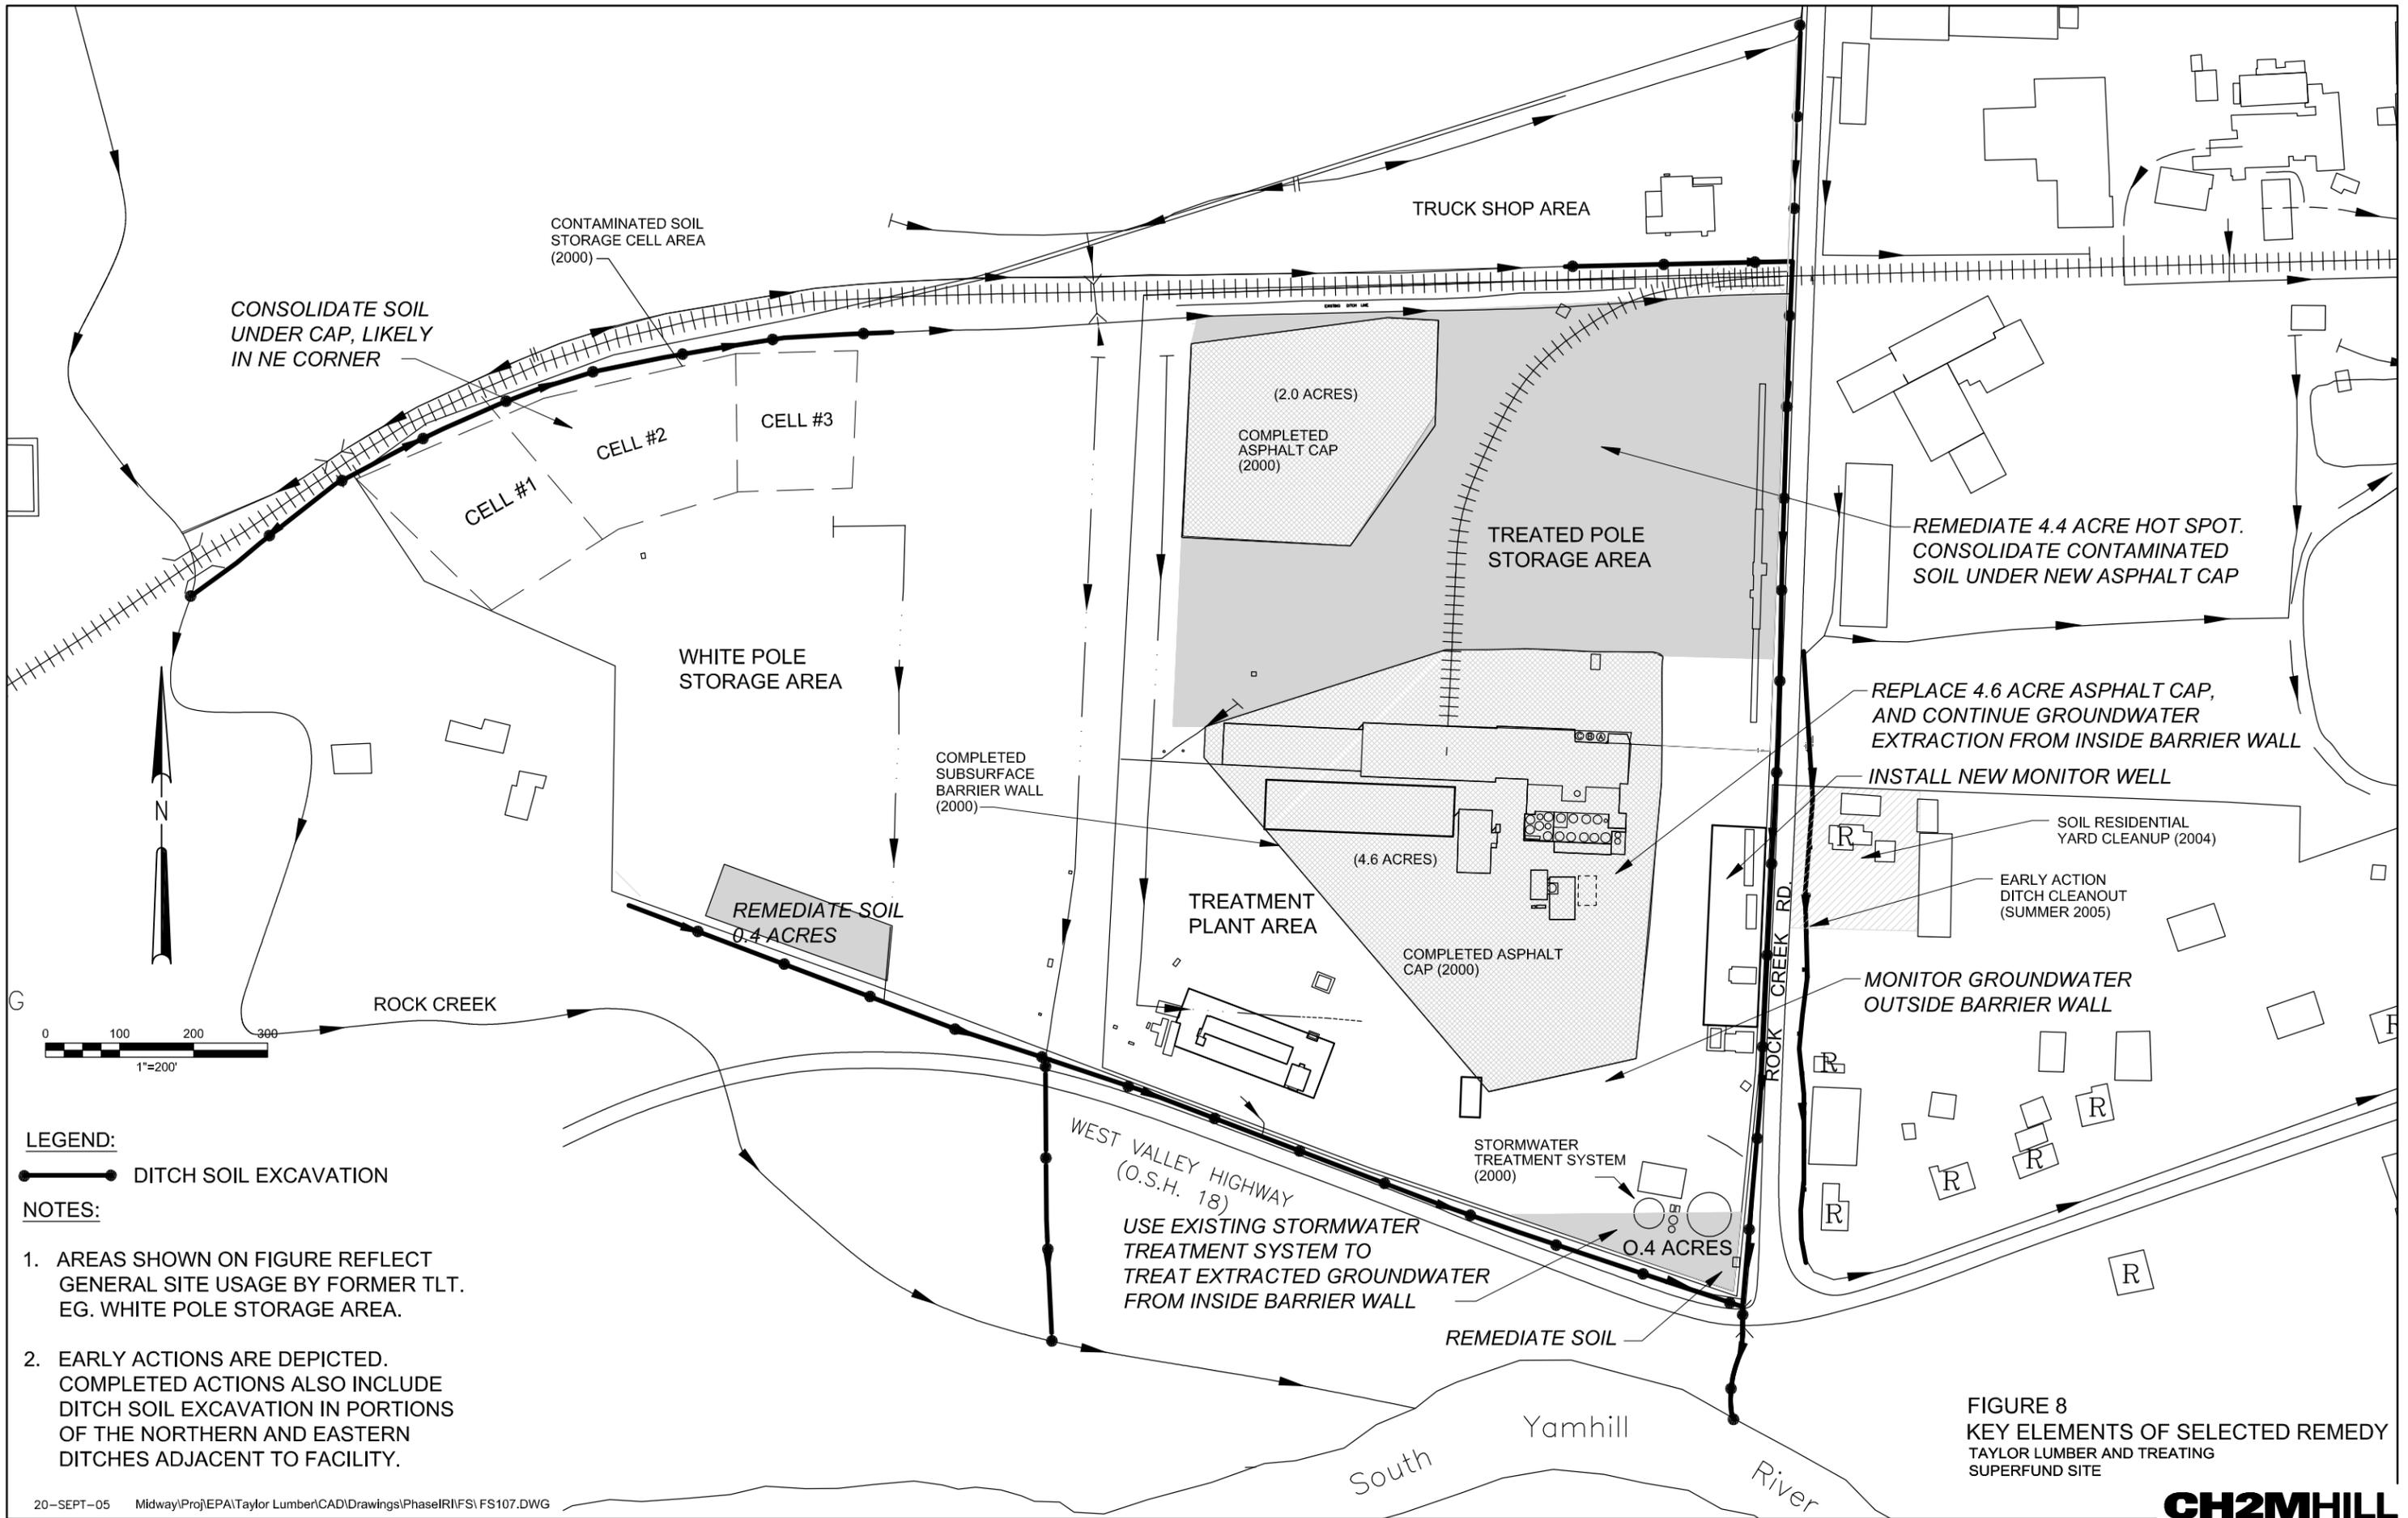
CONSOLIDATE SOIL UNDER CAP, LIKELY IN NE CORNER

REMEDiate 4.4 ACRE HOT SPOT. CONSOLIDATE CONTAMINATED SOIL UNDER NEW ASPHALT CAP

REPLACE 4.6 ACRE ASPHALT CAP, AND CONTINUE GROUNDWATER EXTRACTION FROM INSIDE BARRIER WALL

INSTALL NEW MONITOR WELL

EARLY ACTION DITCH CLEANOUT (SUMMER 2005)

MONITOR GROUNDWATER OUTSIDE BARRIER WALL

USE EXISTING STORMWATER TREATMENT SYSTEM TO TREAT EXTRACTED GROUNDWATER FROM INSIDE BARRIER WALL

- NOTES:**
1. AREAS SHOWN ON FIGURE REFLECT GENERAL SITE USAGE BY FORMER TLT. EG. WHITE POLE STORAGE AREA.
 2. EARLY ACTIONS ARE DEPICTED. COMPLETED ACTIONS ALSO INCLUDE DITCH SOIL EXCAVATION IN PORTIONS OF THE NORTHERN AND EASTERN DITCHES ADJACENT TO FACILITY.
