Figure B-21b
Summary Analytical Results
Inorganics Detected Above Screening Levels
RISBON-59 Area
 Final Remedial Investigation Report
 Casmalia Resources Superfund Site
 January 2011

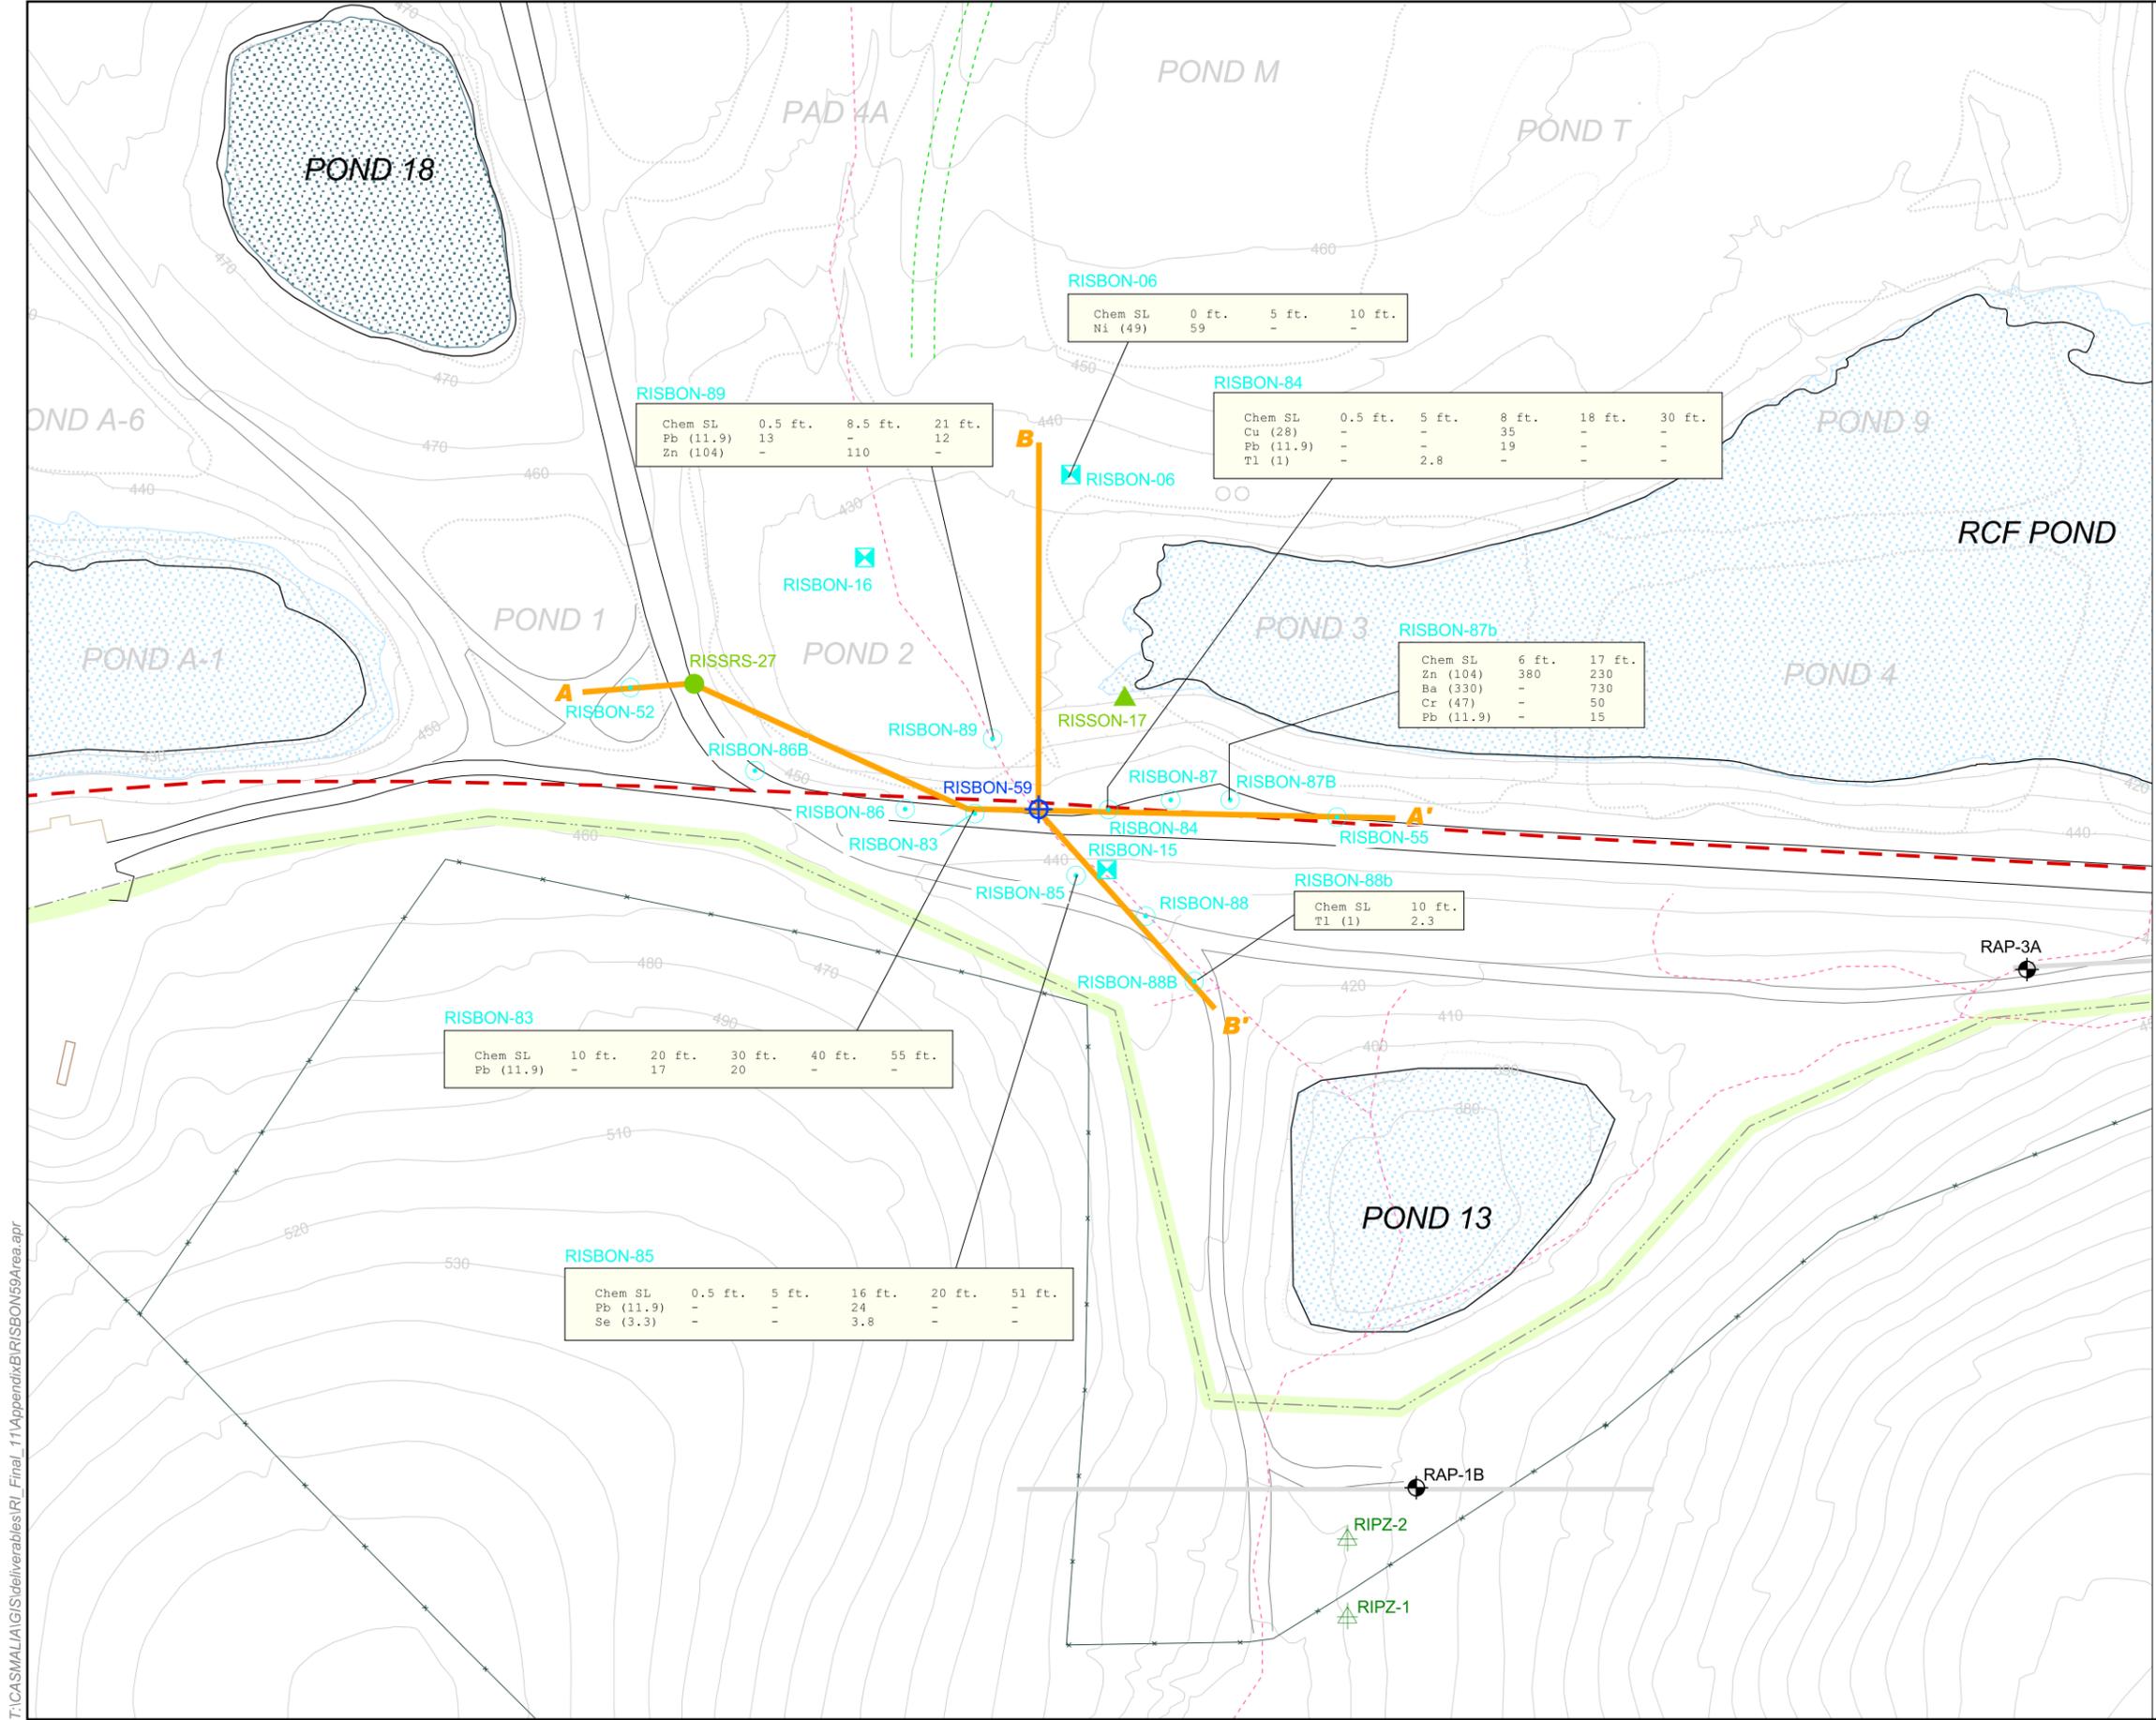
All Values in mg/kg
