FIGURE 6-22
 PESTICIDES/PCBS DETECTED IN NATURAL SOIL
 DES MOINES SOUTH AREA SOURCE CONTROL PROJECT
 DES MOINES, IOWA
ECKENFELDER INC. Nashville, Tennessee
 Mahwah, New Jersey
 Rochester, New York

DES MOINES SOUTH AREA
 SOURCE CONTROL PROJECT
 DES MOINES, IOWA

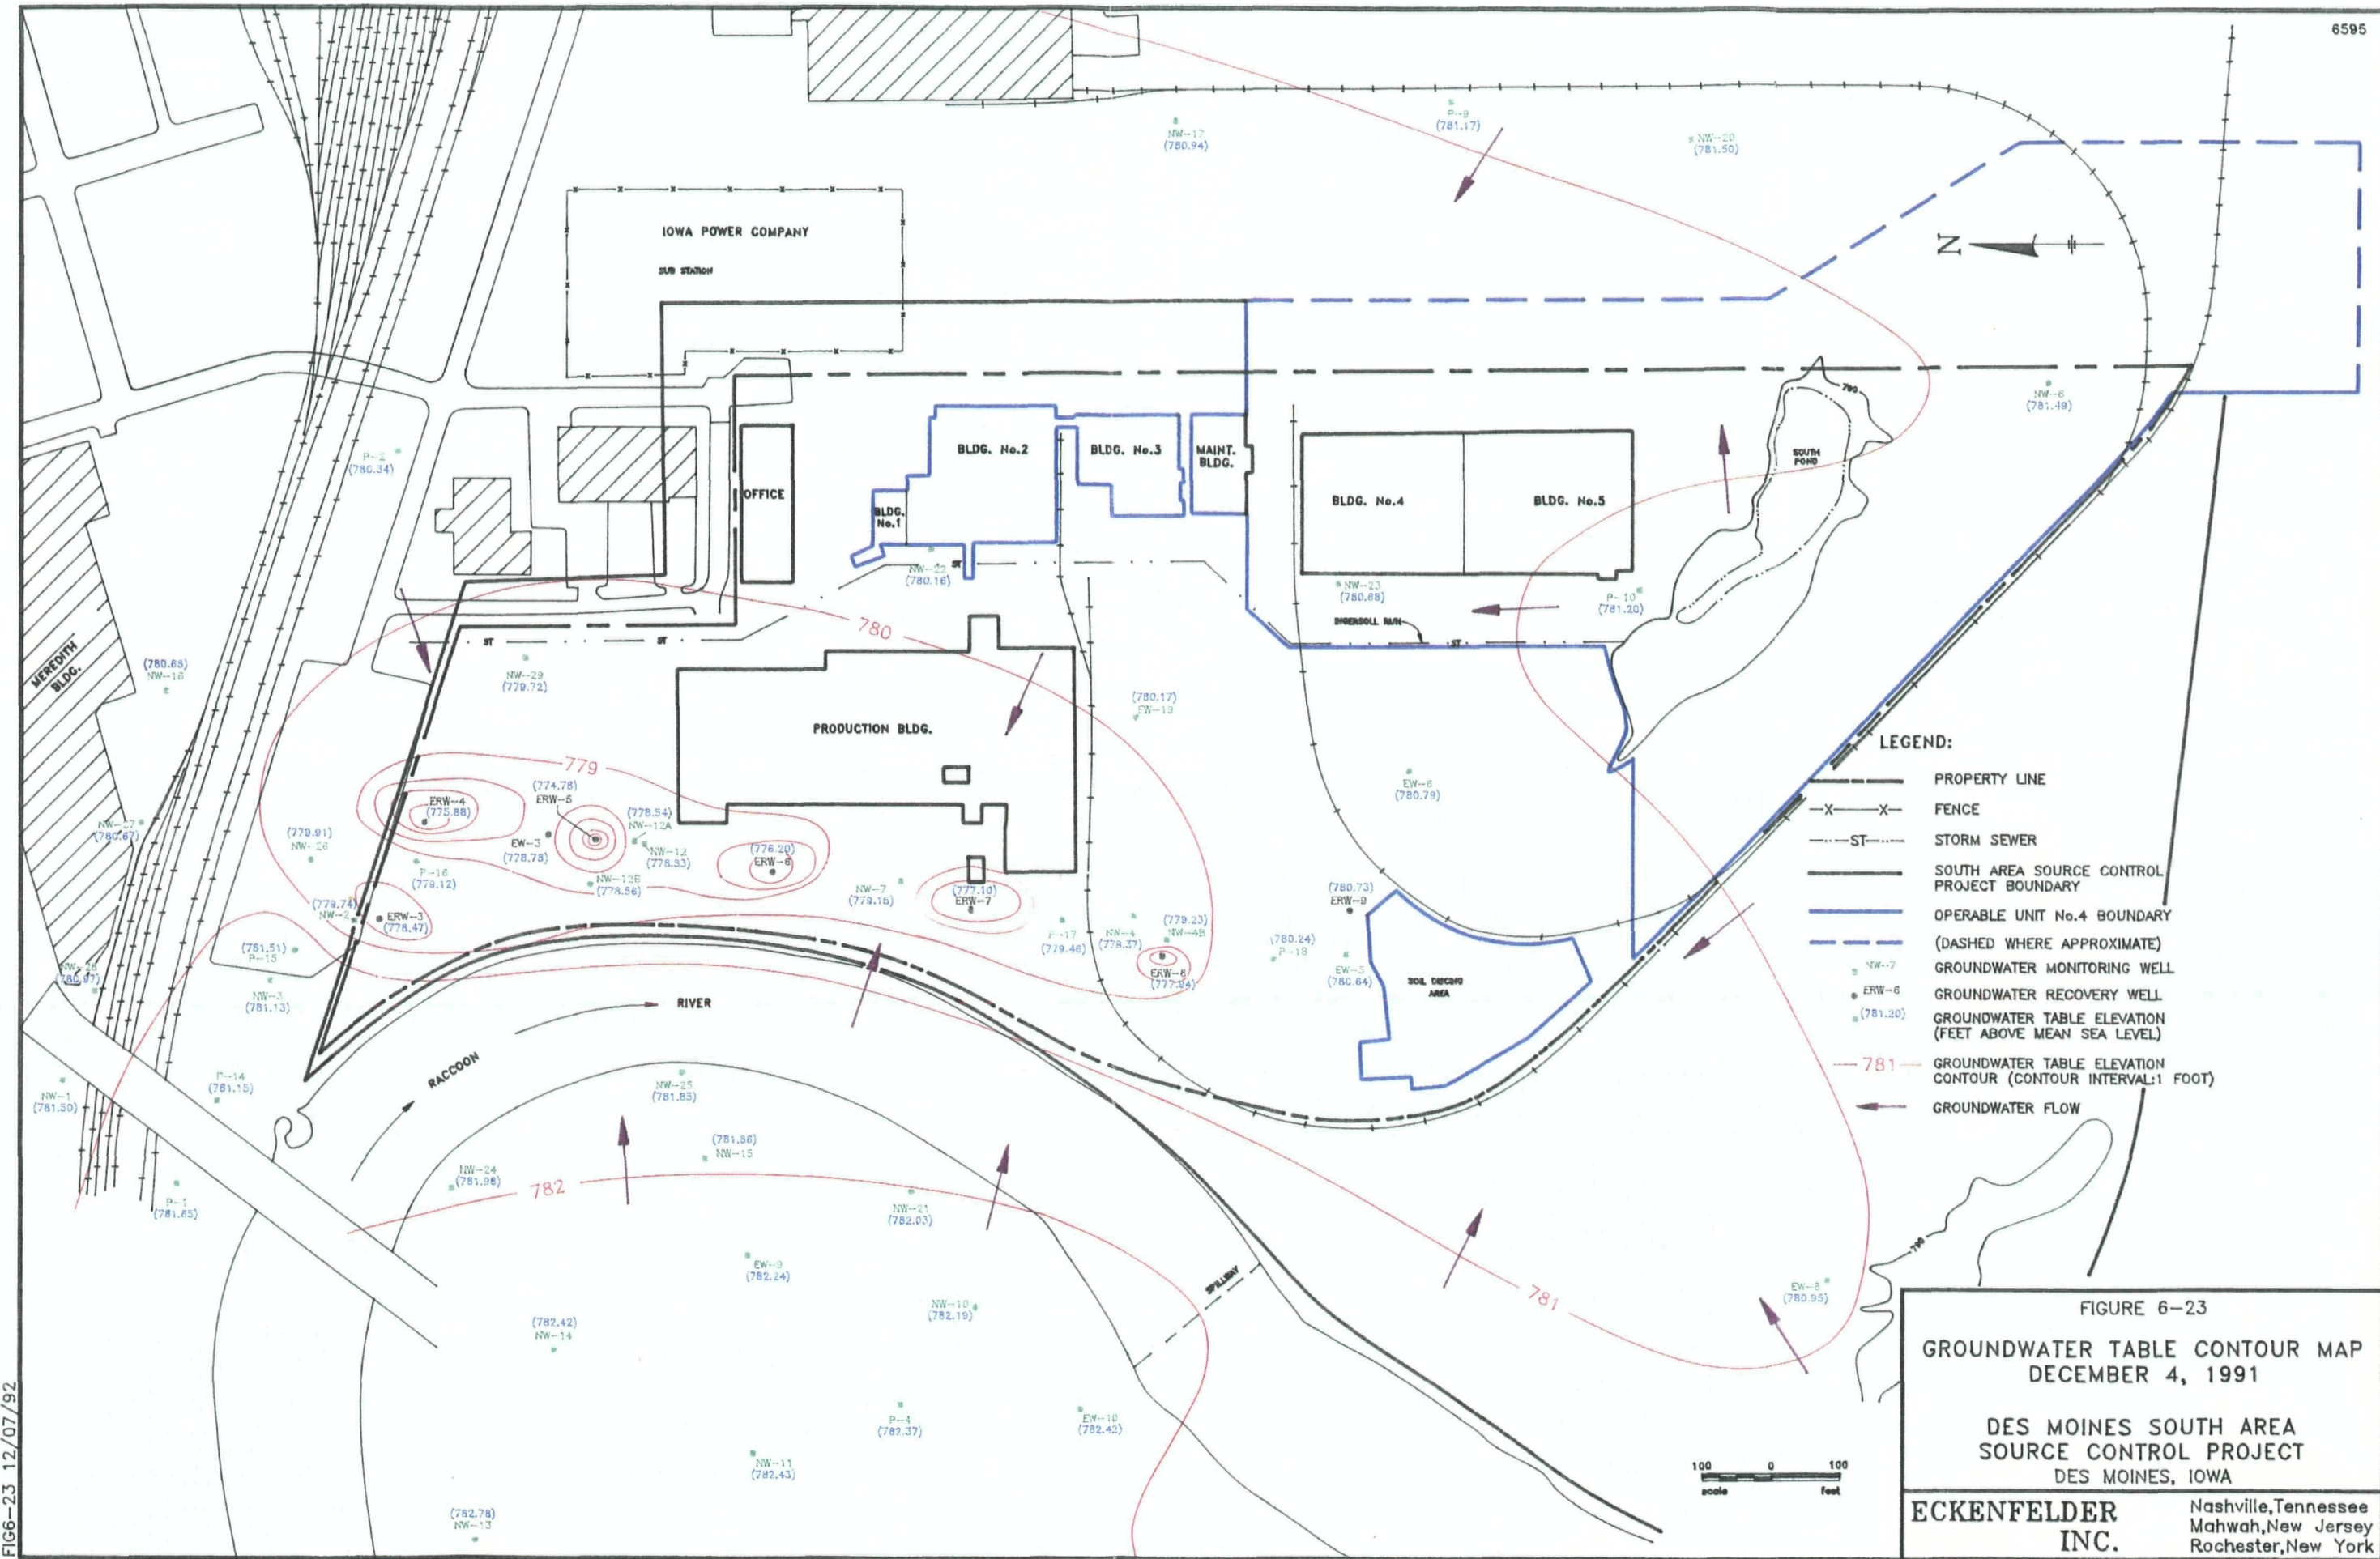
FIG6-23 12/07/92

FIGURE 6-23
 GROUNDWATER TABLE CONTOUR MAP
 DECEMBER 4, 1991
