1. COMPLAINANT"S SUPPLEMENTAL EXHIBIT 1: EPA Site Inspection Report, dated June 15, 2012.

REGIONAL SITE INSPECTION REPORT JOSEPH L. BOLLIG & SONS, INC. case 2012 JUN 29 AM 10: 18

Northeast Quarter of Section 34, Town of Lisbon, Juneau County, Wisconsin May 11, 2012

(REPORT DATE: June 15, 2012)

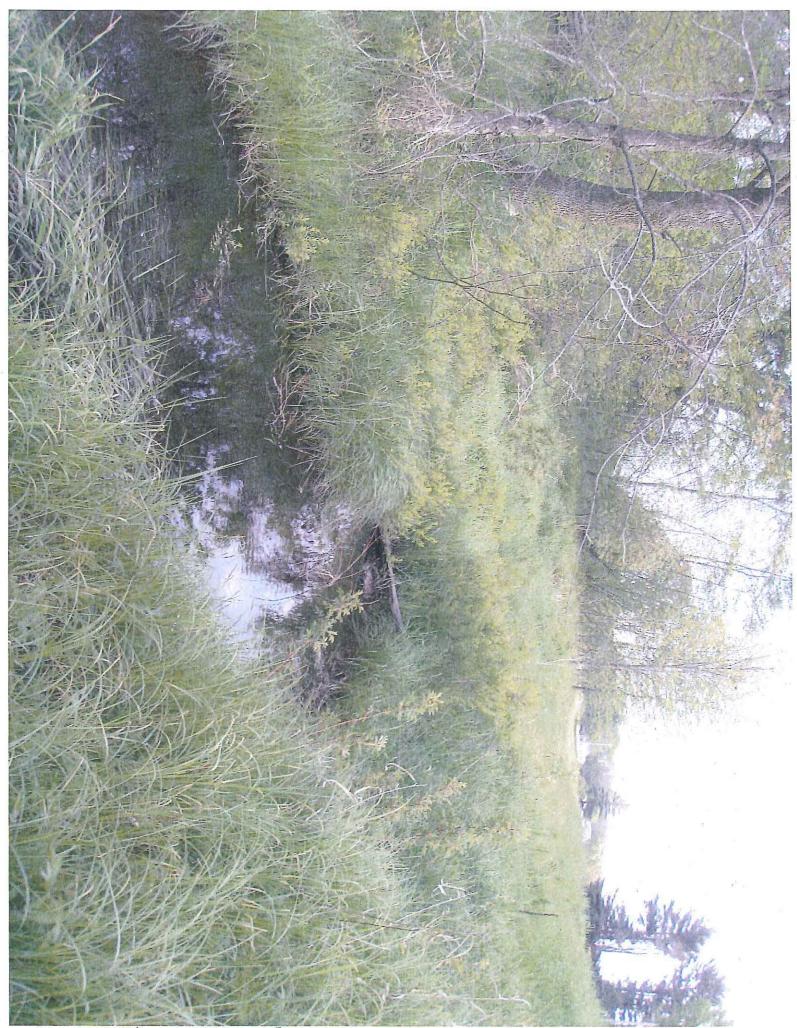
COMPLANANT'S SUPPLEMENTAL EXHIRT - PHOTO 1

OBSERVATIONS: I parked along the east or northbound shoulder of U.S. Highway 12 on May 11th, around 7:45 a.m. where the unnamed tributary enters a culvert beneath the highway. I walked to the upstream side of the U.S. 12 culvert to check for flow and observe the channel. There was no discernable flow into the culvert or in the channel upstream of it, but the channel and culvert contained significant amounts of water. Photo 1 is an upstream view of the unnamed tributary's channel a few feet upstream of the culvert. I walked the channel upstream as it parallels the highway for about 120 feet and took Photo 2 through overhanging dogwoods and alders as the channel bent away from the highway right of way. Crossing the highway to the downstream side of the highway culvert, I took a couple of photos depicting the sinuous channel at the same spot where data was collected by EPA in October 2009. Photo 3 depicts the first channel bend downstream of the highway culvert and the general location of the channel thalweg measurement in 2009. The channel waters were in flood stage as the water levels exceeded the bank height. Photo 4 depicts a close-up of the channel near the thalweg measurement. The floating grasses at the interface of the open channel waters and the vegetated bank belie the flooding nature of the channel at this point in time. A channel thalweg measurement yielded depths of 33 and 35 inches within six inches of each other. In contrast, the channel thalweg was 16 inches in 2009 and described as bankfull or to the top of the discernable channel bank. Photo 5 depicts the flooded ground between the unnamed tributary channel as it meanders toward the Lemonweir River – note the mirrored water surface within the willow clump in the photo center. Photo 6 depicts the continuation of the channel downstream towards the Lemonweir River. Given the increased water depths from the fall of 2009 to the spring of 2012, the flooded ground on the downstream side of the U.S. 12 highway culvert and the lack of flow even with the increased water levels, likely means the Lemonweir River is in flood stage. If the Lemonweir River is in flood stage, then the observations of the unnamed tributary are depicting back waters of the flood.
