Technical Advisory Committee Meeting
2015 RI/FS Summary
Leviathan Mine Site, Alpine County, California

January 28, 2016

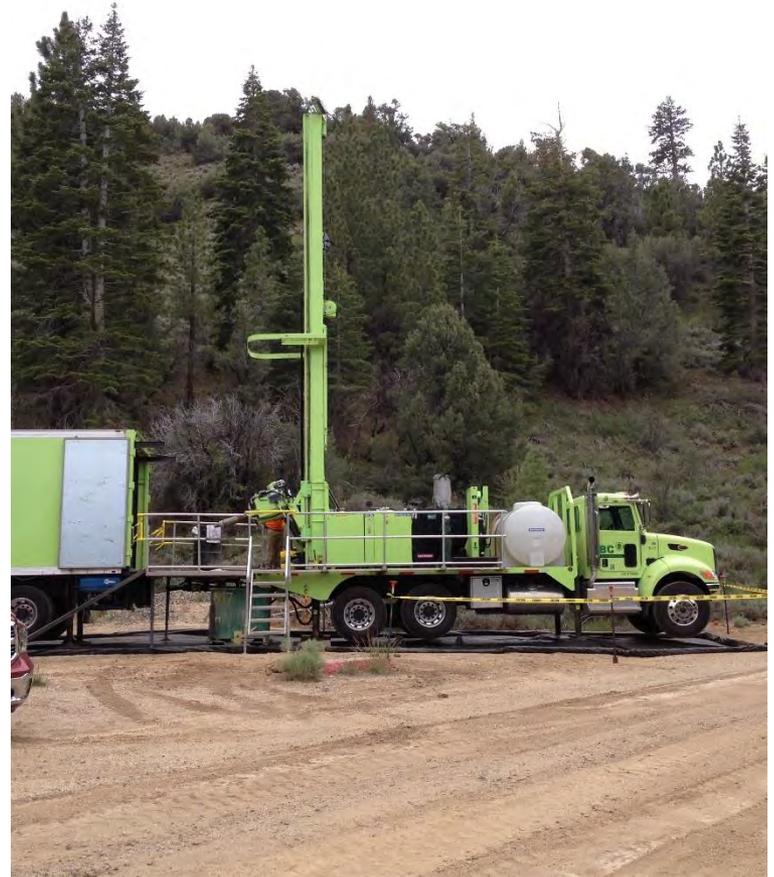
2015 On-Property Monitoring Well Installation (continued)

Locations:

► Four monitoring wells installed:

- MW-41 (LOC-29)
 - Borehole = 141 ft bgs
 - Well = 110 ft bgs
 - Screen = 20 feet
- MW-42 (LOC-10D)
 - Borehole = 182 ft bgs
 - Well = 170 ft bgs
 - Screen = 15 feet
- MW-43 (LOC-10S)
 - Borehole = 76 ft bgs
 - Well = 74 ft bgs
 - Screen = 15 feet
- MW-44 (DB-06)
 - Borehole = 150 ft bgs
 - Well = 141 ft bgs
 - Screen = 10 feet

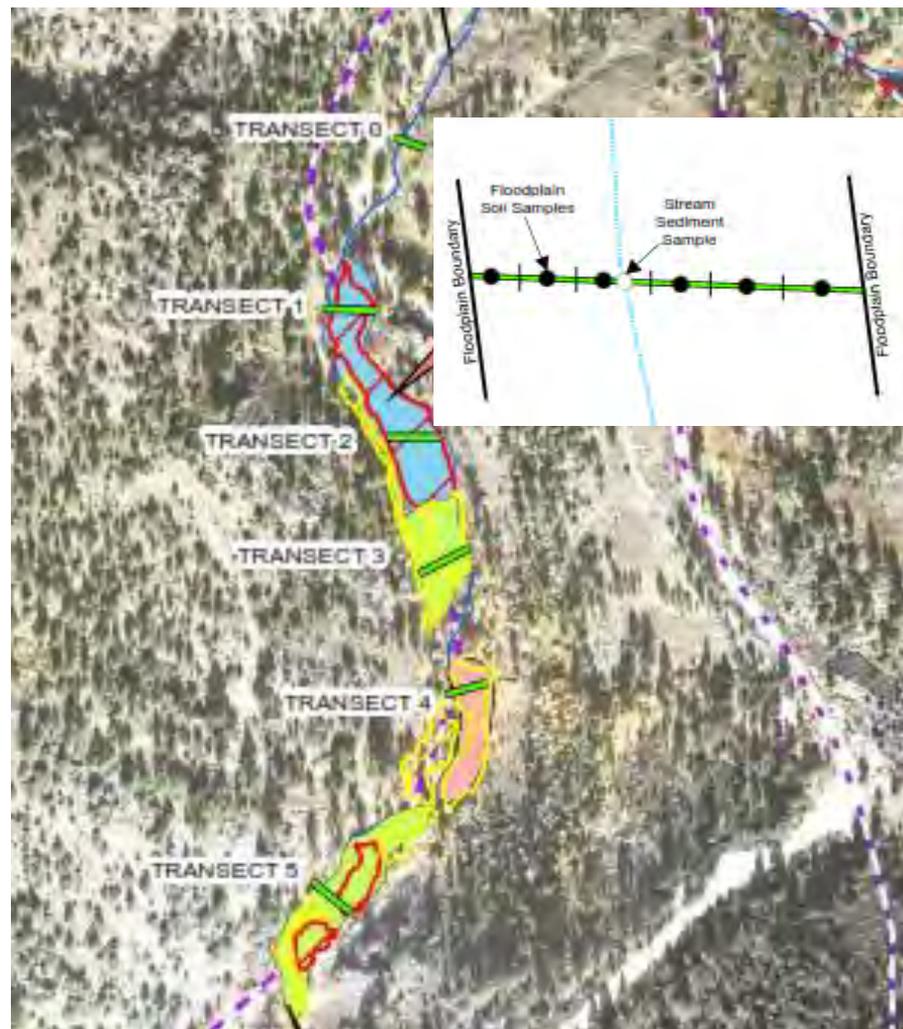
2015 Beaver Dam/Pond Complex Investigation (continued)

Locations:

- ▶ Six transects identified
- ▶ Six floodplain soil sampling locations along each transect
- ▶ One chemical precipitate and stream sediment sampling location along each transect

Sampling and Analysis:

- ▶ Sampling along Transect 1 – 4 completed (except deeper samples along Transect 4)
 - ▶ 88 primary floodplain samples collected depths ranging from 0 to 14.5 feet bgs
 - ▶ Four primary sediment samples collected from 0 to 2 cm bgs
 - ▶ Four precipitate samples

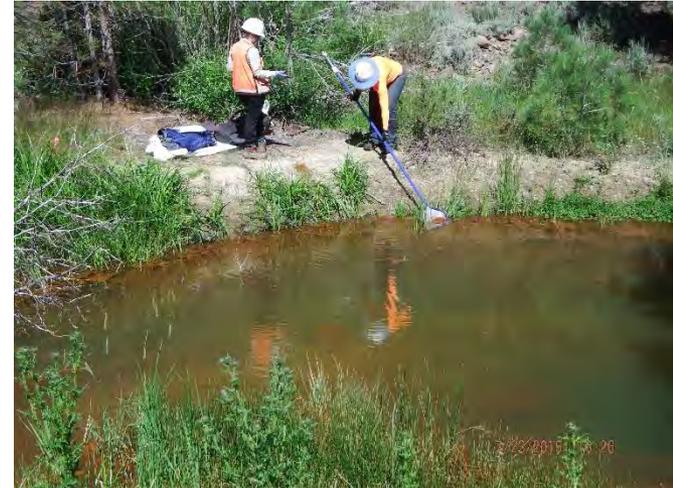
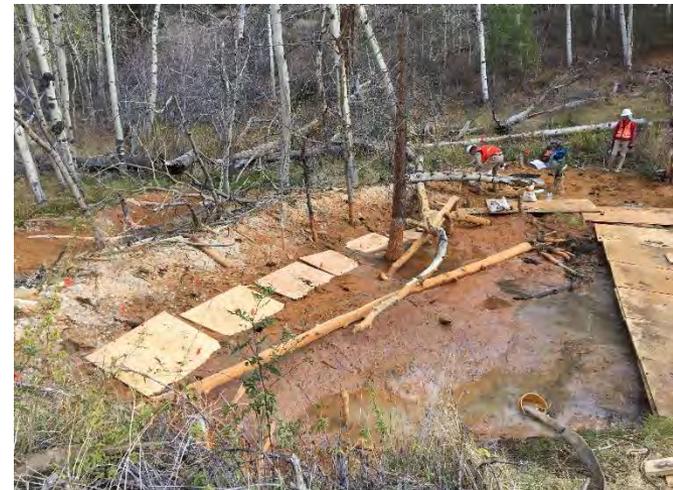
2015 Beaver Dam/Pond Complex Investigation

Dam Mud Characterization Sampling

Phase 1:

- ▶ Mud in three dams
- ▶ Precipitate in five ponds

Phase 2:

- ▶ More extensive sampling of mud in three dams

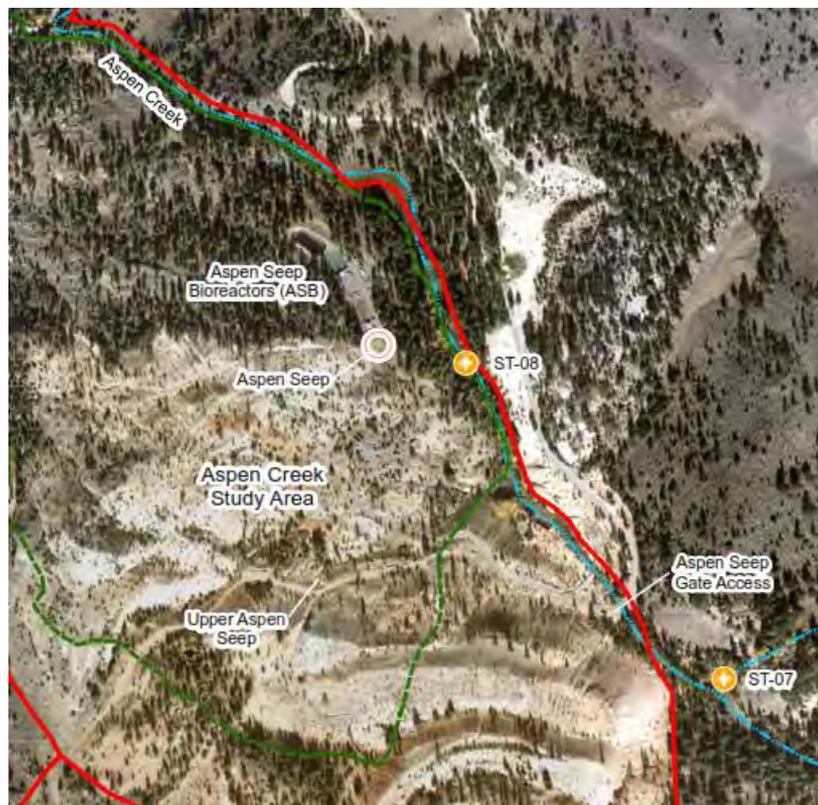
2015 Aspen Creek Storm Water Station Installation

Locations:

- ▶ ST-07 – Aspen Creek upstream of the mine
- ▶ ST-08 – Aspen Creek adjacent to Aspen Seep

Installed:

- ▶ Sampler enclosure
- ▶ V-notched weir
- ▶ Automatic sampler, water quality probes, and velocity/area sensor

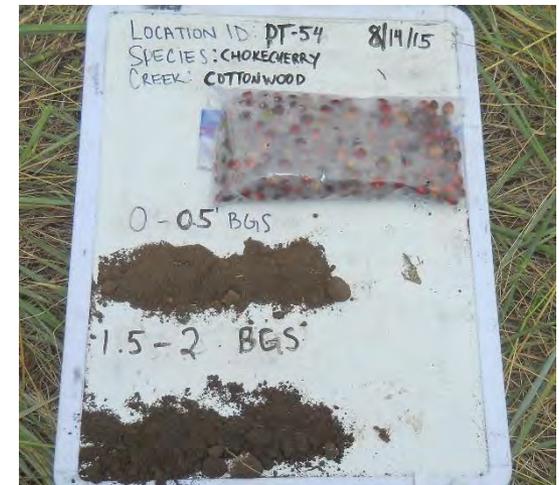
2015 River Ranch Soil Investigation

Locations:

- ▶ Spatially distributed samples
 - ▶ 28 locations
- ▶ Transects
 - ▶ 1 transect – 3 sample locations

Sampling and Analysis:

- ▶ Depth
 - ▶ 0-0.5, 0.5-1.5, 1.0-1.5, 1.5-2.0 ft bgs
- ▶ Submitted to laboratory for analysis
 - ▶ 0-0.5 & 1.5-2.0 ft bgs all locations
 - ▶ 0.5-1.0 & 1.0-1.5 ft bgs select locations
- ▶ Analysis
 - ▶ RI/FS metals, soil pH, TOC, soil conductivity, cations
