Fracture Stereonet  
RIPZ-15  
Final Remedial Investigation Report  
Casmalia Resources Superfund Site  
Casmalia, California

**E-9**

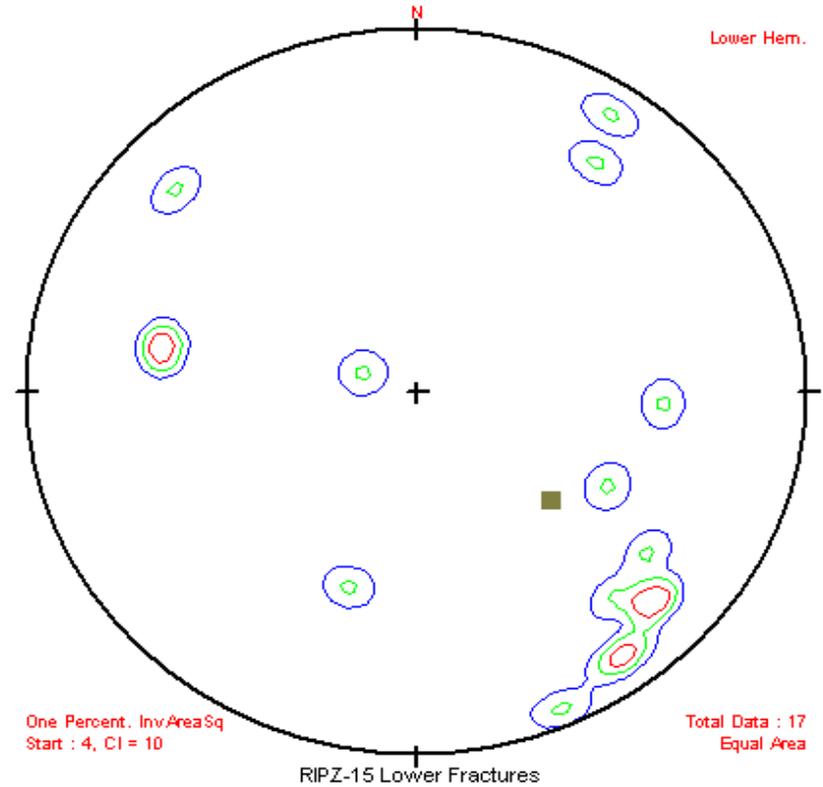
RIPZ-15 Borehole was cased below the Upper HSU

■ Mean Direction (strike,dip): 221,38
