**Action Memorandum Amendment
Kenwood Stormwater Drainage Pathway
Montrose Chemical Superfund Site**

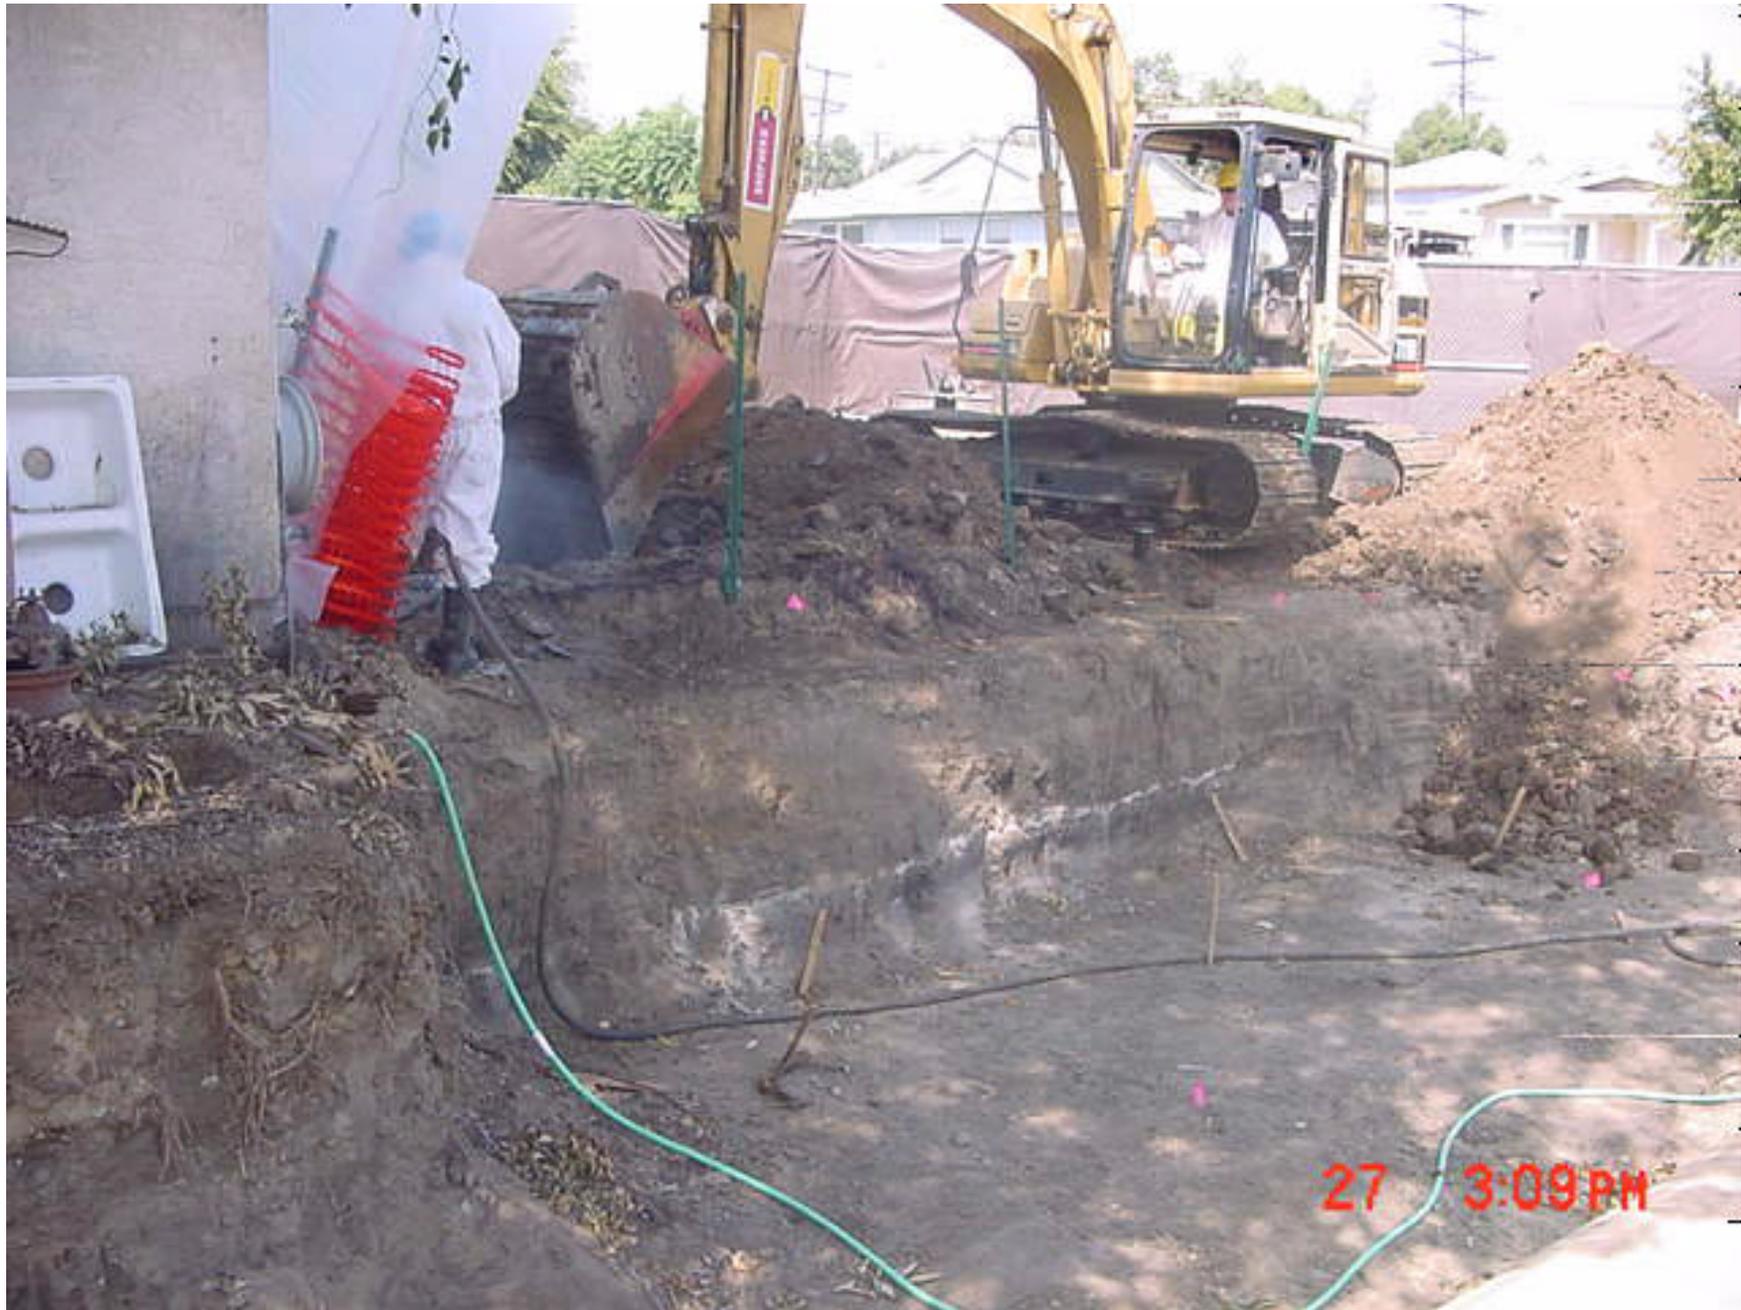
**Figure 1A**

*Example of Depositional Layer in
open excavation at 20713 Kenwood*

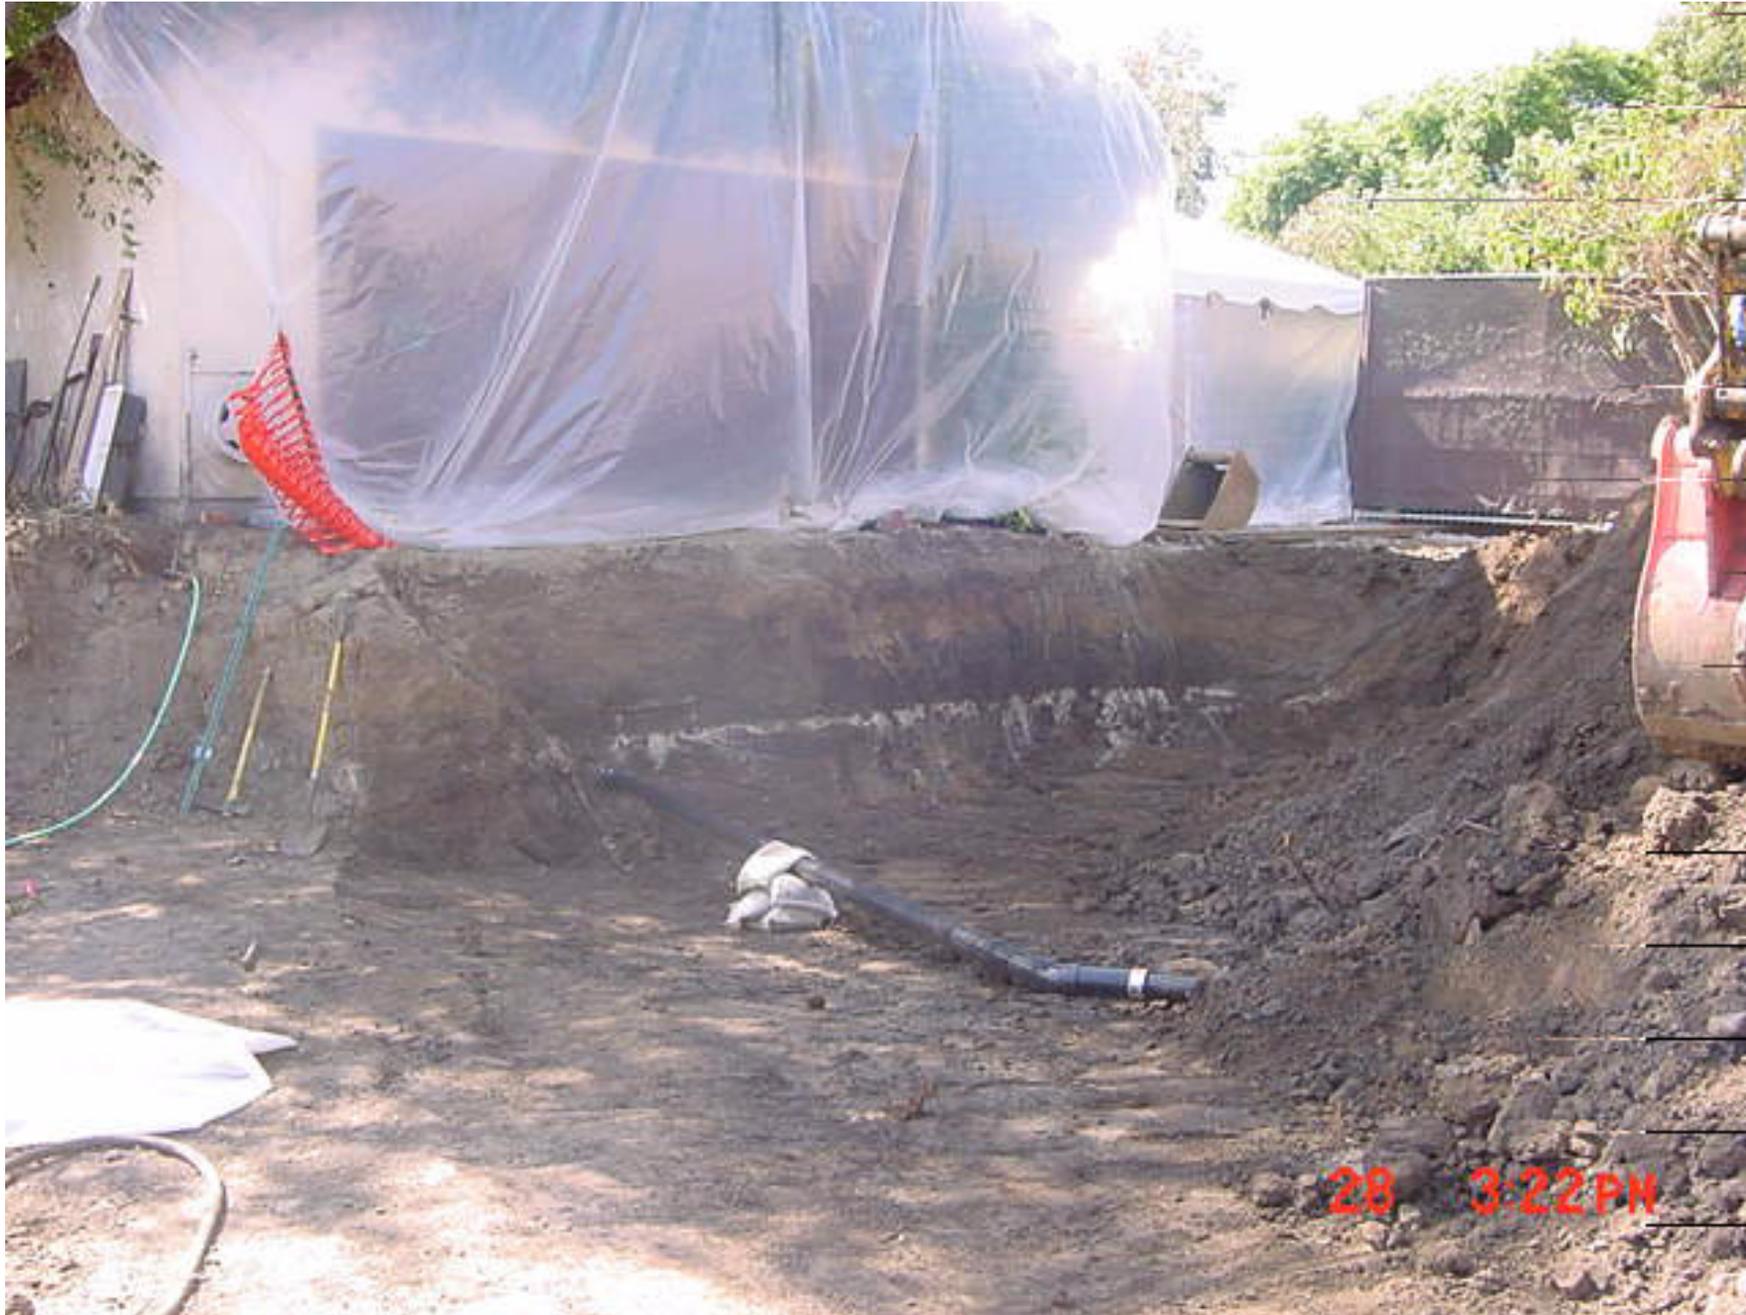
**Figure 1B**

*Example of Depositional Layer in
open excavation at 20713 Kenwood*

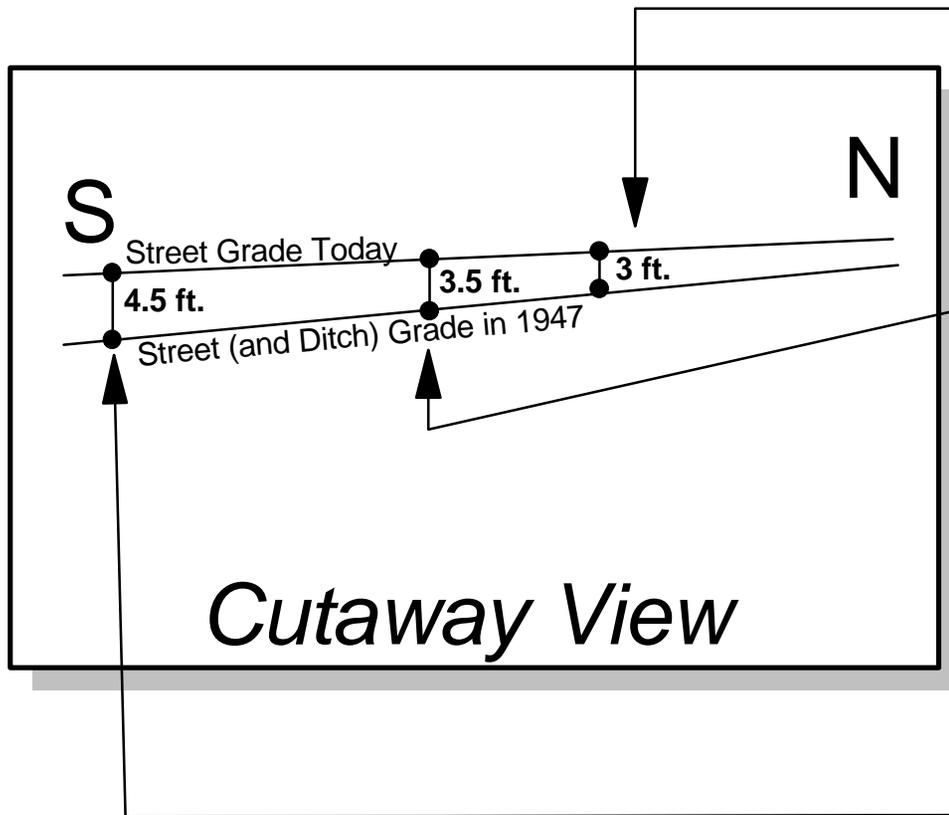
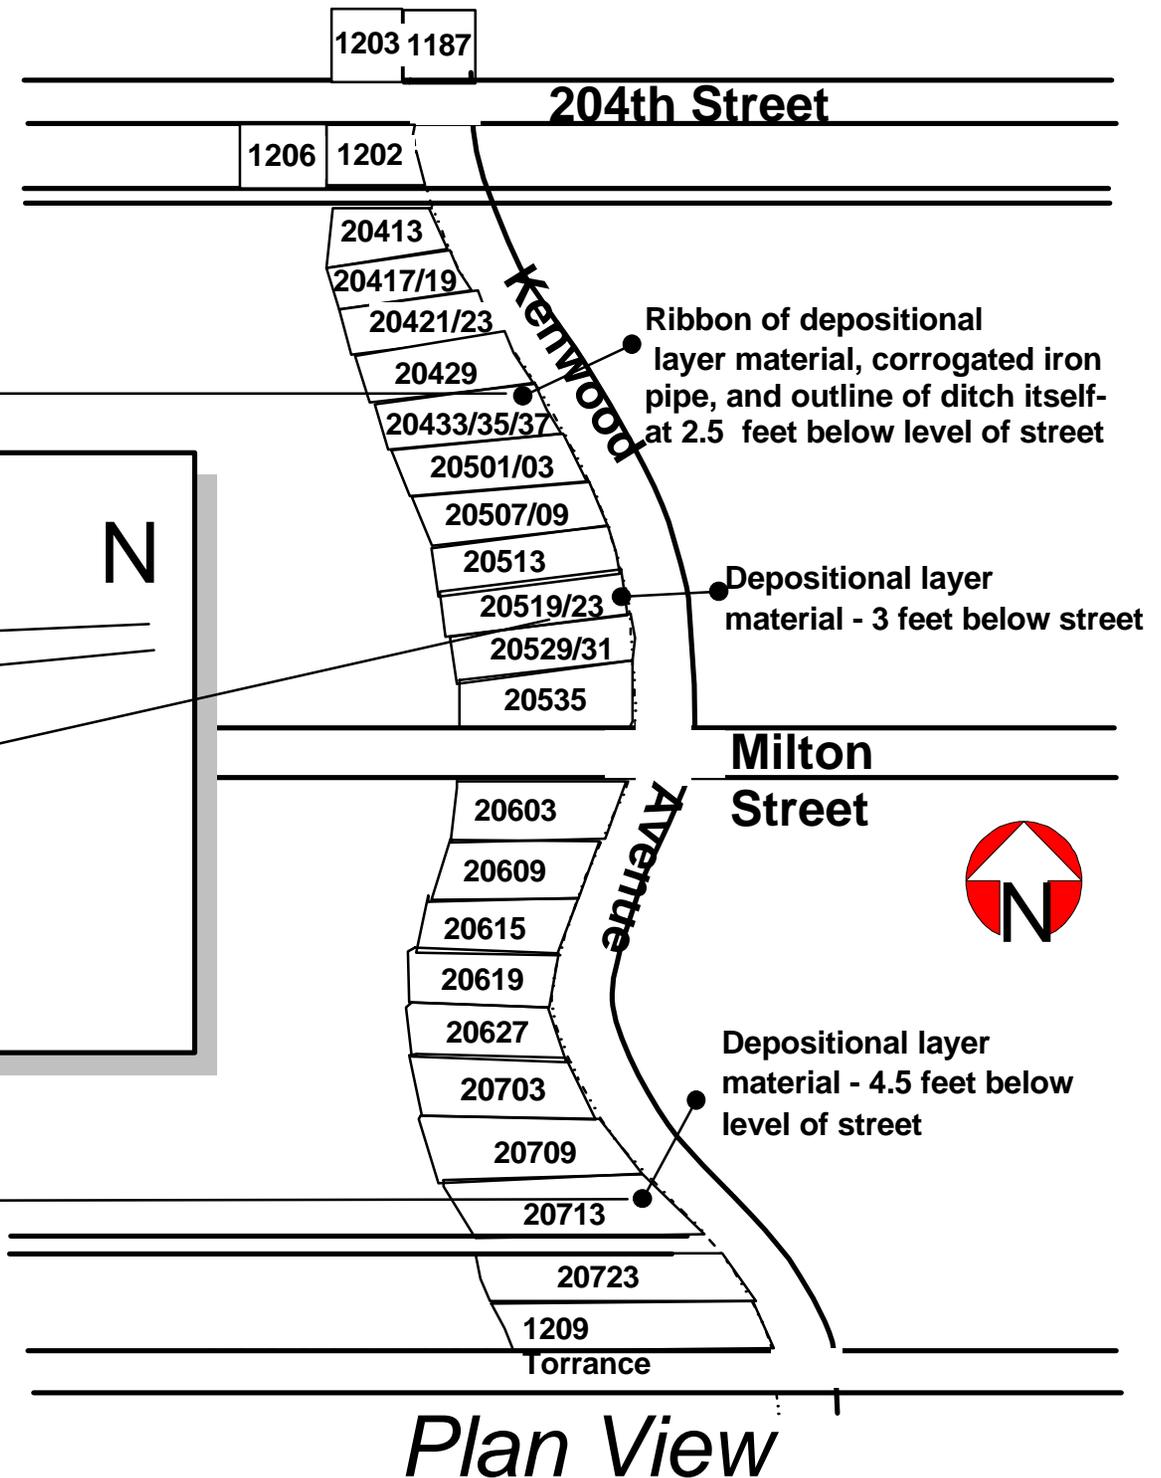
Figure 2A

*Small "ribbons" of
Layer Material
3 Feet Depth*

*"U" Shape outlining former ditch
visible on side of excavation;
corrugated iron pipe found*

*Approximate Area
of Layer Material
3.5 Feet Depth* **Front Yard**

*Approximate Area
of Layer Material
4.5 Feet Depth*

Remnants of the original ditch have been found at progressively increasing depths relative to the current street as one moves south down Kenwood. The range of depths is from about 3 feet in the north to 4.5 feet at the south end of the street.

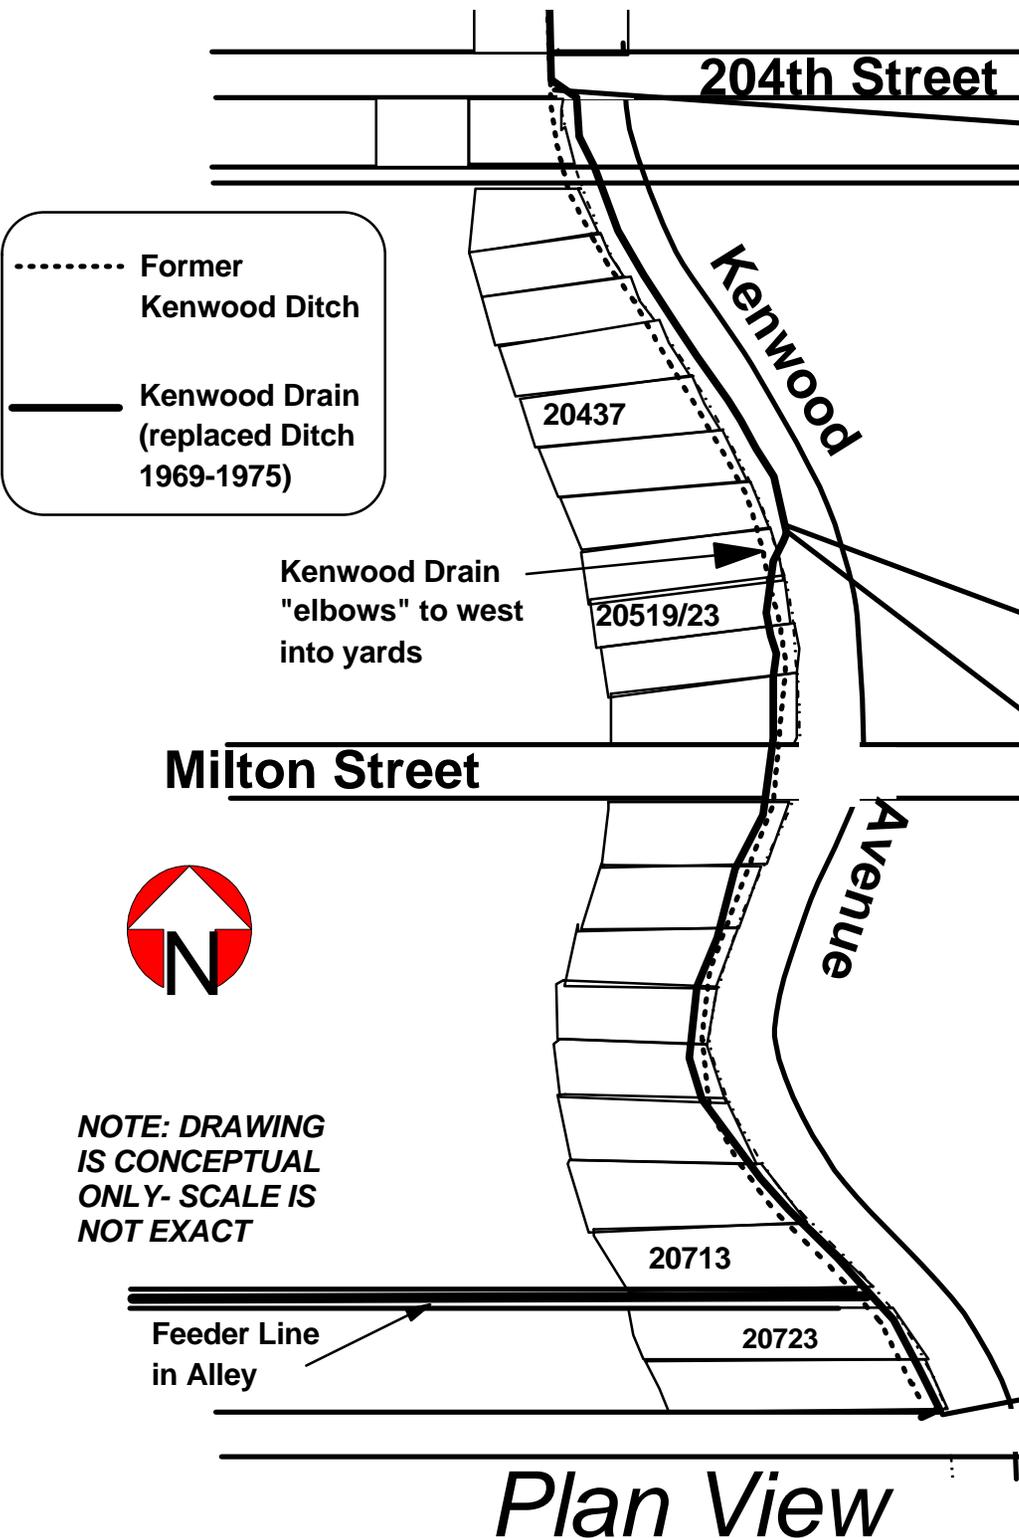
**Figure 2B**

The former Ditch and current drain are more laterally separated in the north portion of the street than in the south portion...

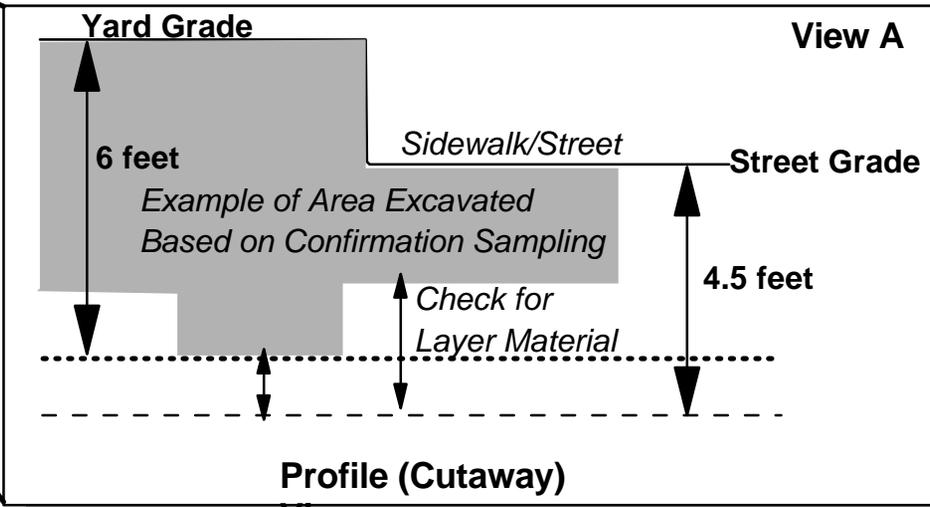
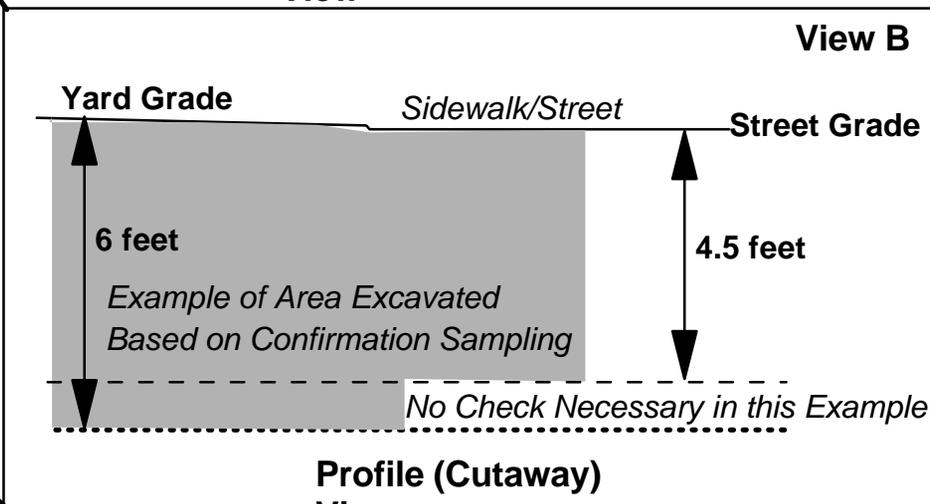
Figure 4
 Action Memorandum Amendment
 Kenwood Stormwater Drainage Pathway
 Montrose Chemical Superfund Site

EPA is already removing soils down to as much as 6 feet below current yard grade, based on sampling data. The historical grade of the ditch is as much as 4.5 feet below the current street grade. After digging to the planned depth below yard grade, EPA will now also check for layer material to a depth of 4.5 feet below current street grade and remove it if found.
