Date: August 2010
 Atlantic Richfield Company
 Project: 138645

Figure 2-1
Electrical Systems Potential Hazard Area

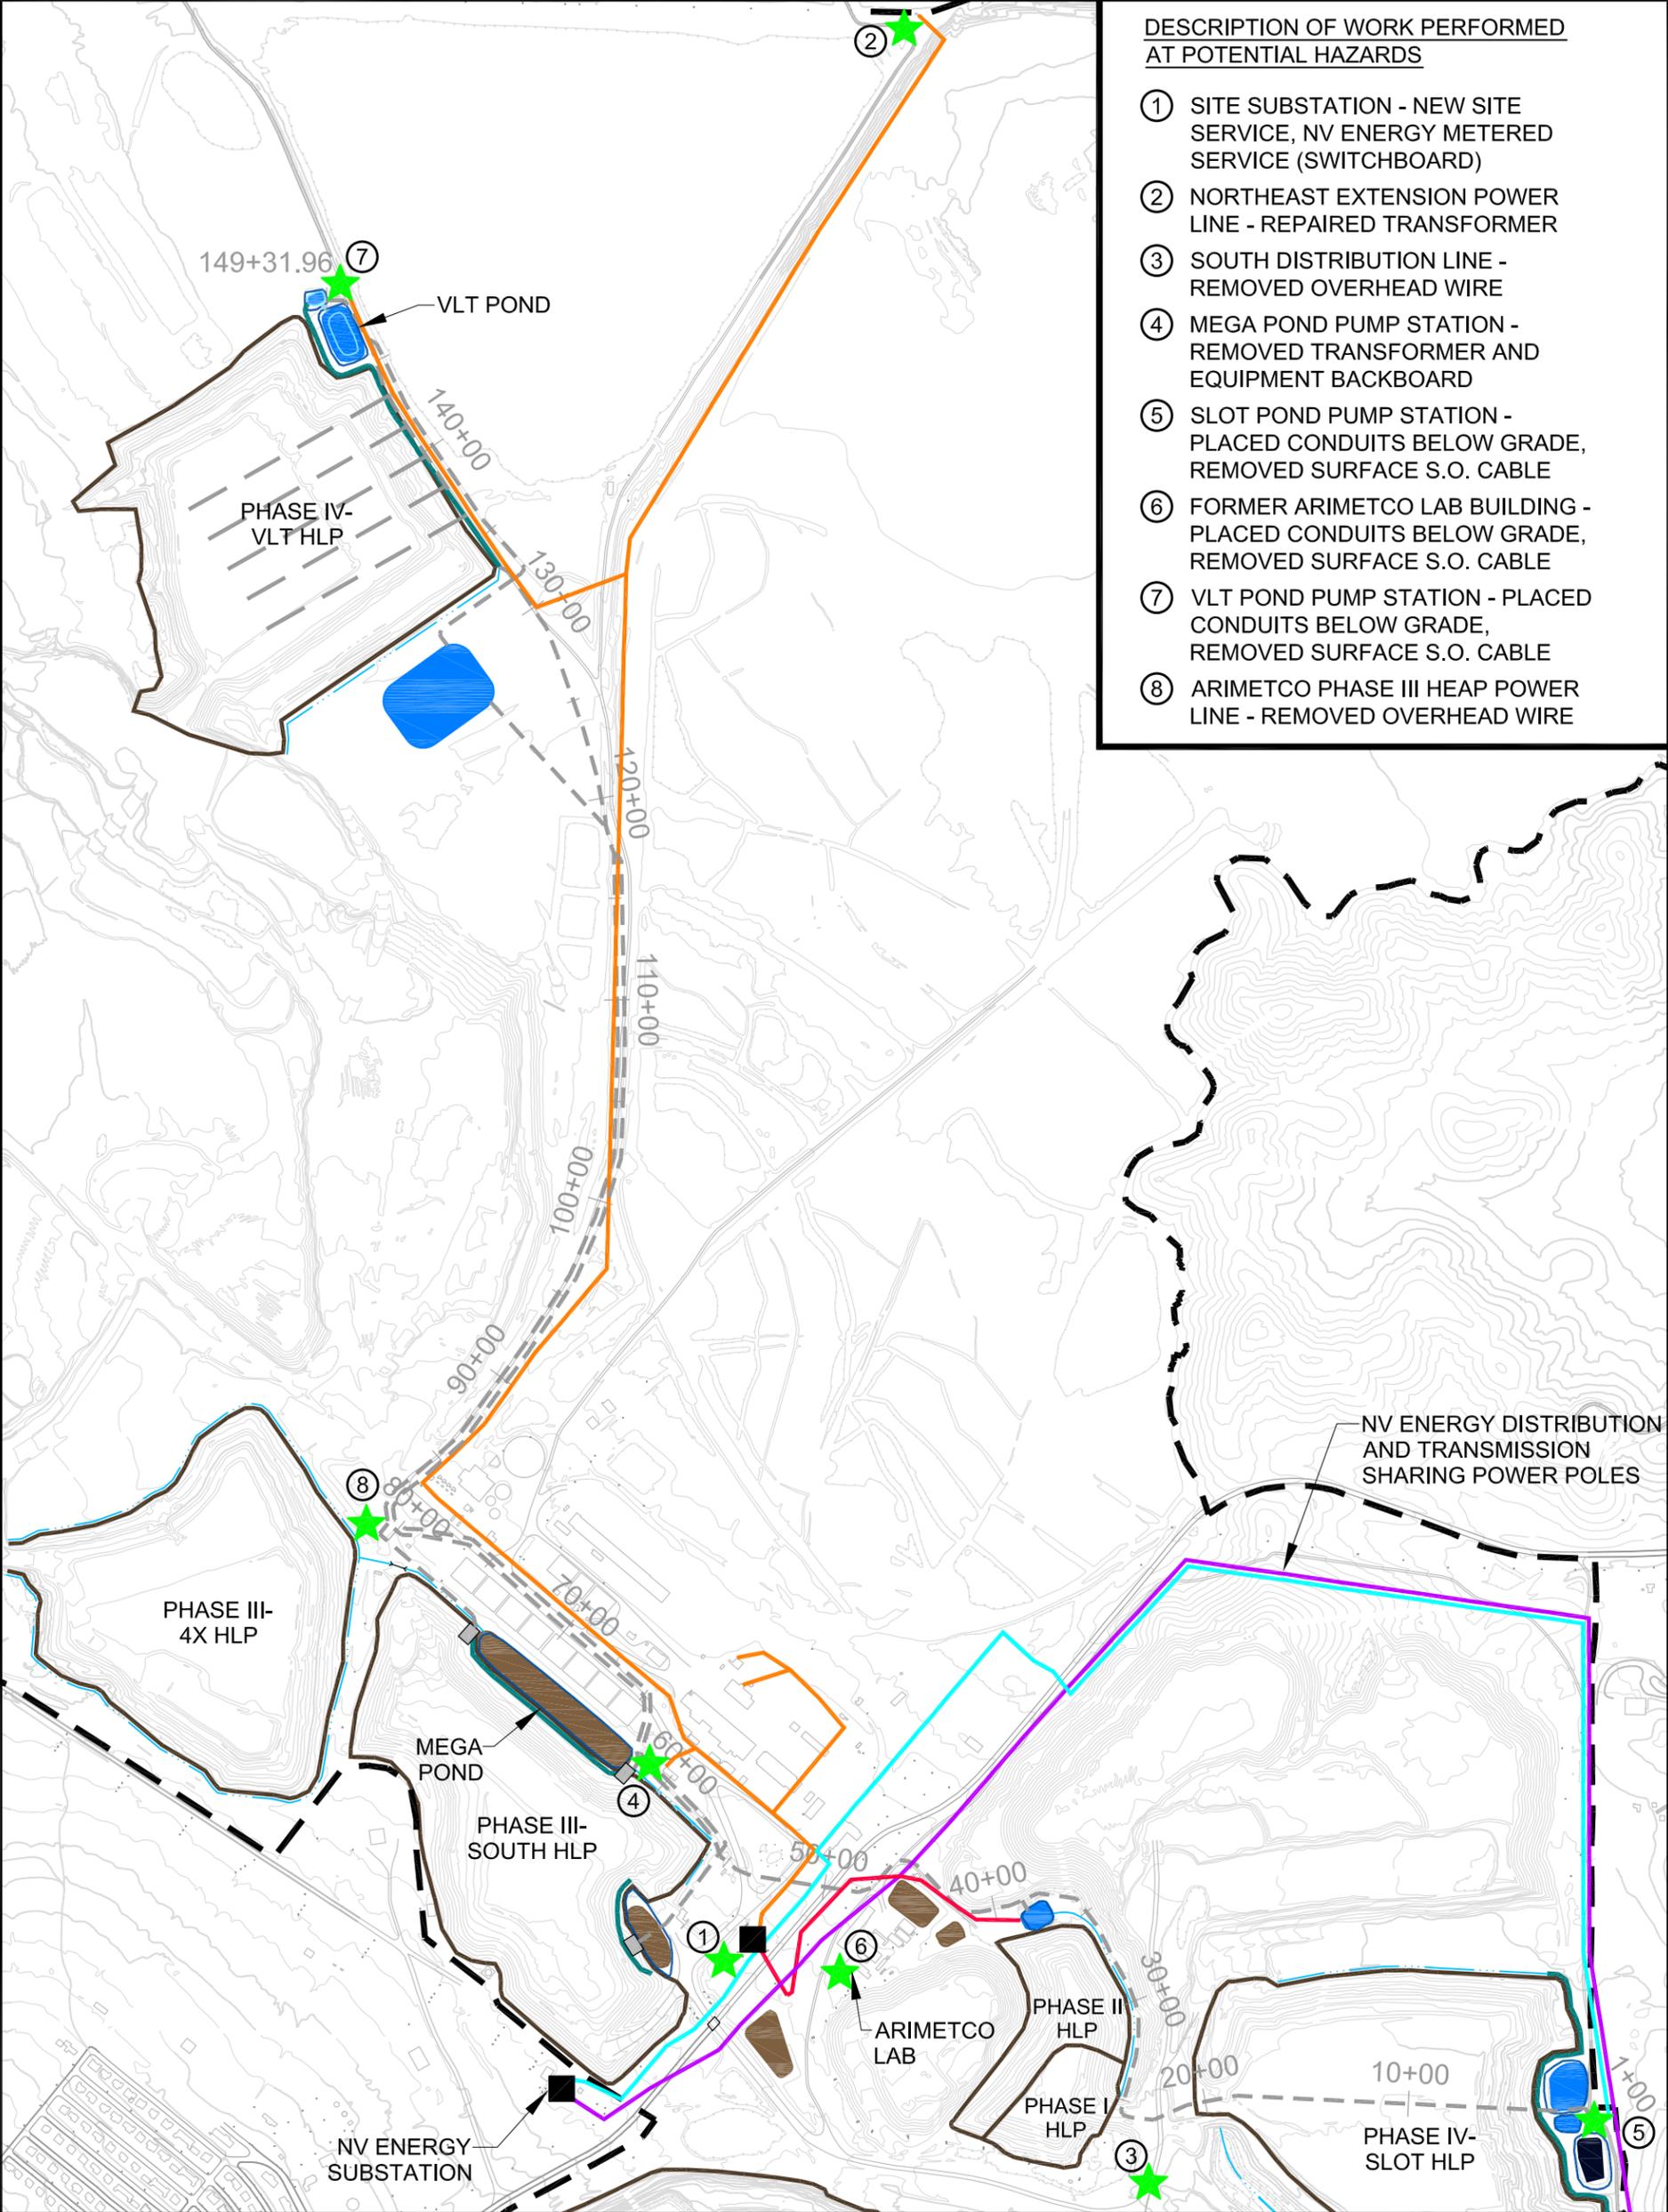
- ① SITE SUBSTATION - NEW SITE SERVICE, NV ENERGY METERED SERVICE (SWITCHBOARD)
- ② NORTHEAST EXTENSION POWER LINE - REPAIRED TRANSFORMER
- ③ SOUTH DISTRIBUTION LINE - REMOVED OVERHEAD WIRE
- ④ MEGA POND PUMP STATION - REMOVED TRANSFORMER AND EQUIPMENT BACKBOARD
- ⑤ SLOT POND PUMP STATION - PLACED CONDUITS BELOW GRADE, REMOVED SURFACE S.O. CABLE
- ⑥ FORMER ARIMETCO LAB BUILDING - PLACED CONDUITS BELOW GRADE, REMOVED SURFACE S.O. CABLE
- ⑦ VLT POND PUMP STATION - PLACED CONDUITS BELOW GRADE, REMOVED SURFACE S.O. CABLE
- ⑧ ARIMETCO PHASE III HEAP POWER LINE - REMOVED OVERHEAD WIRE
