5-Year Review Report
for
Former March Air Force Base
and
March Air Reserve Base
Riverside County, California

September 2003

**Earth Tech, Inc.
Colton, California, and
San Antonio, Texas**

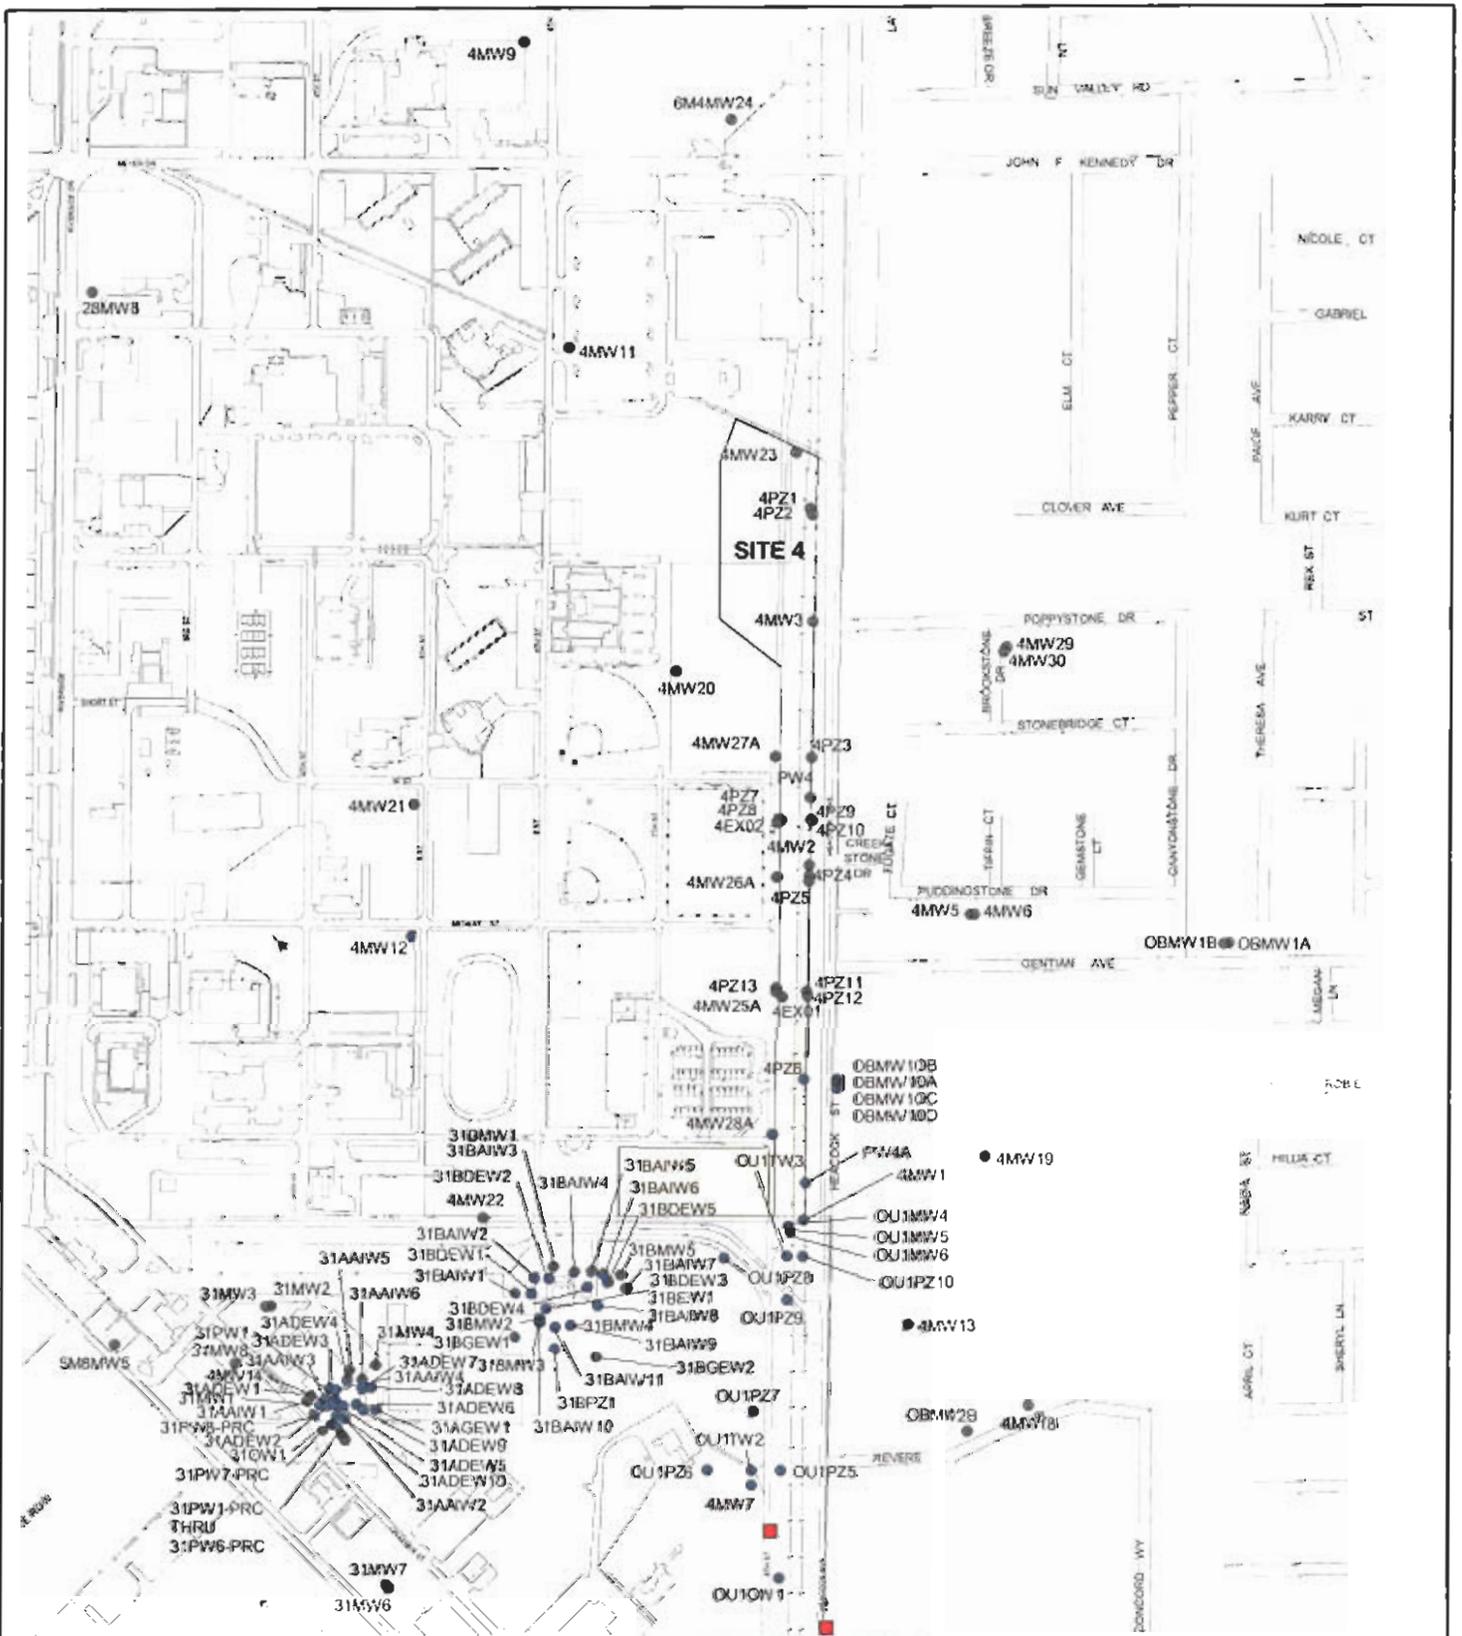
DEPARTMENT OF THE AIR FORCE HQ AIR FORCE RESERVE COMMAND ROBINS AFB, GEORGIA	
MARCH AIR RESERVE BASE CALIFORNIA	
SITE 4 Operable Unit 1 5-Year Review March Air Force Base	
	Project No 30563 Date: 09-03
Figure 4.1-1

The Site 4 landfill was in operation from 1955 to 1969. The RI/FS performed at Site 4 noted that the landfill is up to 25 feet deep and contains primarily sanitary waste, construction rubble, and debris. Small amounts of medical wastes and empty fuel containers are also present. An estimated 150,000 cubic yards of waste were deposited at the landfill during its operation.

Soil samples from boreholes, test pits, and surface locations as well as soil gas and groundwater samples, were collected from Site 4. Based on the results of the sampling, it was noted that beryllium and several PAHs were present in the surface soil (0 - 2 feet below ground surface [bgs]) at concentrations that exceed U.S. EPA Region IX Preliminary Remediation Goals (PRGs). The analytical data also indicated the presence of very low concentrations of chlorinated solvents in the subsurface soil and soil gas beneath the site.

In the Site 4 groundwater plume, six organic contaminants were detected at concentrations exceeding applicable cleanup standards. A groundwater monitoring well situated in the southeast corner of the site (4MW1) has consistently contained elevated concentrations of PCE and TCE. Both PCE and TCE are found in solvents that were used to clean and degrease military equipment.

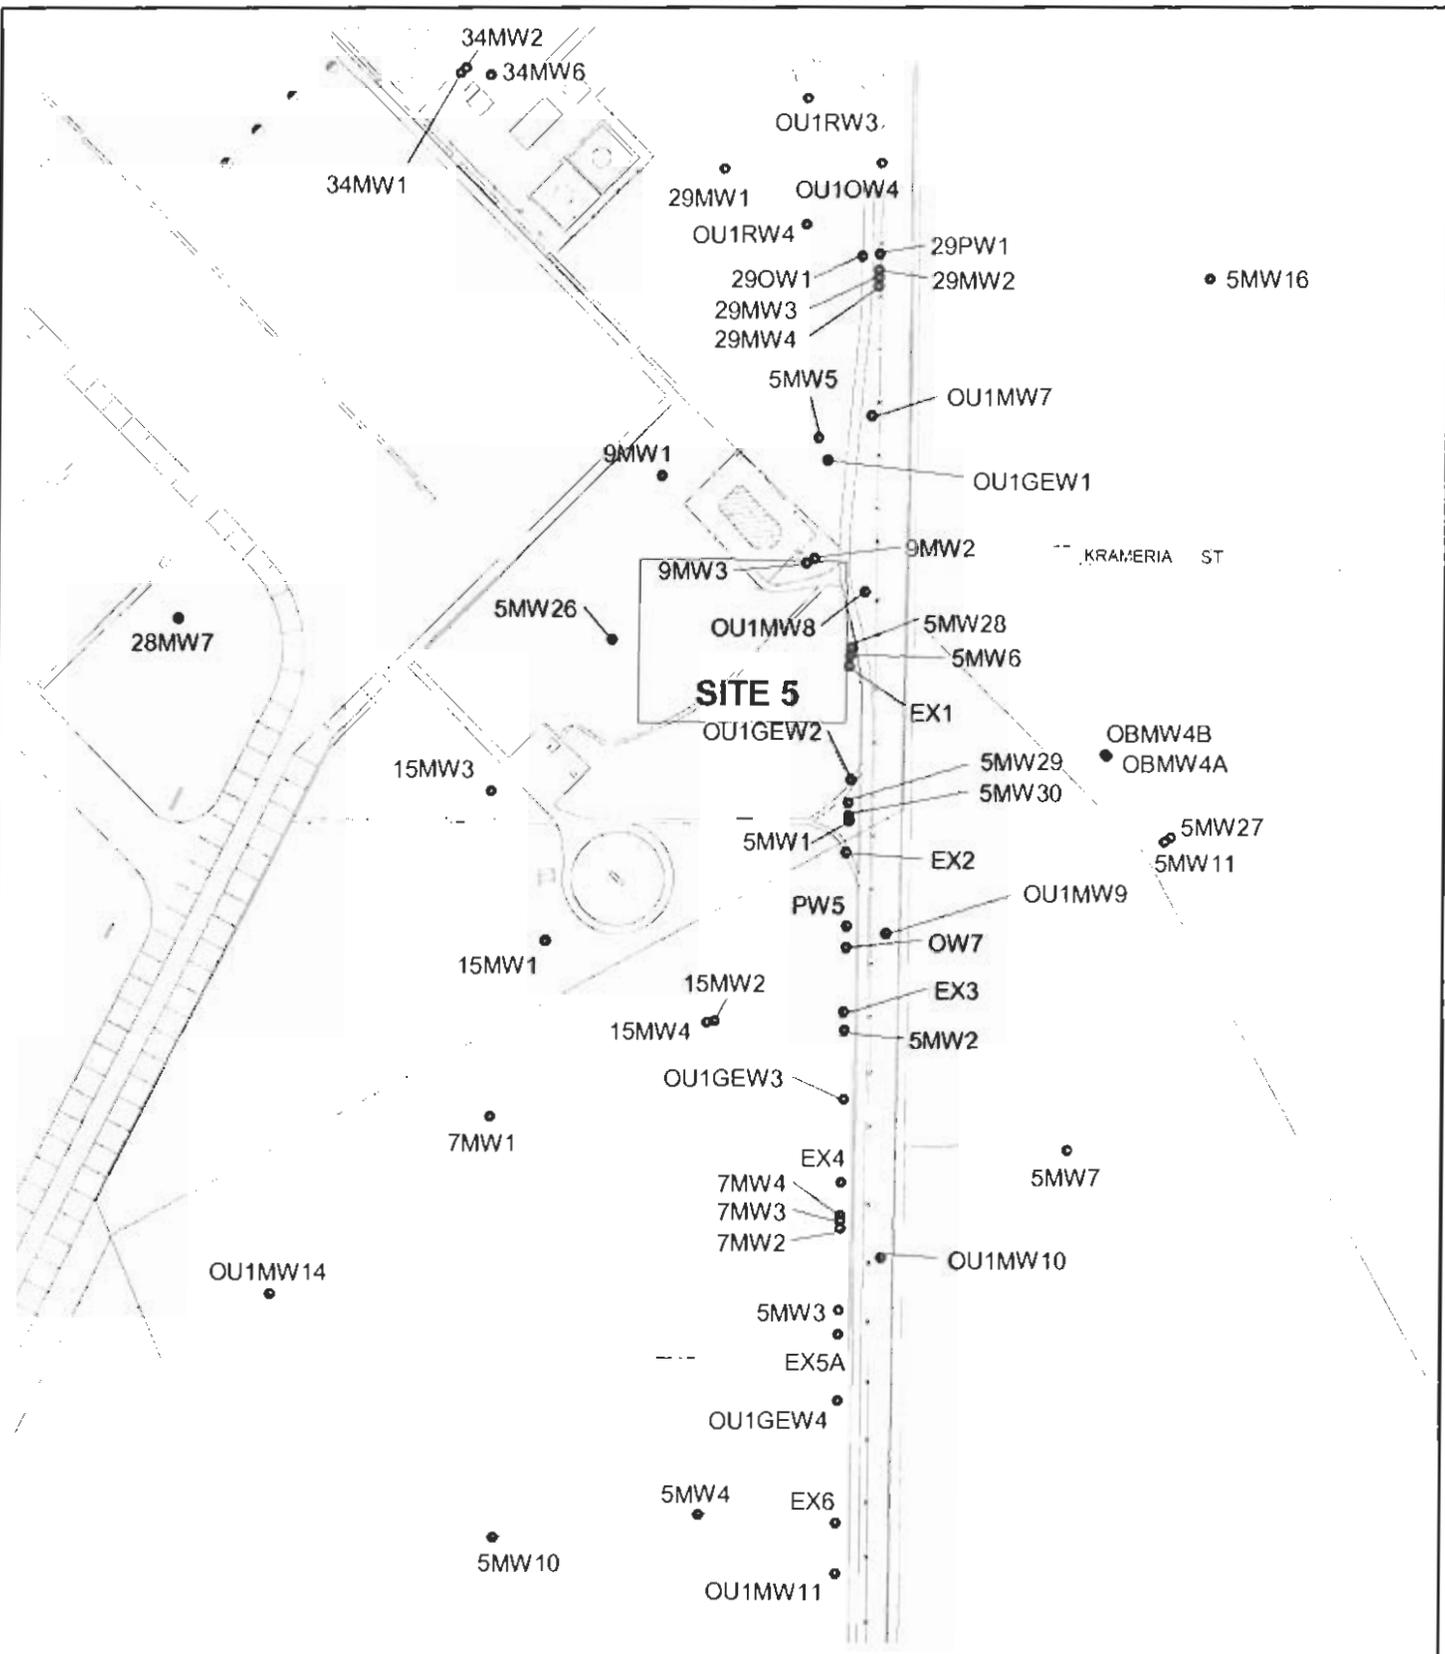
IRP Site 5 (Site 5), Landfill No. 3 is situated within the current cantonment area of March ARB and is controlled by the AFRC. Site 5 covers approximately 5 acres and is situated along the southeast end of the flightline area (Figure 4.2-1). The landfill was in operation from the late 1940s to approximately 1960. The OU1 RI/FS performed at Site 5 noted that the landfill waste consisted of construction rubble, newspaper, office waste, bottles, and miscellaneous paper products. The majority of the waste consists of construction rubble, including concrete and wood. The landfill pits range from 12 to 17 feet in depth. The waste is typically intercalated with soil, probably due to the daily placement of soil cover by the landfill operator. It is estimated that approximately 18,500 cubic yards of waste is present at Site 5 based on data collected during the OU1 RI/FS. The waste pits were characterized as being approximately 40 feet wide, 12 to 17 feet deep, and up to 240 feet long.
