**Site 29 Amendment to Operable Unit 2  
Record of Decision**

**South Base**

**SITE 29  
AMENDMENT TO  
OPERABLE UNIT 2 RECORD OF DECISION  
SOUTH BASE  
EDWARDS AIR FORCE BASE  
CALIFORNIA**

**JULY 2012**

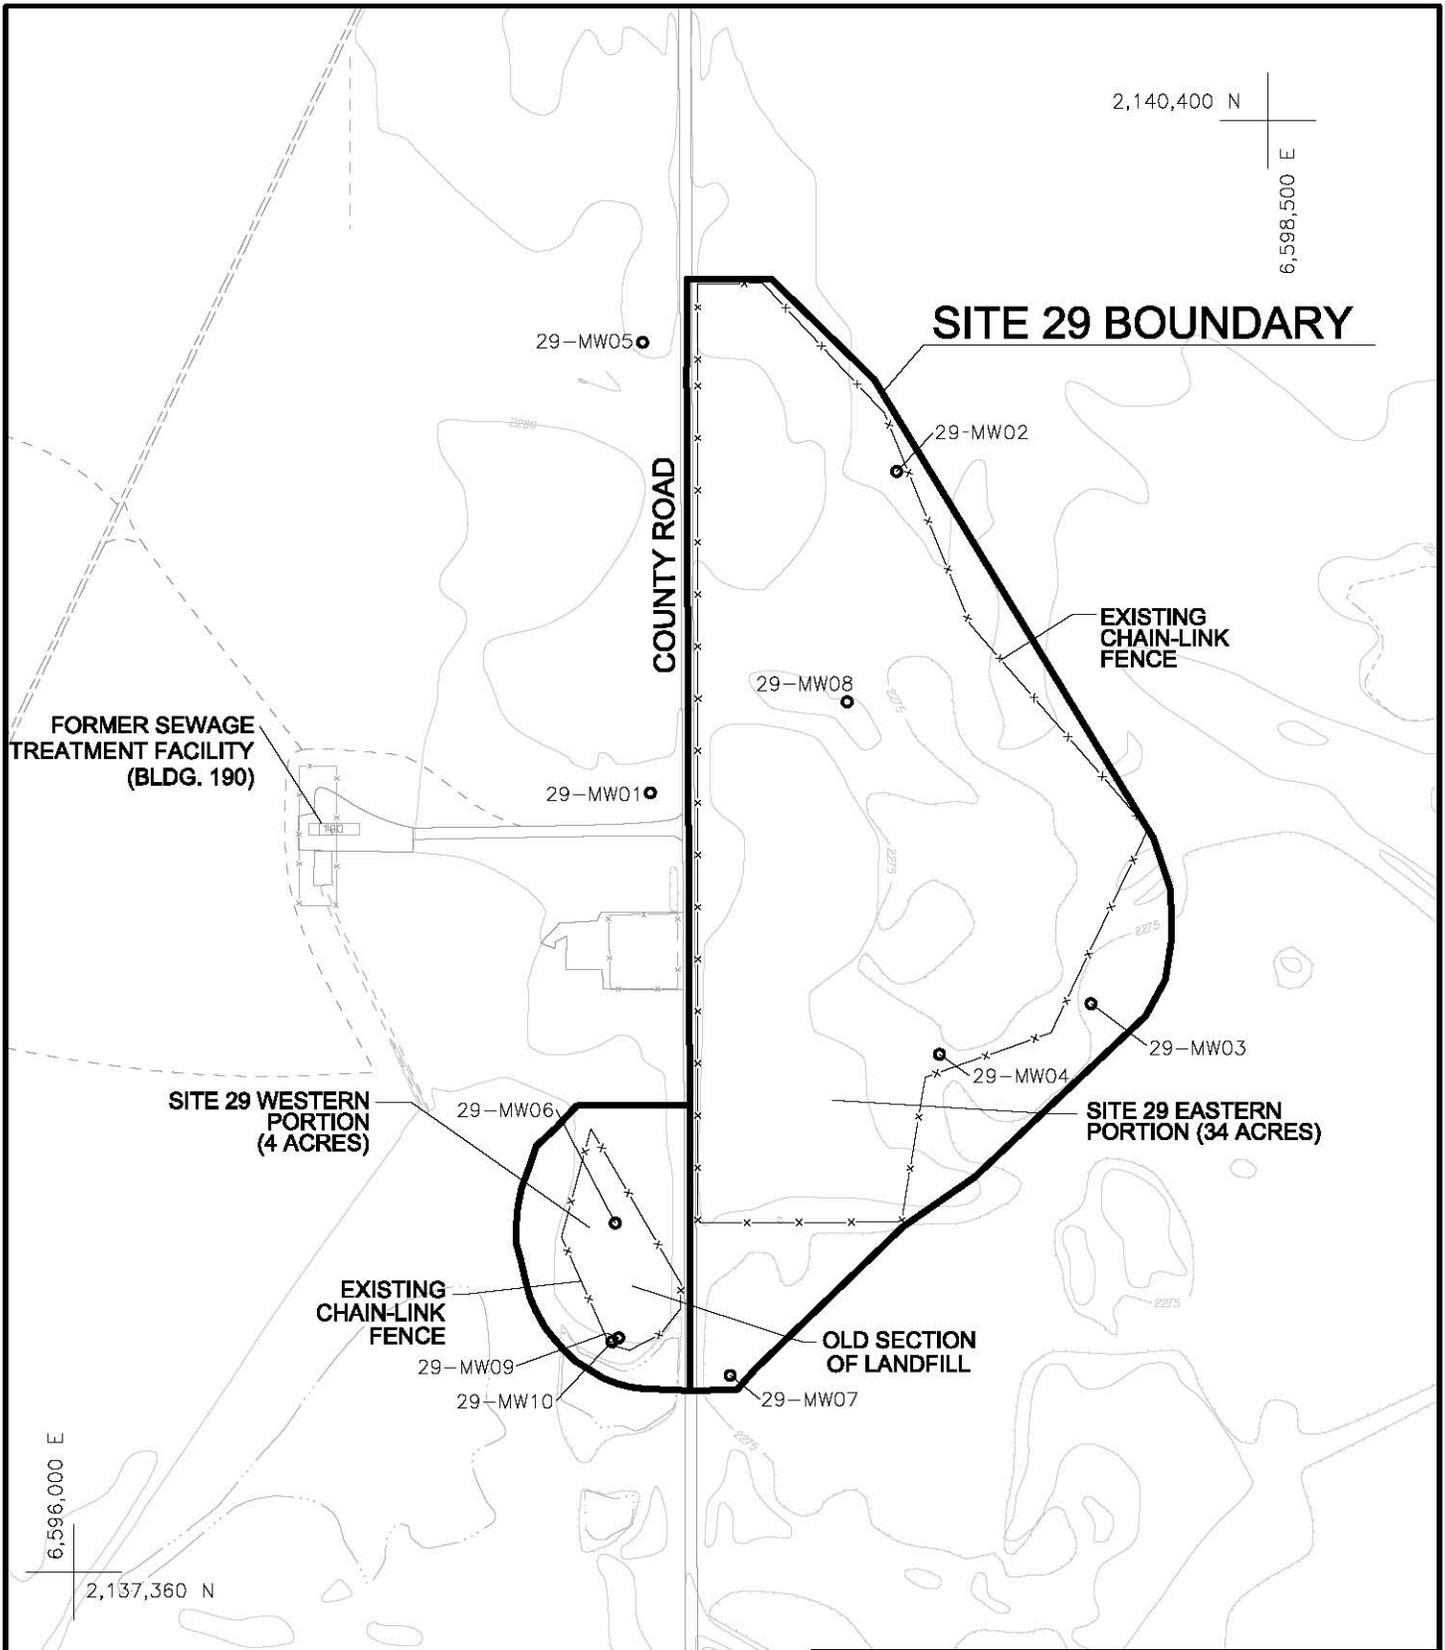
Site 29 ROD		
<b>Location Map Site 29</b>		
Date <b>07-12</b>	<b>South Base Edwards AFB</b>	Figure
Project No. 60142113		2-1

- EXISTING GROUNDWATER MONITORING WELL LOCATION

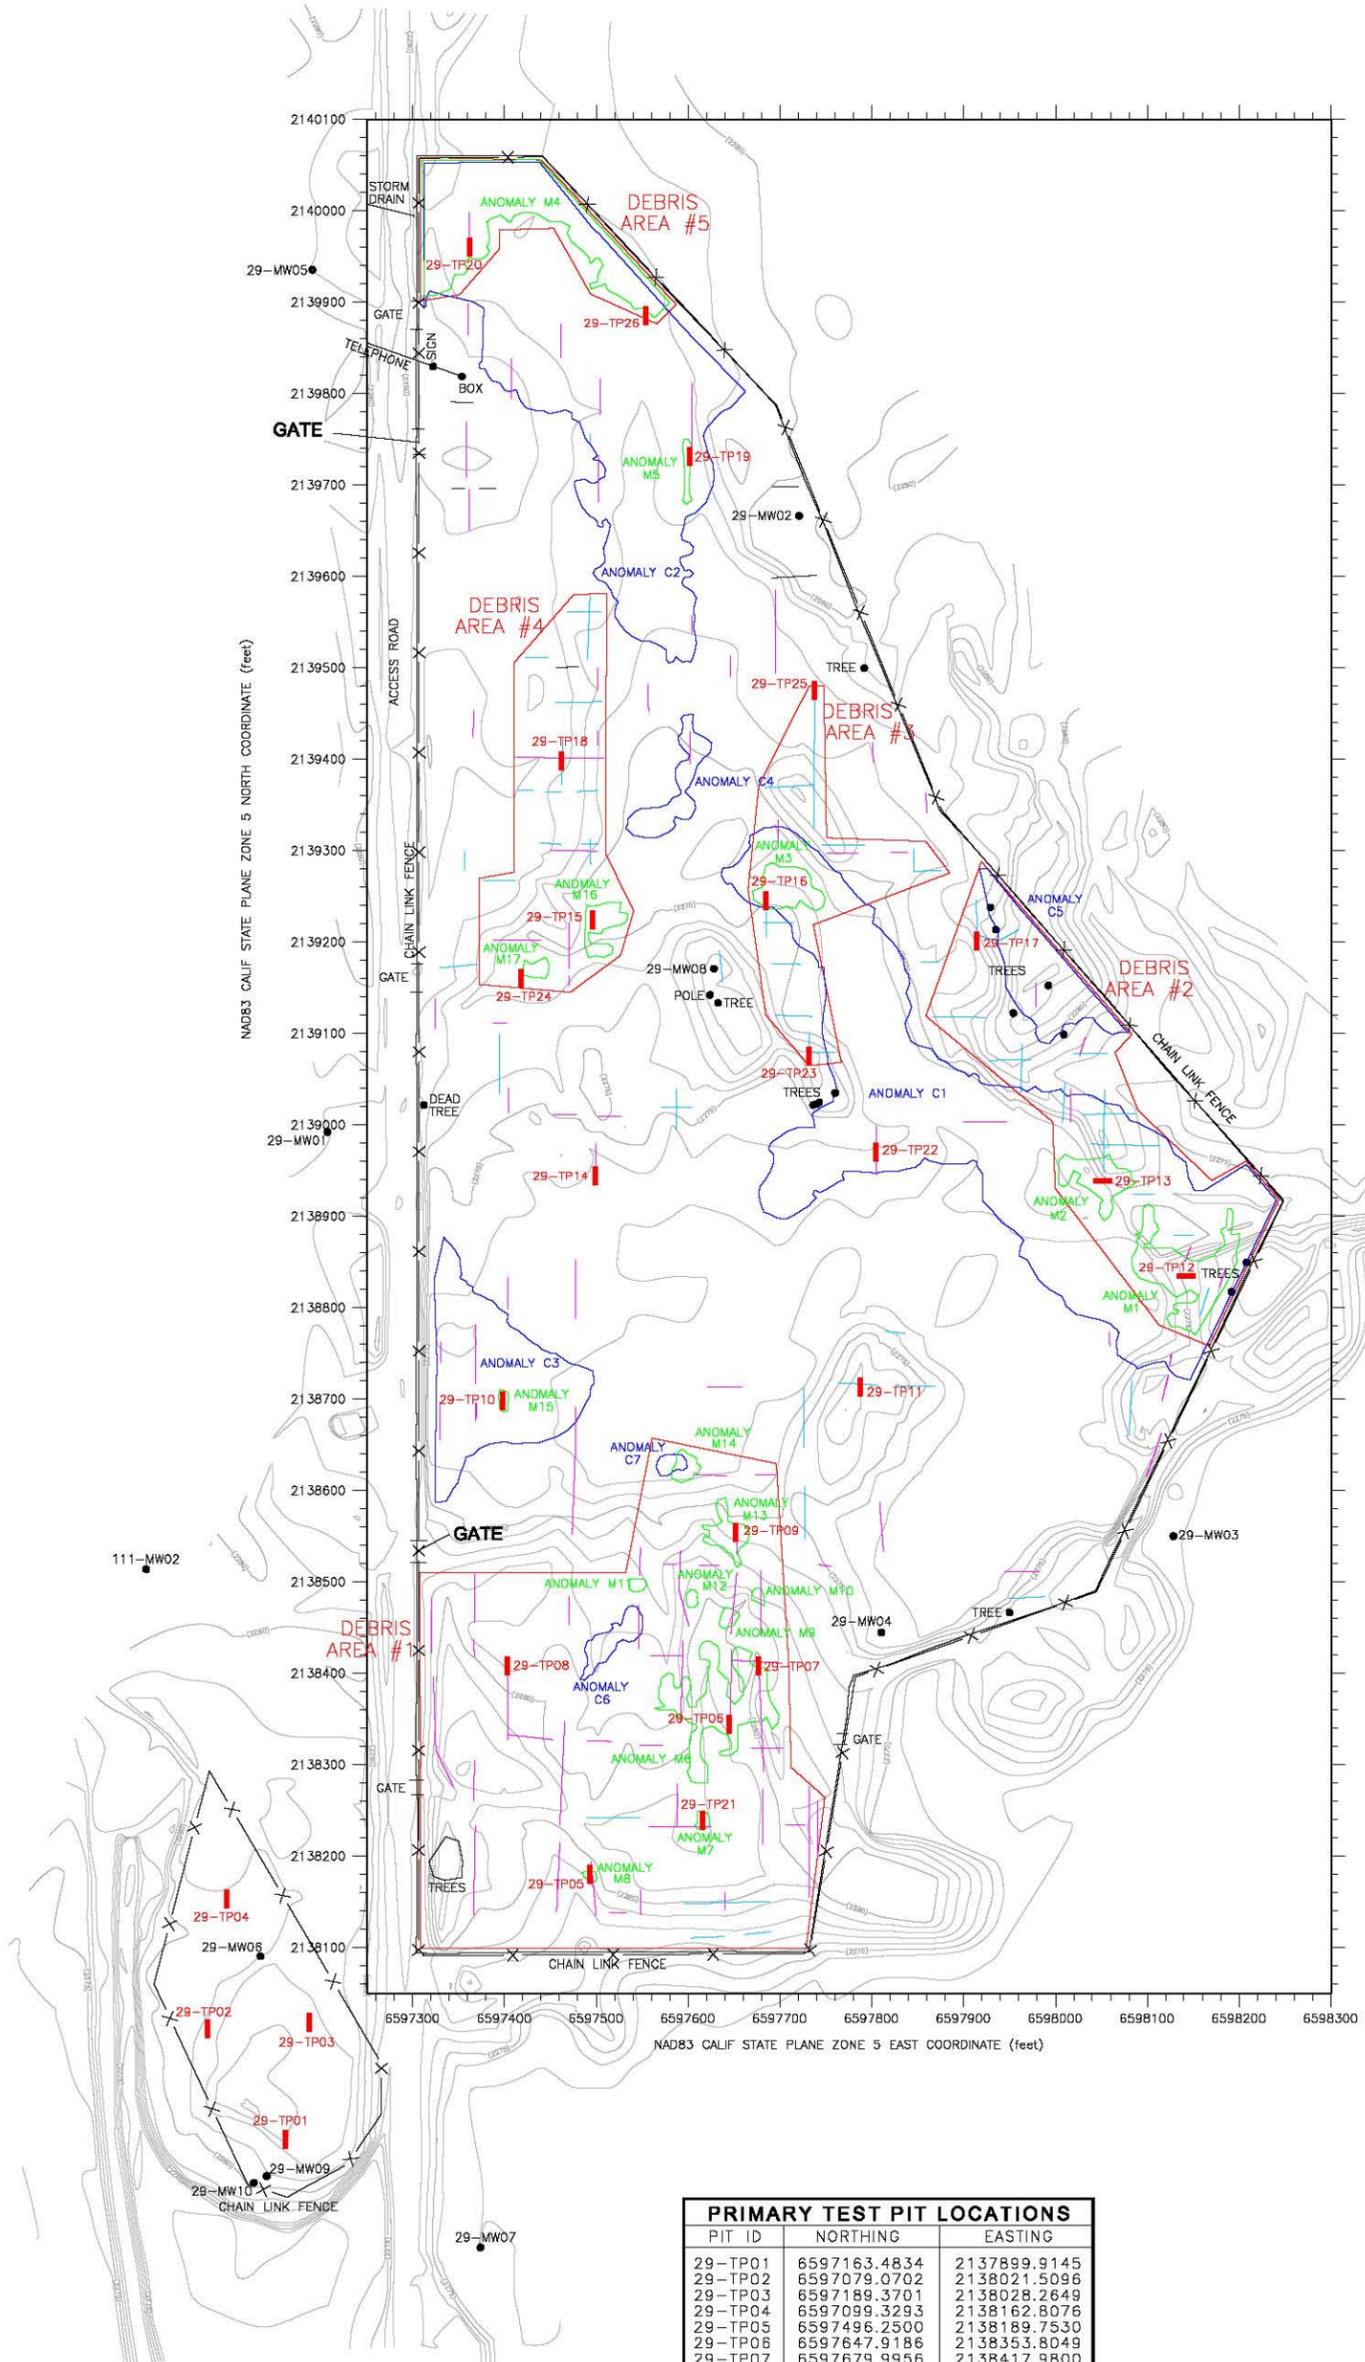
Site 29 ROD		Site 29	
Subsurface Debris Areas Identified during Geophysical Survey February 2010			
Date 07-12	Project No. 60142113		Figure 3-1
South Base Edwards AFB

- ▬ PROPOSED TEST PIT LOCATION
- ▭ EM-31 SOIL CONDUCTIVITY ANOMALIES (7) PRIMARILY RESPONDING TO SOIL TYPE/MOISTURE CONTENT CHANGES, NOT SUBSURFACE DEBRIS

Data collected from the geophysical survey were interpreted to designate the locations of the primary test pits in the Eastern Landfill, with an emphasis being placed on confirming the interpreted subsurface debris areas. In general, the primary test pits were located within the five subsurface debris areas identified in the Geophysical Survey Report (Figure 3-1). Some primary test pits were located outside of these five areas to investigate isolated geophysical anomalies. The four test pits located in the Western Landfill area were based on disturbed areas observed on historical aerial photographs. A total of 26 test pit locations were planned prior to mobilization based on anomalies (both metal and

Test pits excavated in the geophysical survey designated Areas #2 and #3, shown on Figure 3-1, uncovered no subsurface debris. The majority of Areas #2 and #3 consist of stabilized dune deposits with mature Joshua trees growing on them. In addition, no evidence of disposal trenches in Areas #2 and #3 was observed on the historical aerial photographs (AECOM 2010b). For these reasons,

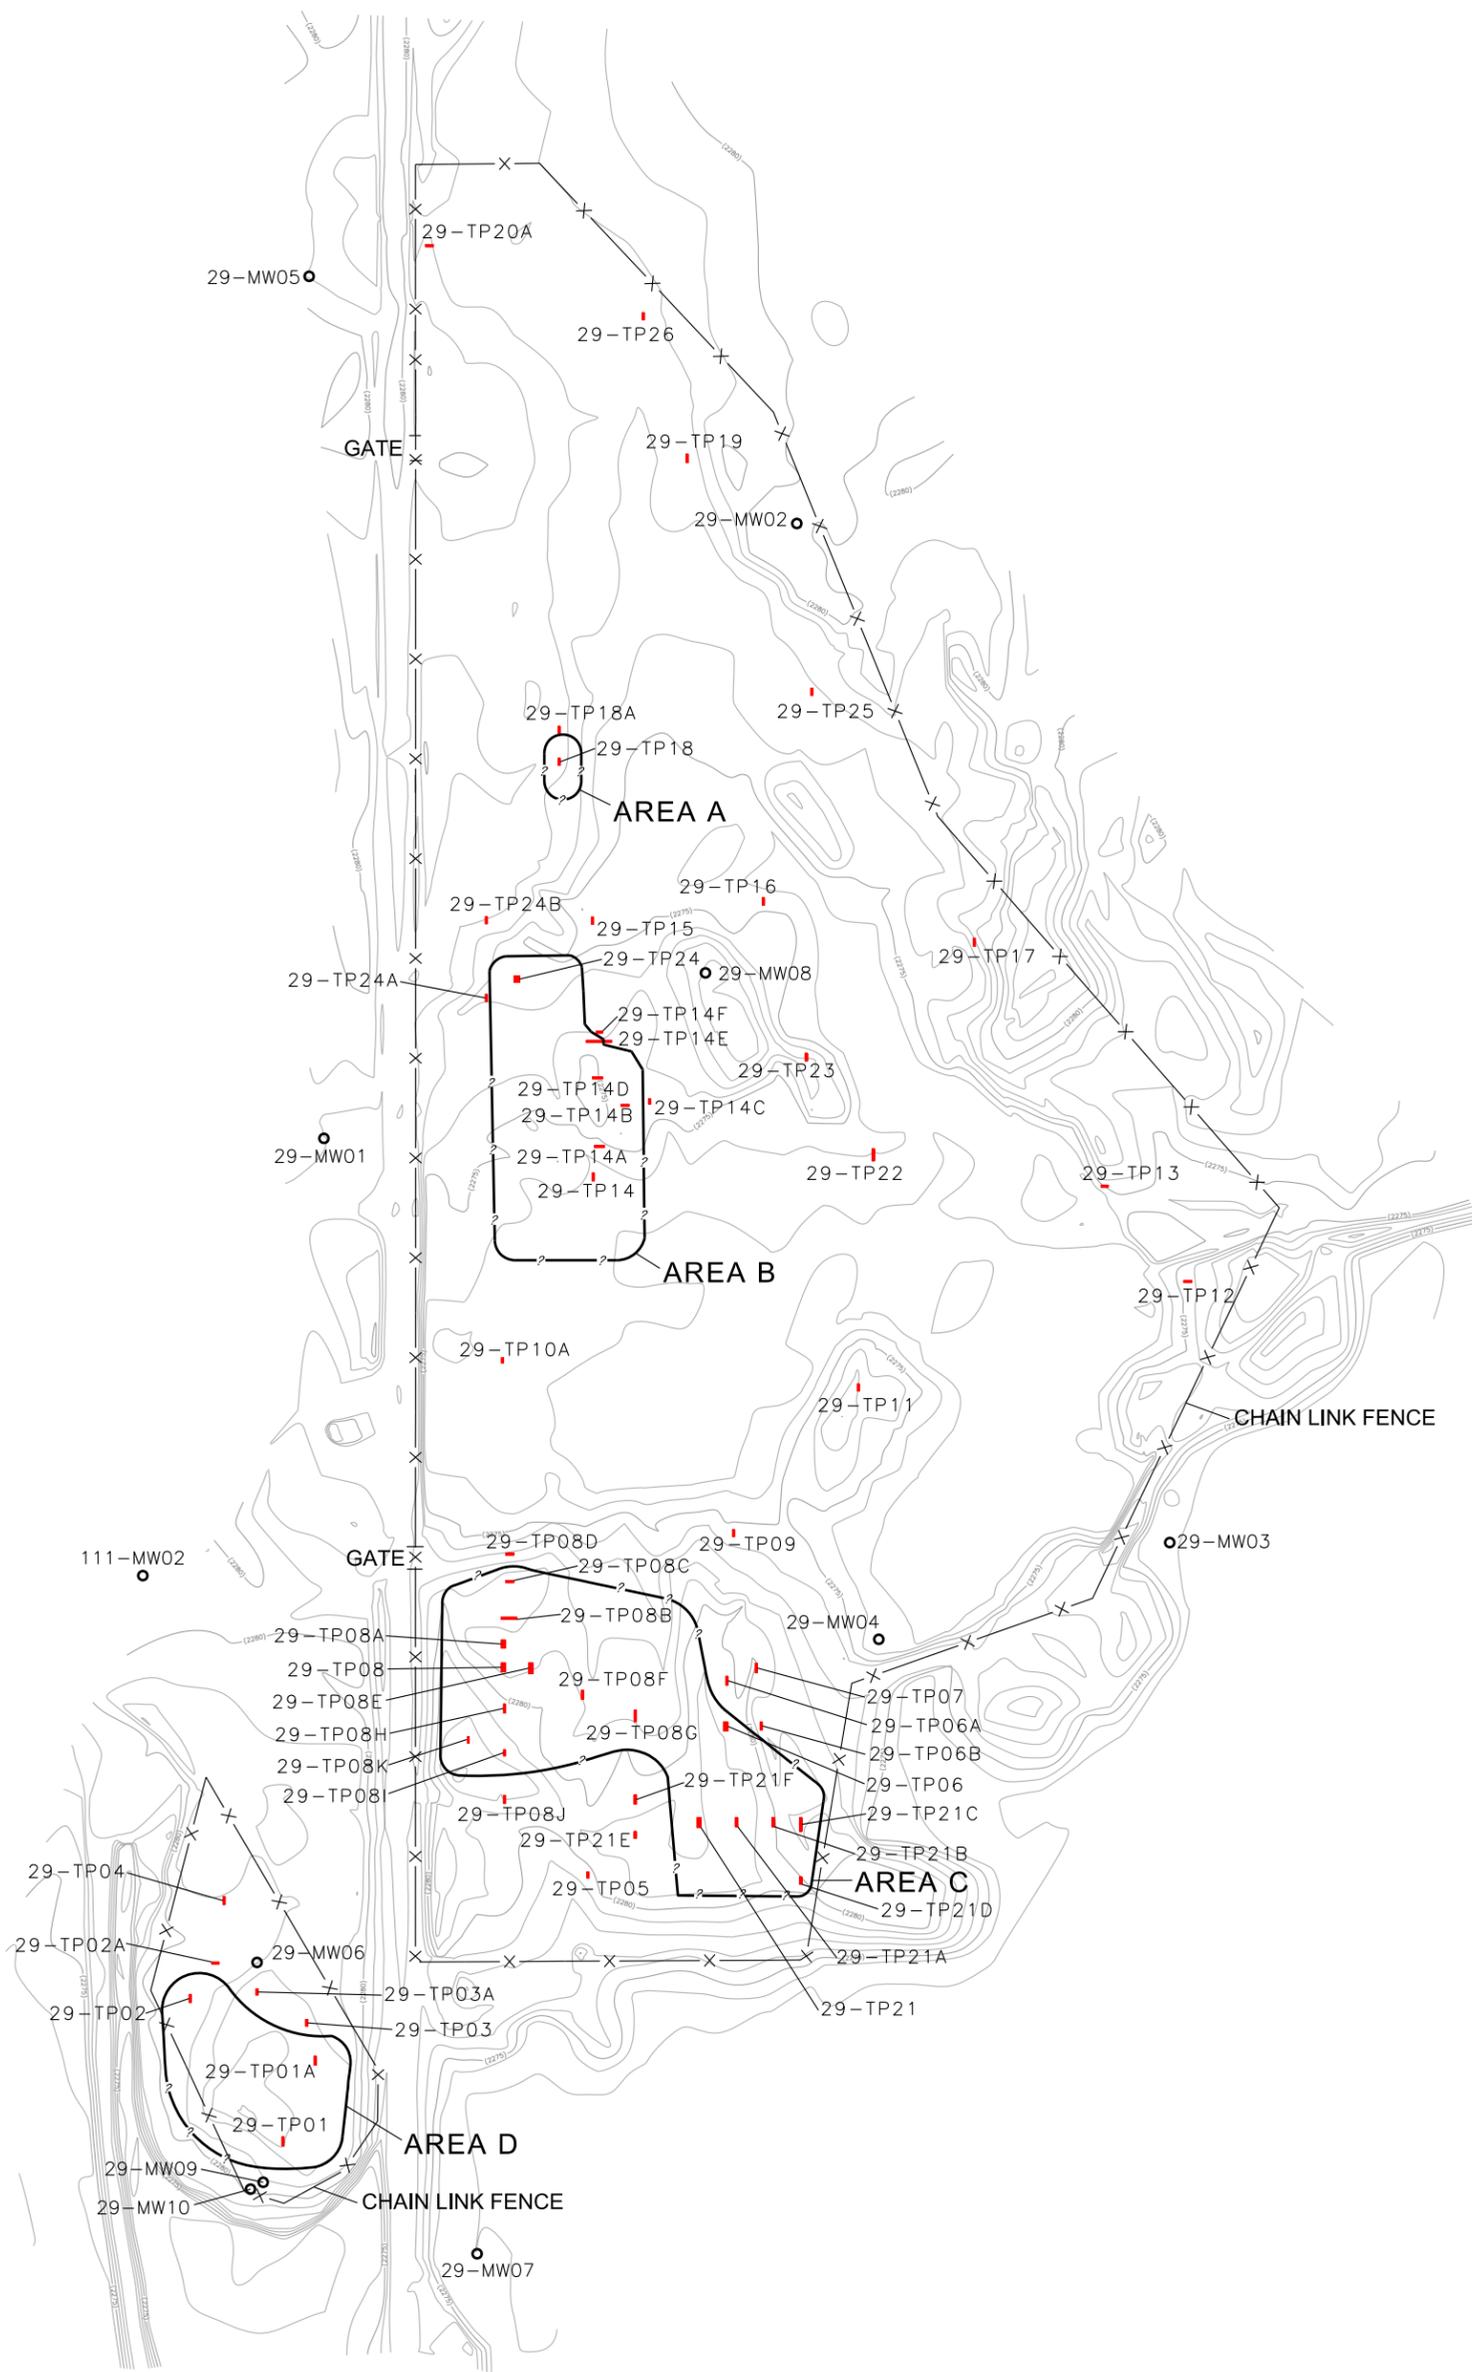
Site 29 ROD		<b>Site 29 Estimated Extent of Subsurface Debris</b>	
Date	7-12	South Base Edwards AFB	Figure 3-2
Project No.	60142113

- TEST PIT LOCATION
- INTERPRETED AREAS OF SUBSURFACE DEBRIS (BASED ON TEST PIT EXCAVATIONS)
- EXISTING GROUNDWATER MONITORING WELL LOCATION

If subsurface debris was found, secondary test pits were excavated to delineate the area of subsurface debris. The locations of these secondary test pits were chosen based on field observations, including where, horizontally and vertically, the debris was encountered, as well as the thickness of the debris in the initial test pit. Primary and secondary test pit locations are shown on Figure 3-2.

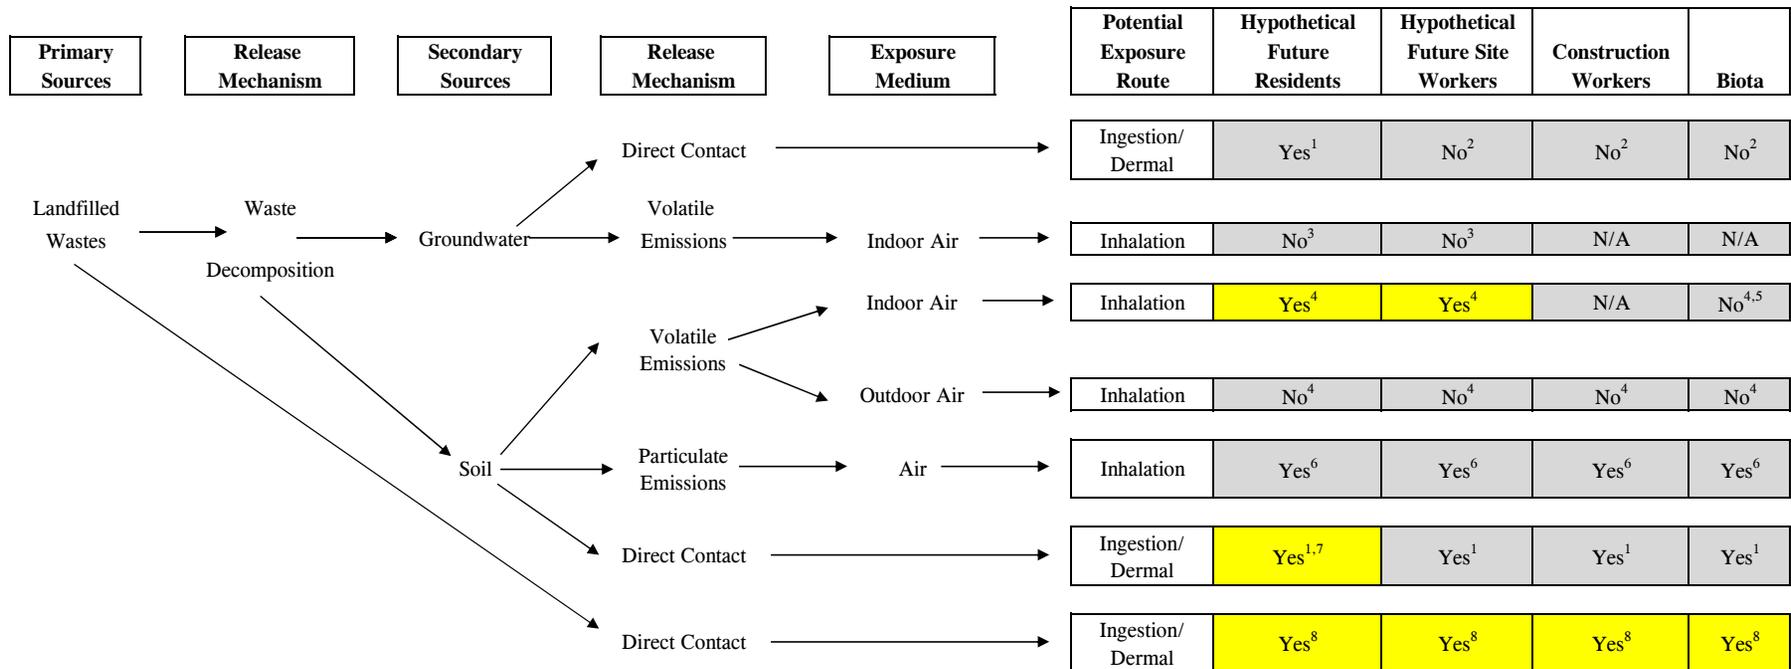
FIGURE 3-3. PATHWAYS RETAINED FOR CERCLA RESPONSE - SITE 29

Yellow highlights indicate pathways retained for CERCLA response

No changes to the Exposure Pathways Retained for CERCLA Response are proposed as a result of the Pre-design Investigation. Pathways retained for CERCLA response are presented in Figure 3-3. Landfilled wastes are identified as a potential threat, albeit slight, to groundwater, and direct contact with landfilled wastes or potentially contaminated soils beneath such wastes could cause a threat to humans or animals. However, due to the limited extent and mostly inert nature of the waste, these threats are lower than previously evaluated. The risks associated with removing the observed waste types are manageable.
