**Final Remedial Investigation Report**

Casmalia Resources Superfund Site  
Casmalia, California

FIGURE	<b>G-21</b>
SHEET:	<b>1 OF 1</b>
REVISION NUMBER:	0
DATE:	January 2011

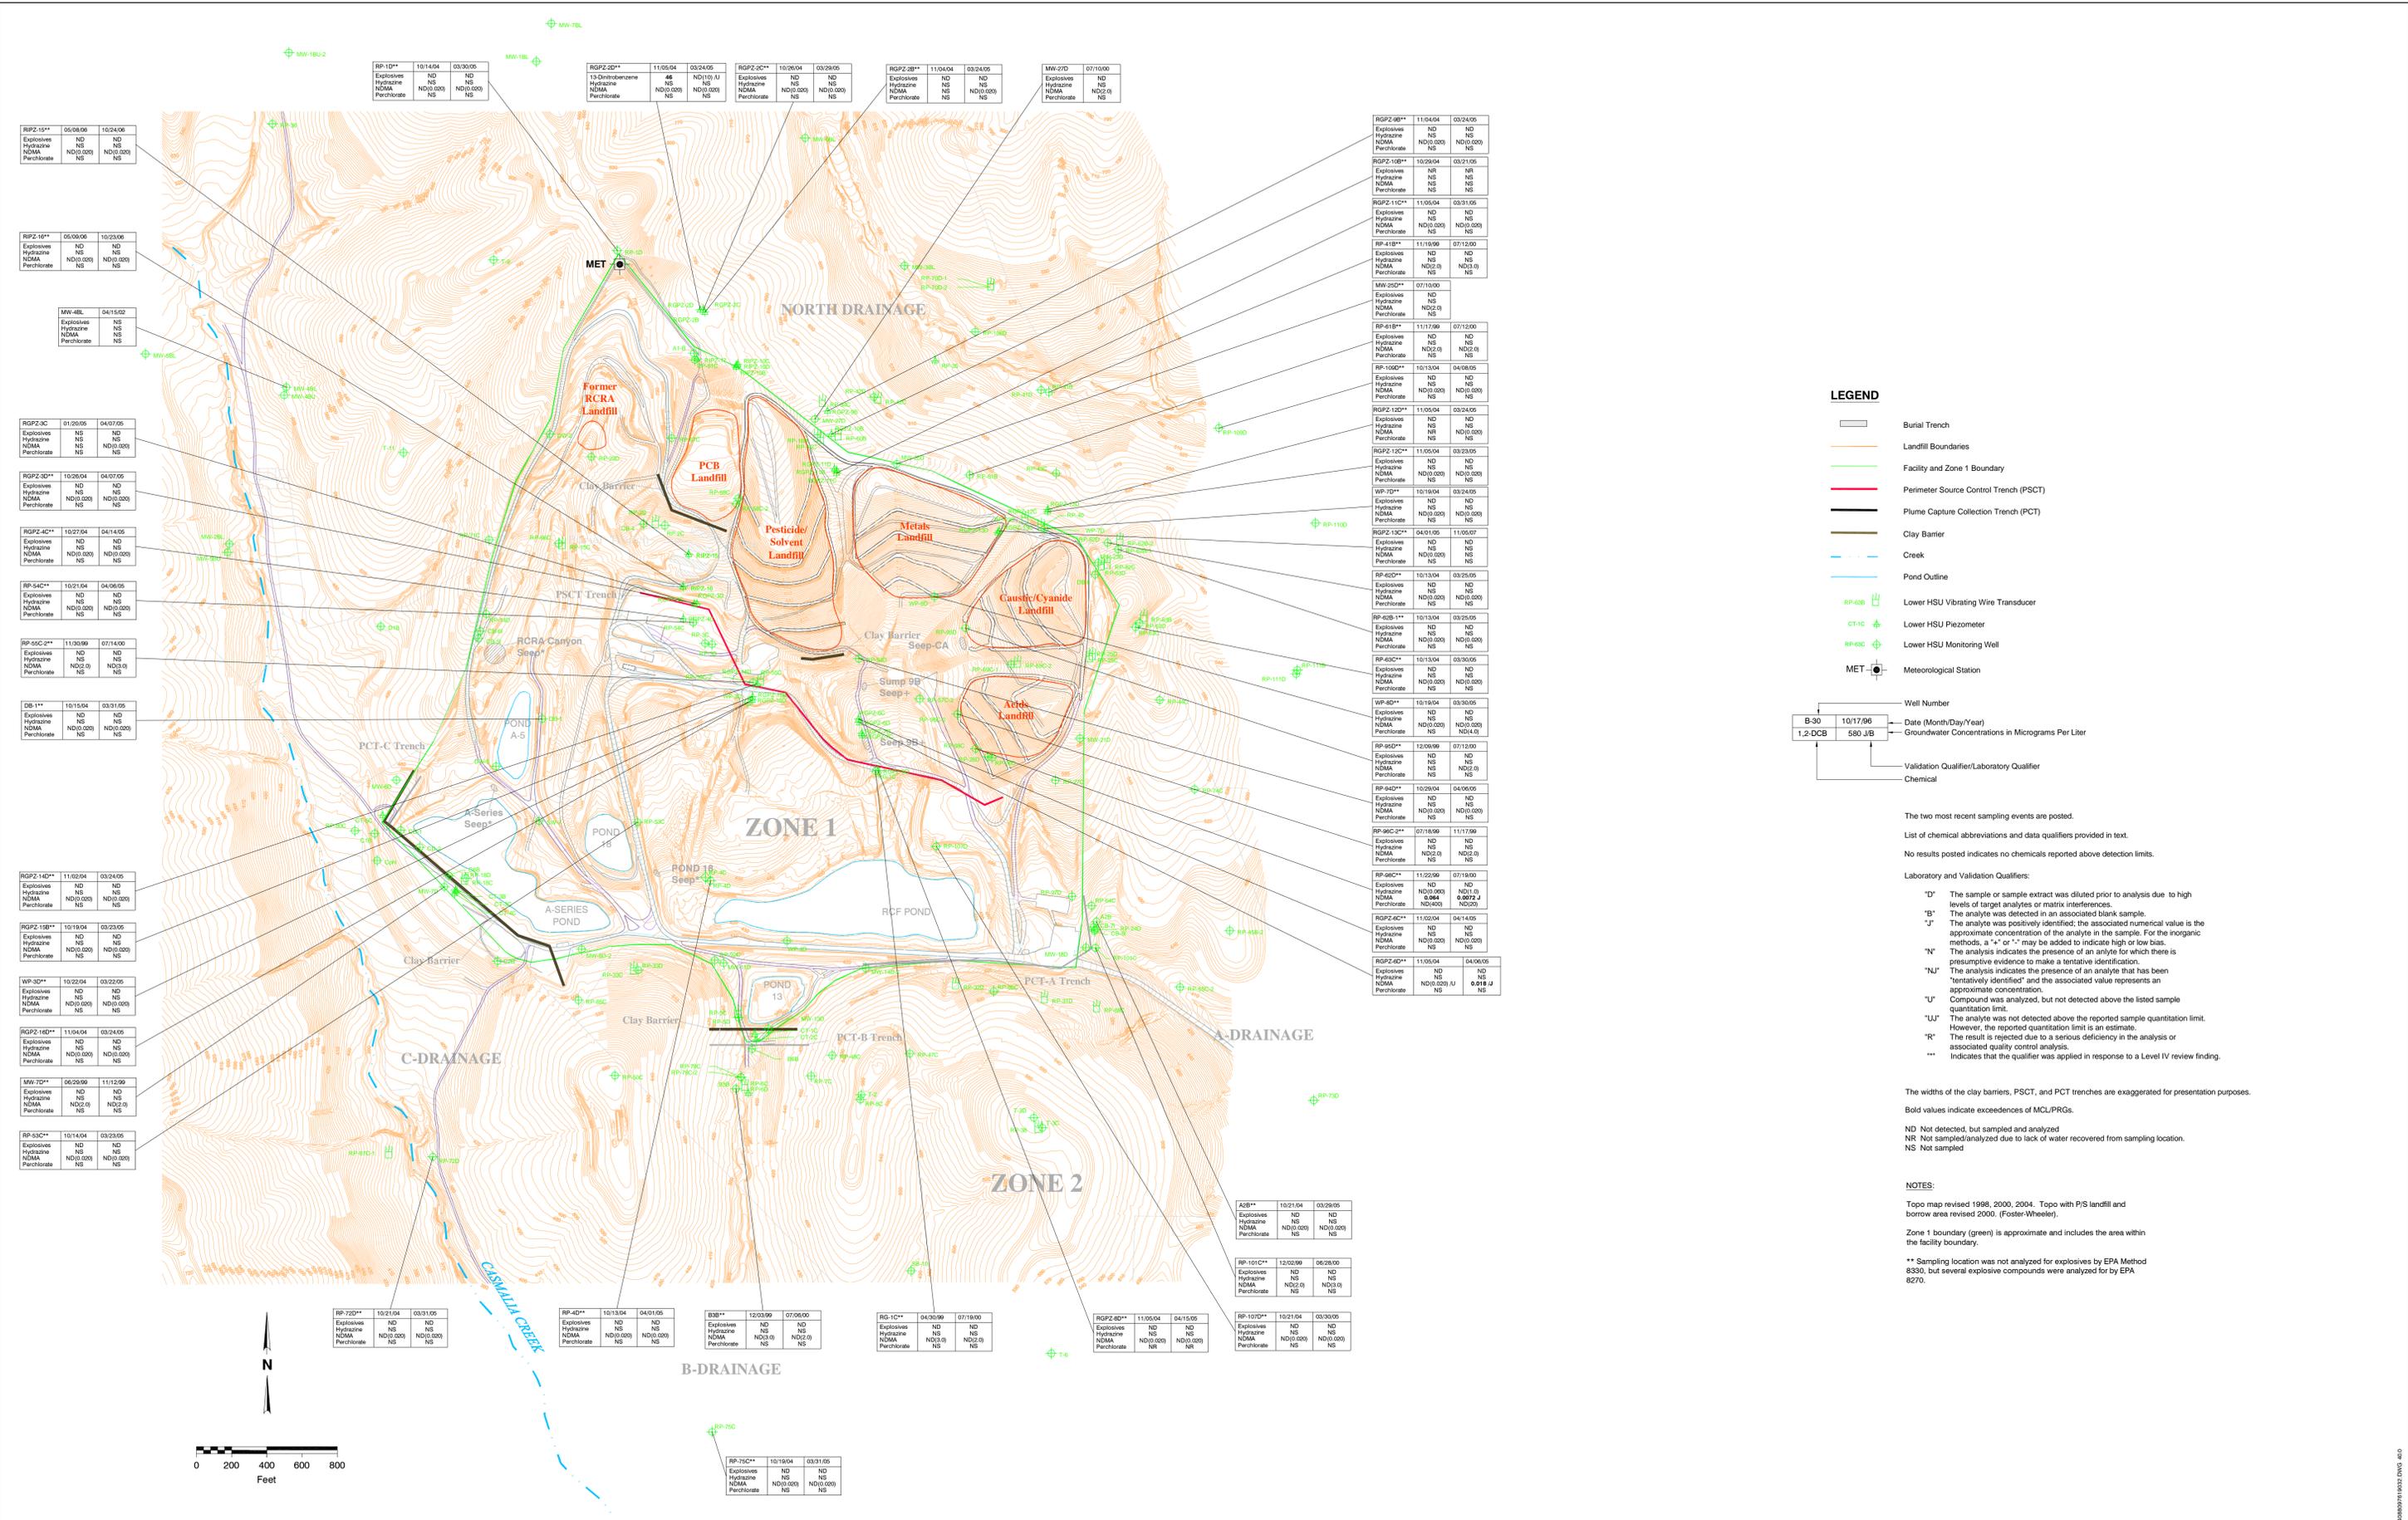
The two most recent sampling events are posted.

No results posted indicates no chemicals reported above detection limits.

The widths of the clay barriers, PSCT, and PCT trenches are exaggerated for presentation purposes.

Bold values indicate exceedences of MCL/PRGs.

Zone 1 boundary (green) is approximate and includes the area within the facility boundary.
