Figure B-16a

### Summary Analytical Results Inorganics Detected Above Screening Levels Remaining On-Site Areas

Final Remedial Investigation Report  
Casmalia Resources Superfund Site  
January 2011

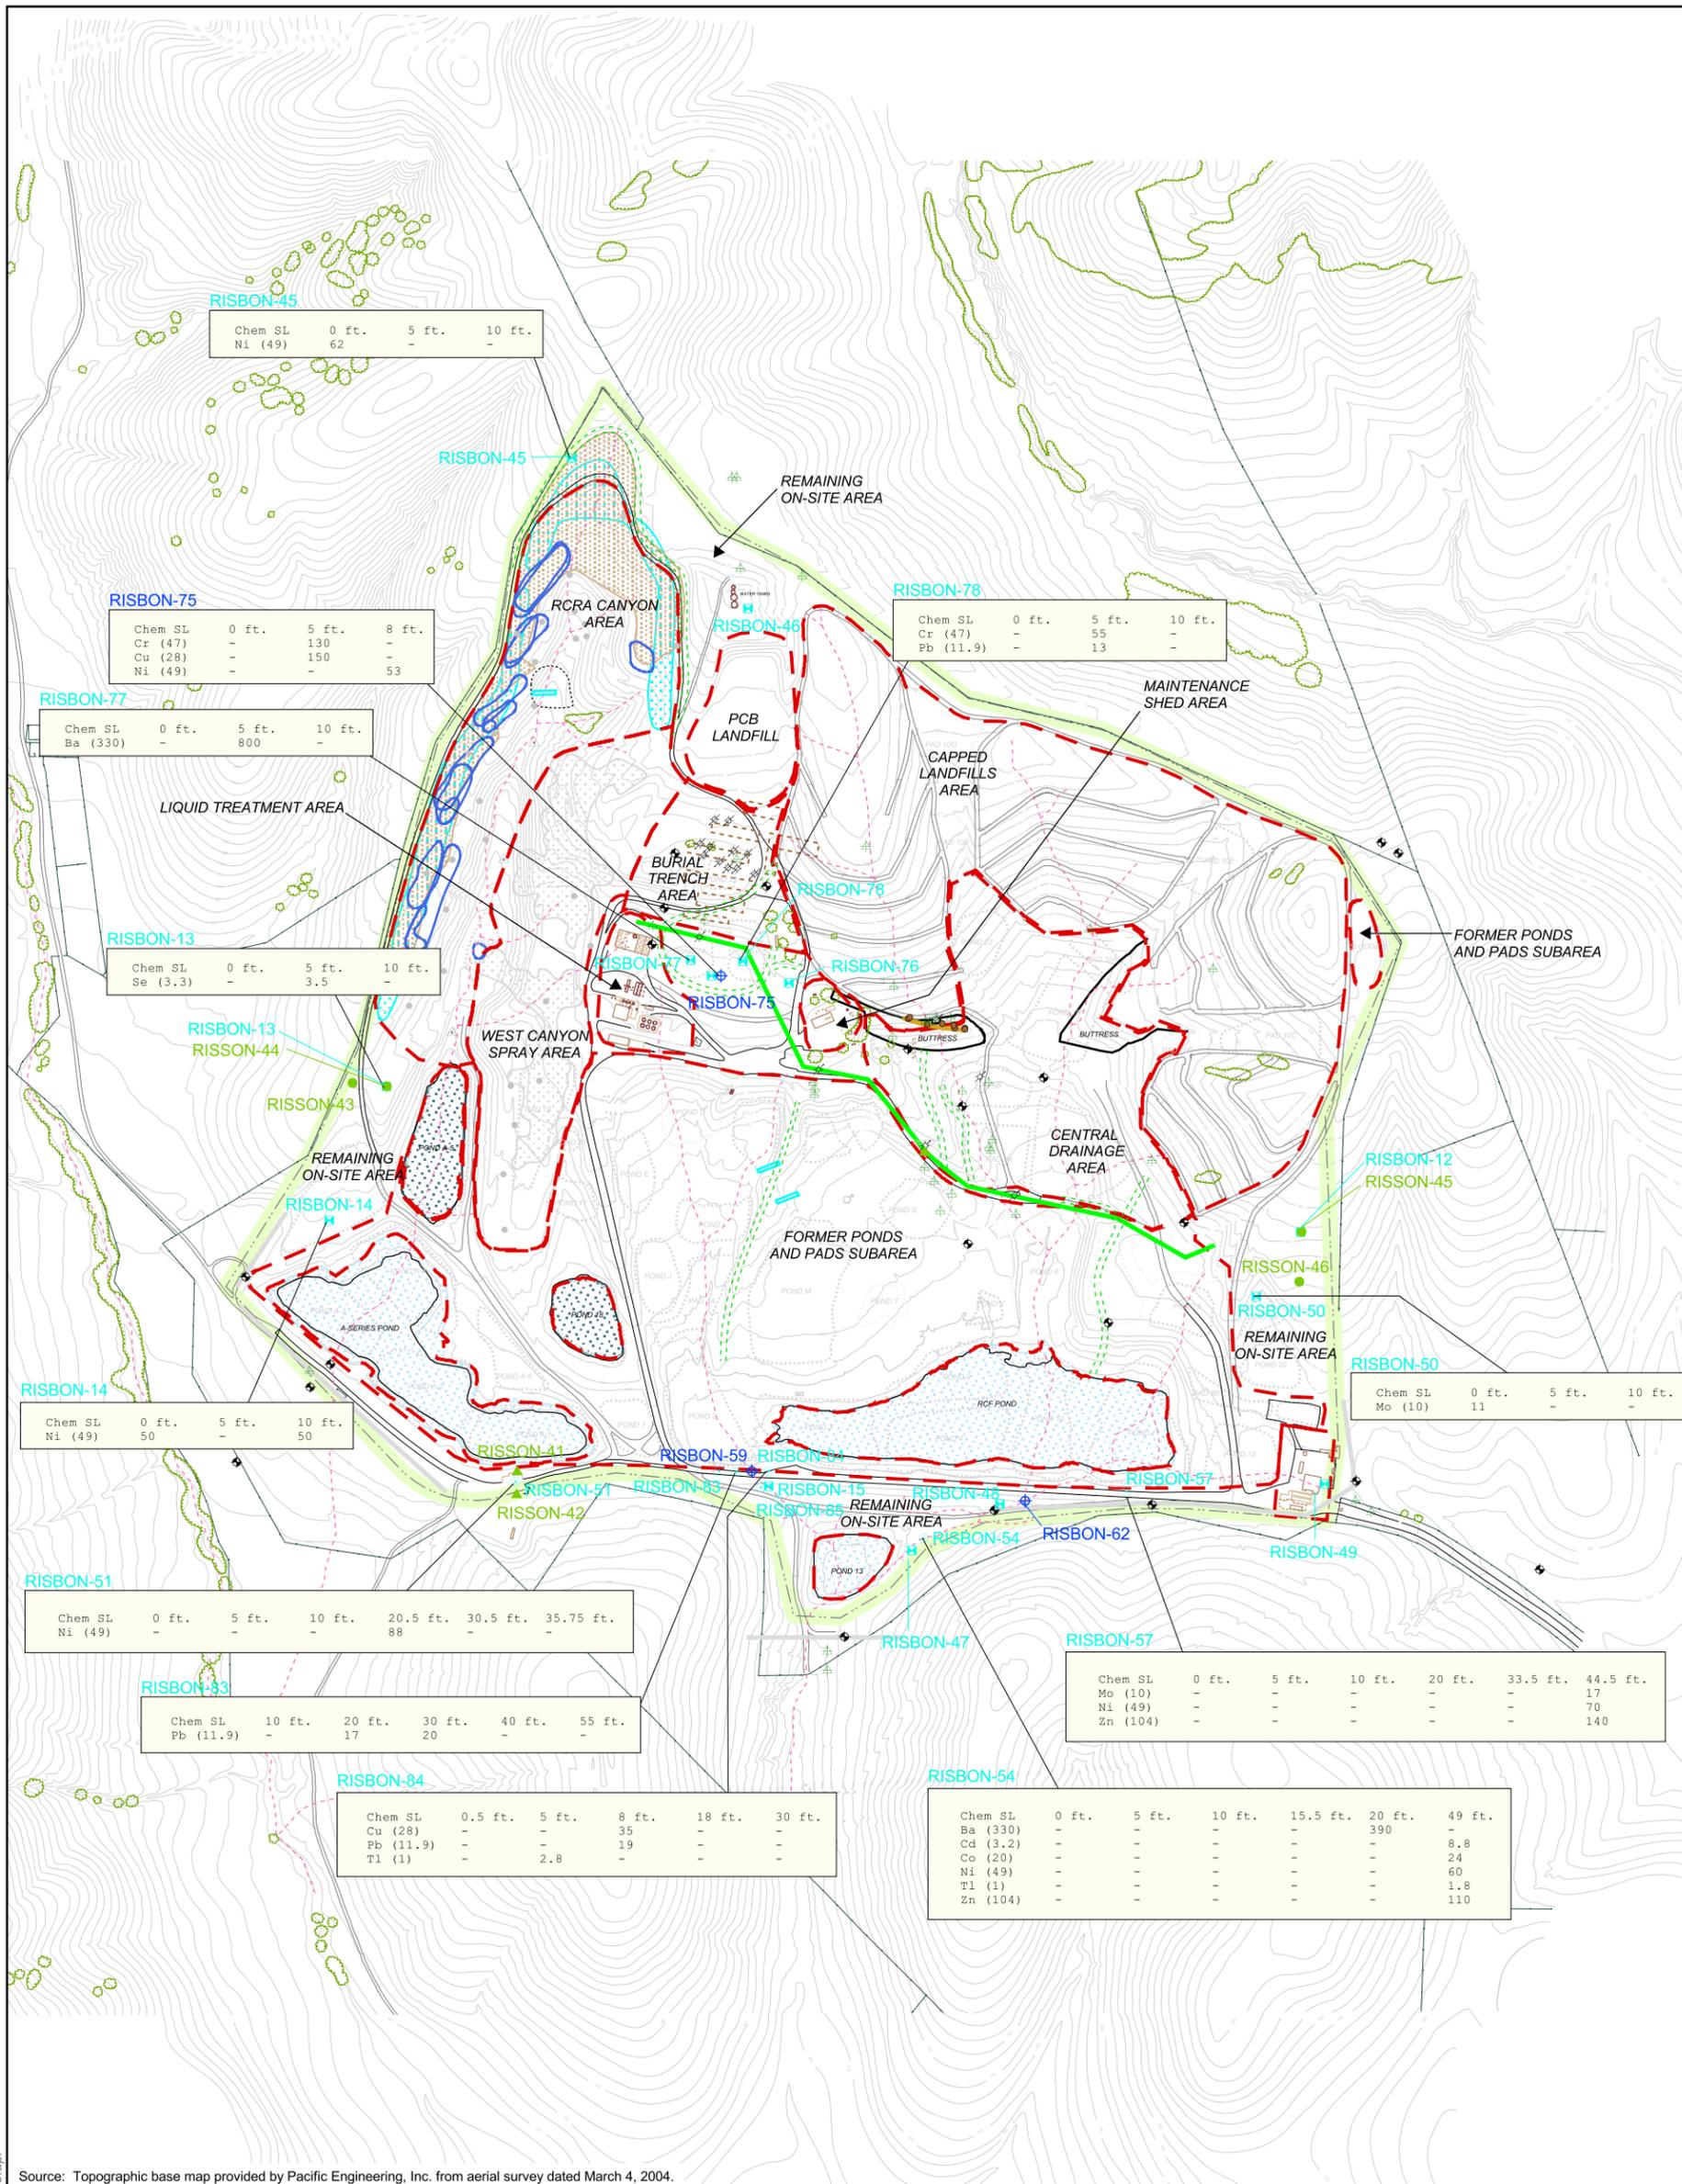
All Values in mg/kg
