Environmental Survey and Assessment for Asbestos Containing Materials

Work Area at Tallaboa Industrial Park (formerly PR Olefins)
Road 127, Peñuelas, Puerto Rico
(Work Plan Approved by EPA, Reference No. CAA-02-2014-1009)

Carlos E. Ocasio-Feliciano
Best Environmental Consultants, Inc.
Lead-Asbestos-Mold Consultants
PO Box 560180
Guayanilla, PR 00656-0180

January 29, 2019

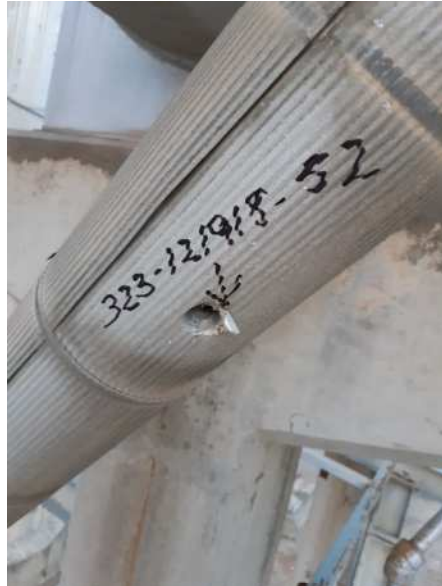
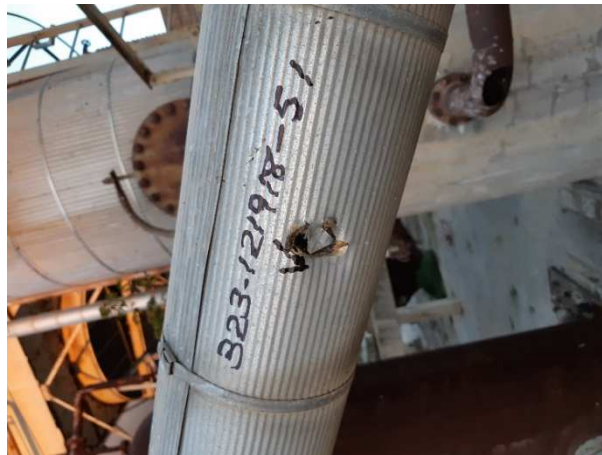
General View Sampling Point #51& 52, Front Side Pipe 6'' ϕ , Tower 13
