SITE VISIT RECORD

Subject: Violation: 2020-00951 Wetlands and Channels Excavated

Date: May 18, 2021

2020-00951

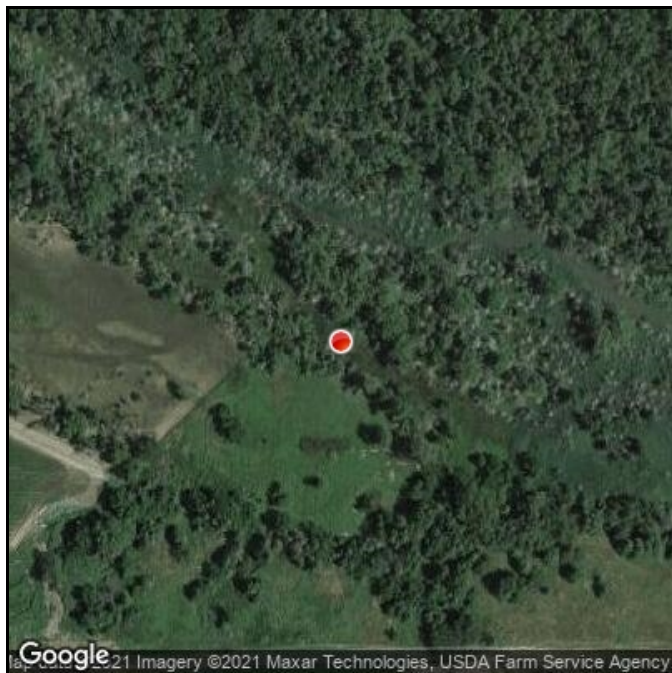
IMG_1243.JPG

Photo taken facing north showing culverted crossing and vegetation removal to the northeast.

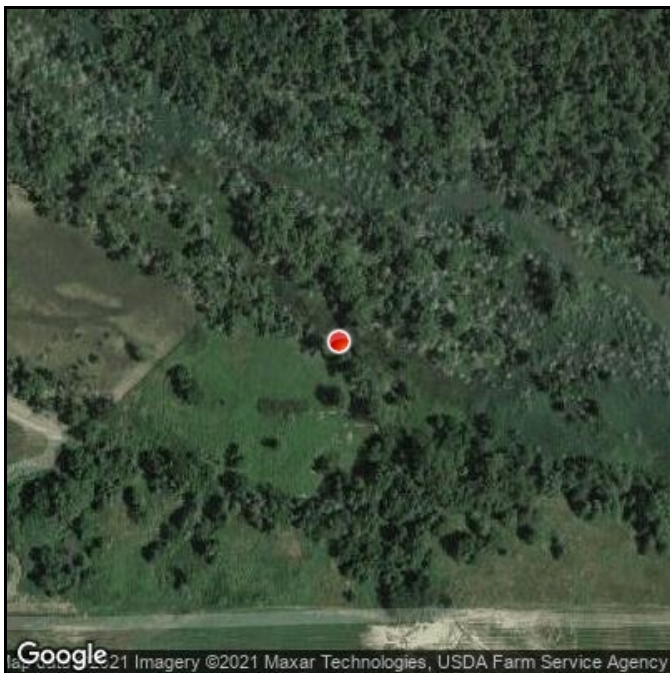
IMG_1244.JPG

Photo taken facing east showing excavated channel and berm installed along north side of the channel.

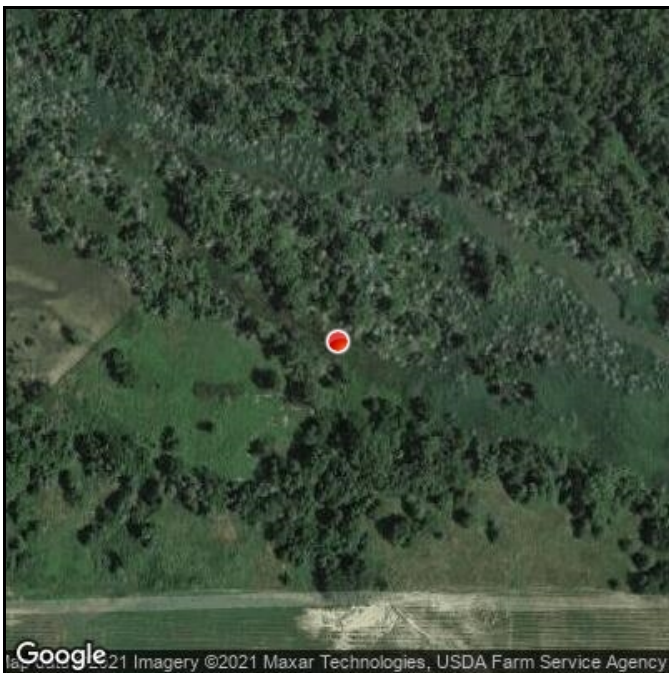
IMG_1254.JPG

Photo facing east following the constructed berm.

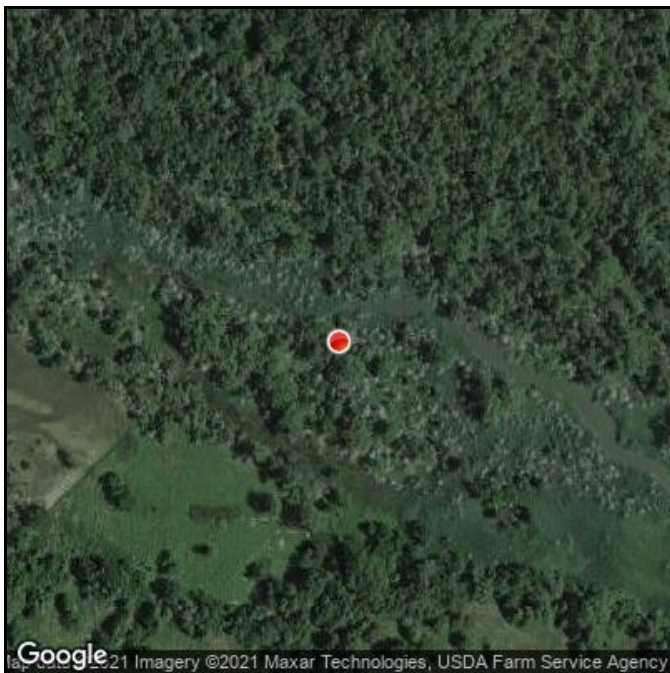
IMG_1256.JPG

Photo facing north showing another crossing.

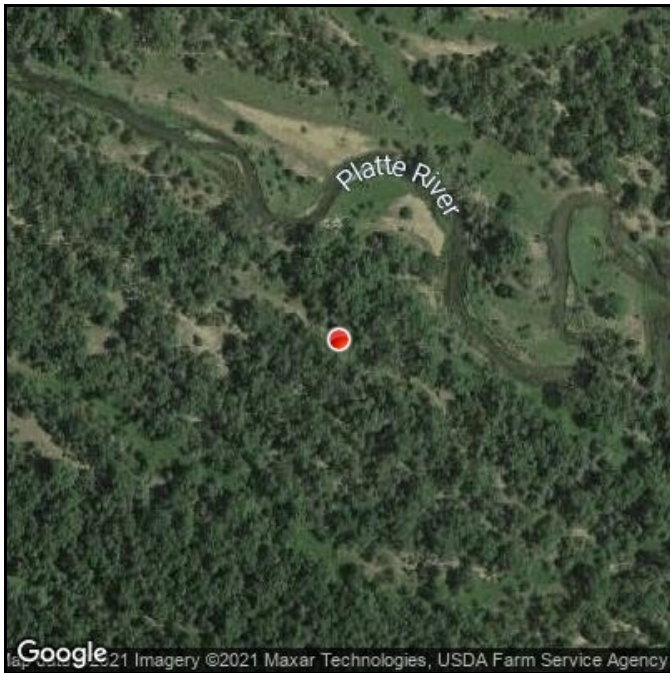
IMG_1261.JPG

Photo facing east, this is the western limit of the excavated channel connecting to the constructed berm abutting the Platte River.

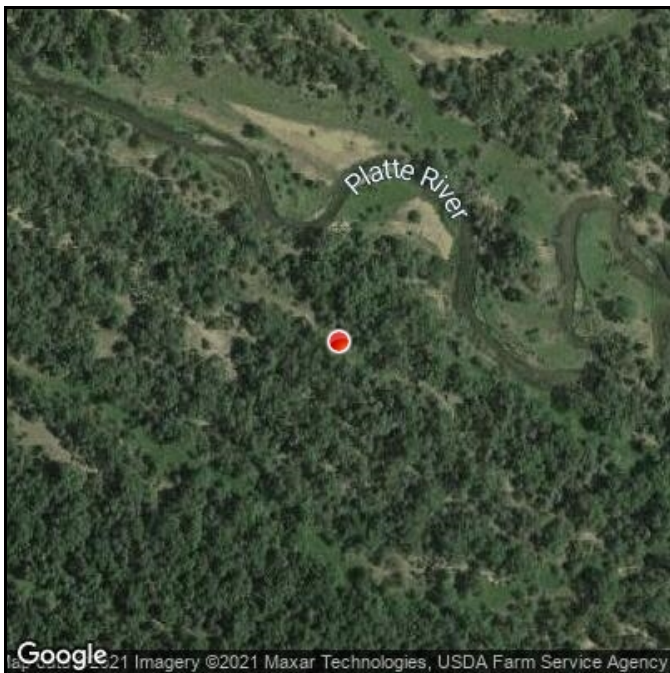
Photo shows the fill from the excavated channel to the north.

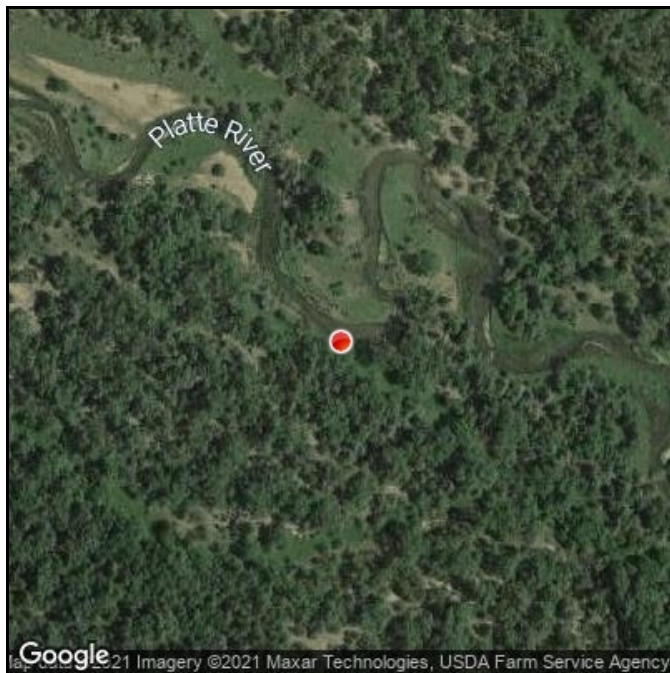
IMG_1264.JPG

Showing the berm, excavated channel to the south and Platte River to the north.

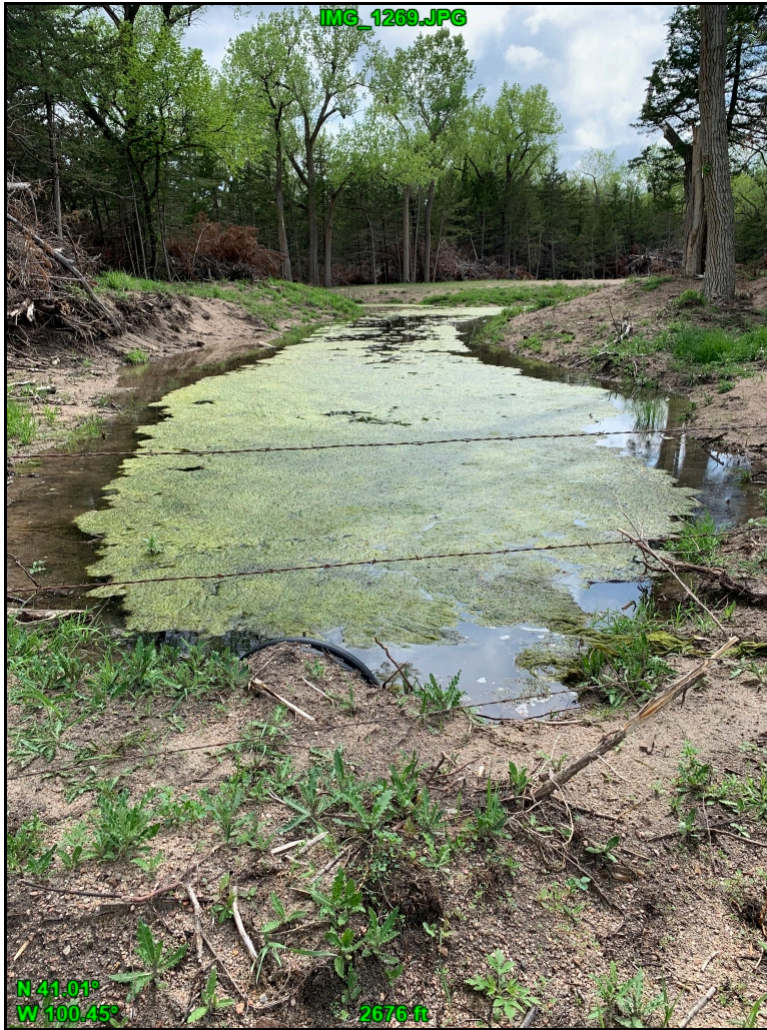
IMG_1270.JPG

Culvert outlet at Platte River

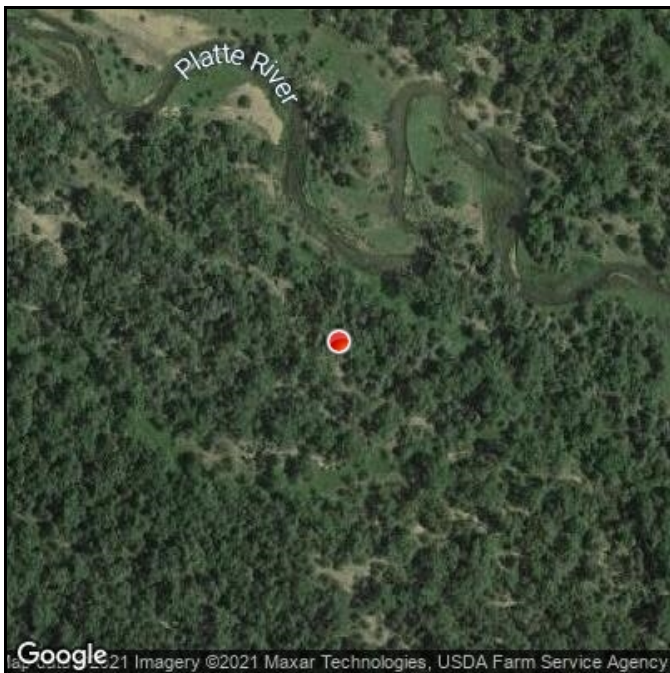
IMG_1280.JPG

Fill location and excavated channel confluence. This flows north into the Platte River.

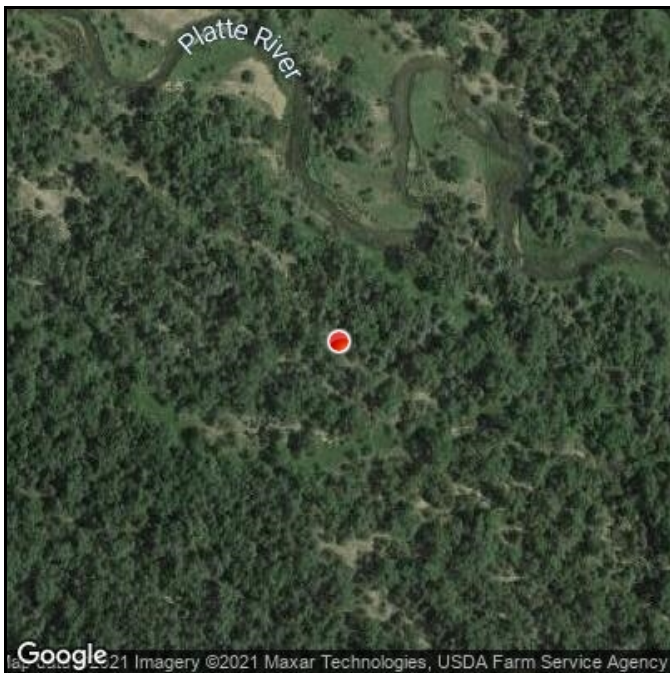
Fill location from excavated channels.

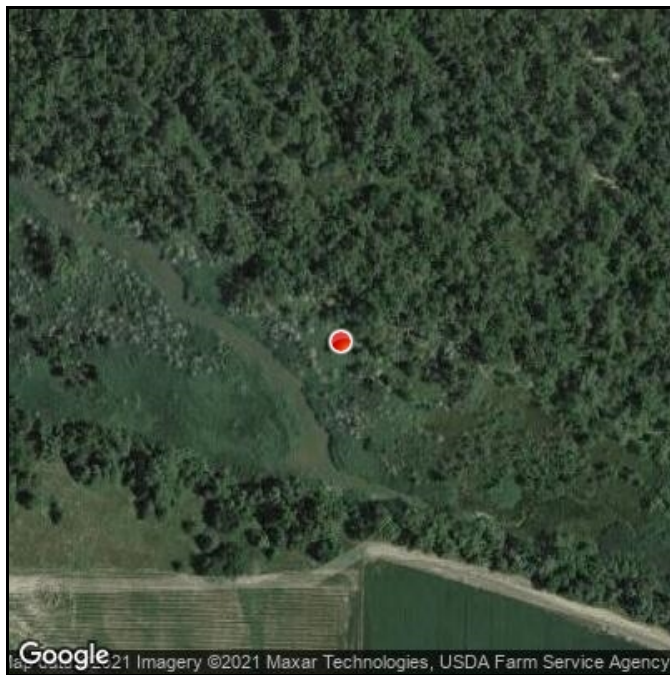
IMG_1287.JPG

Shows another berm along the new channel north of crossing 3.

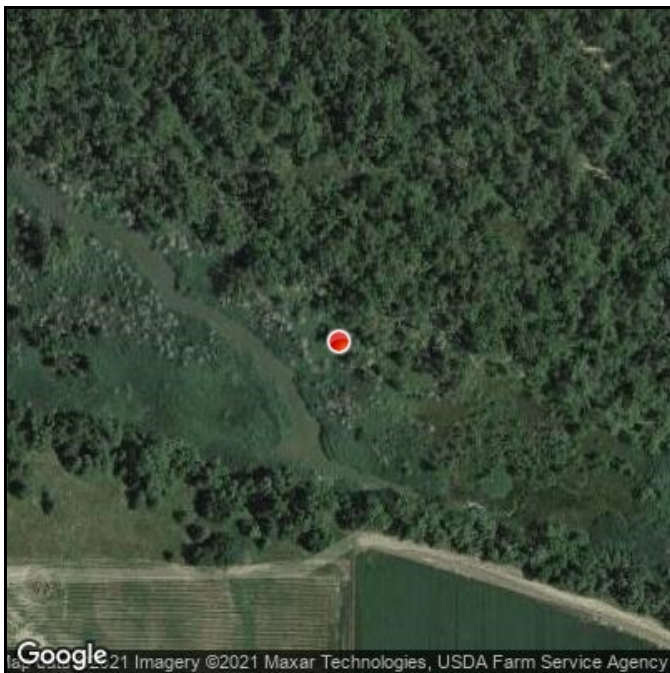
IMG_1288.JPG

Crossing 4 and excavated channels. This is the largest area of excavation.

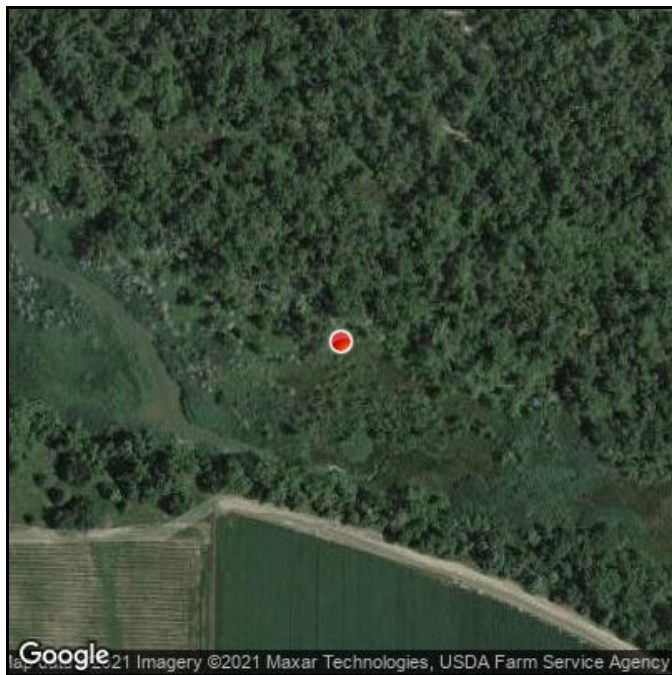
IMG_1291.JPG

Northern end of excavated channel northeast of crossing 4.
