Annual Monitoring Checklist
IRP Site 5 (Landfill 7)
Andersen AFB, Guam
 N62742-09-D-1953 - Contract Task Order No. 009

**PHOTOGRAPHIC LOG – IRP SITE 5 (LANDFILL 7), ANDERSEN AFB, GUAM
N62742-09-D-1953 - CONTRACT TASK ORDER NO. 009 - JULY 8, 2011 INSPECTION**

3.0 Site 5 (Landfill 7) 2012 Annual LUC Monitoring Checklist

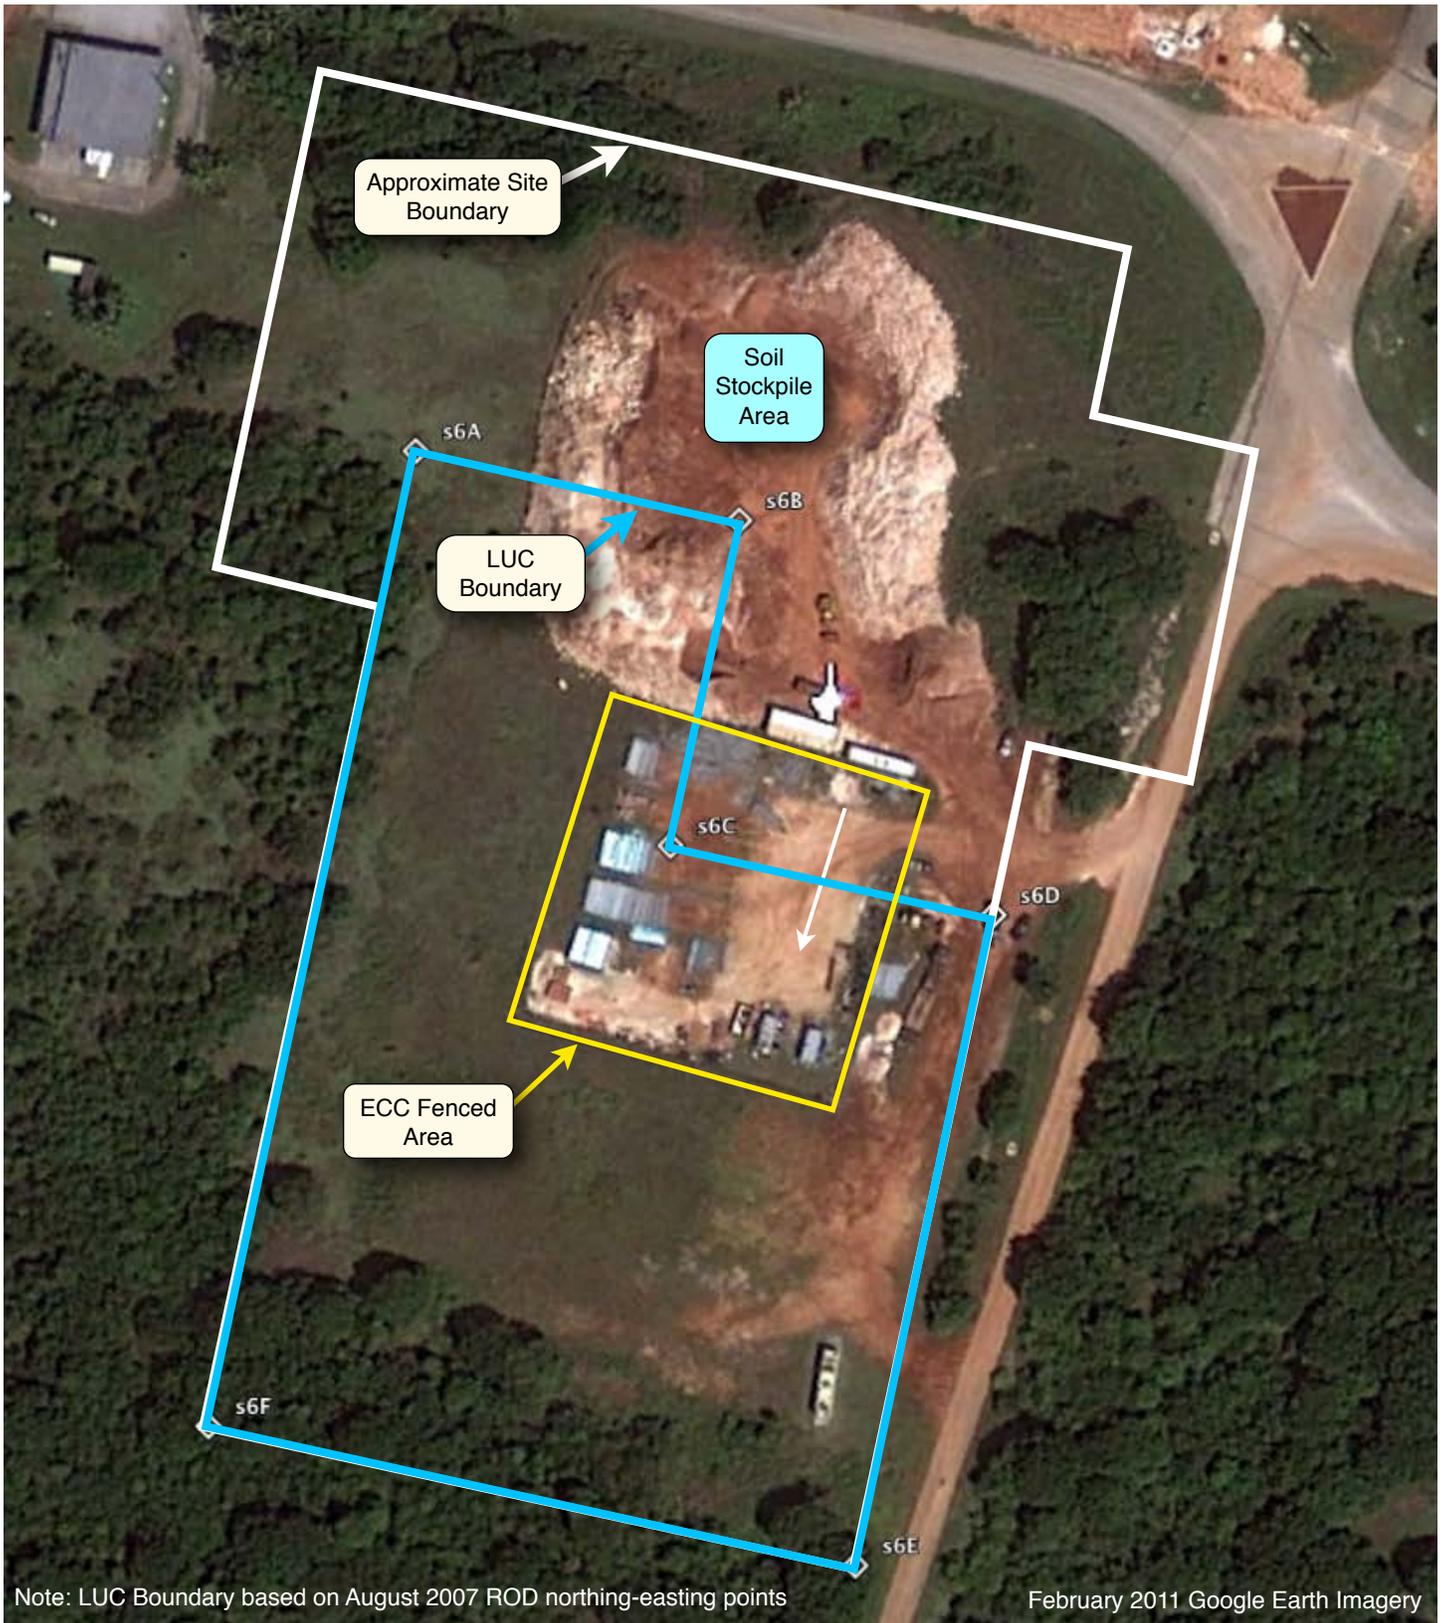
Figure A-1. Proposed Area for Implementation of LUCs at Site 6, Andersen AFB, Guam.

This site is currently being used as a laydown/storage yard by ECC Corporation. See Fig 1: Approximate Site Boundary, LUC Boundary, and ECC Laydown/Storage Fenced Area. Part of the ECC fenced area lies within the LUC boundary. Soil appears to have been moved between the LUC boundary area and other areas within the site.

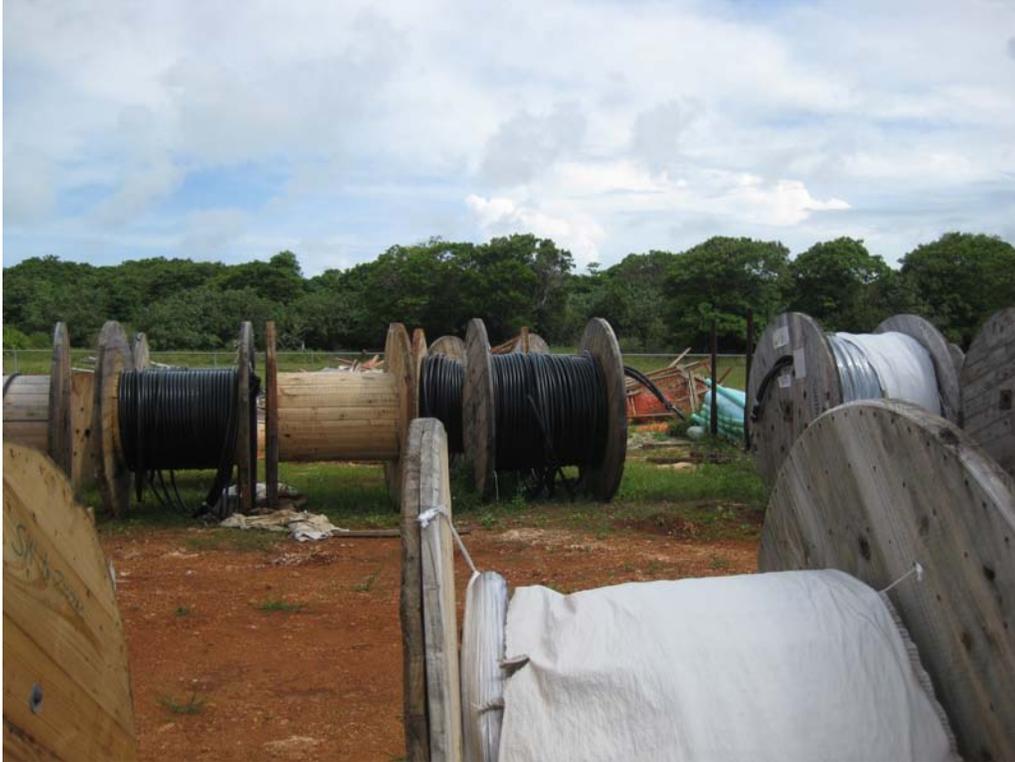
Photo 3 Material storage within ECC laydown/storage area.

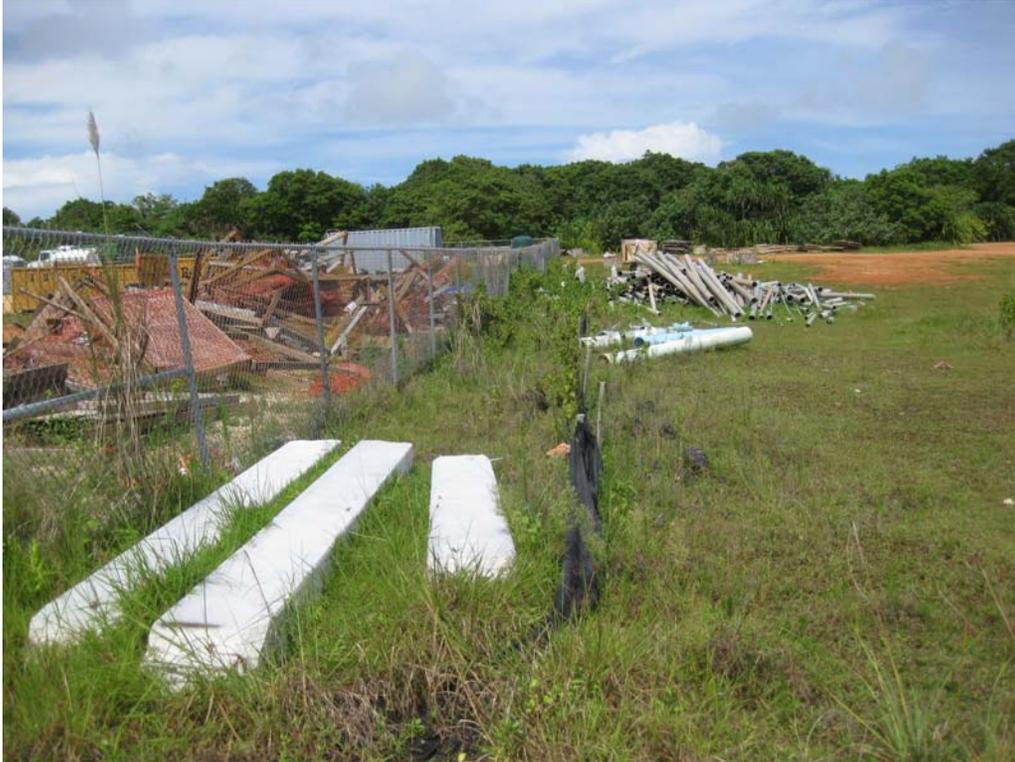
Photo 5 Material storage outside of ECC laydown/storage area (west side looking south).

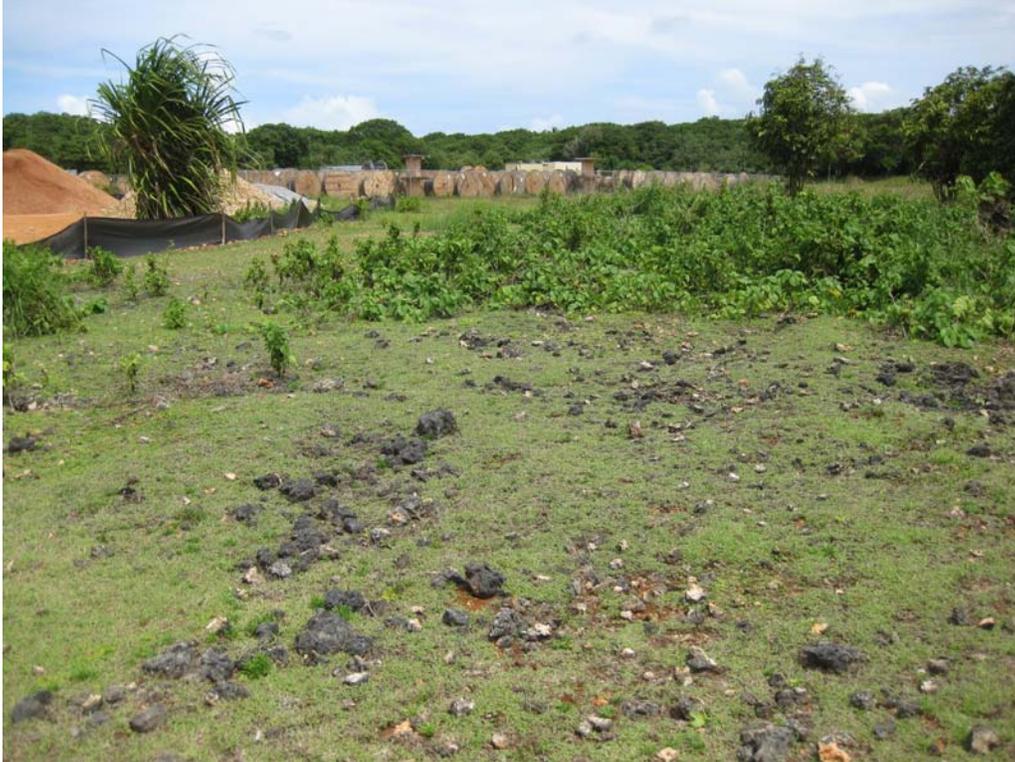
Photo 7 View looking south from northernmost point of LUC area toward ECC laydown/storage area.

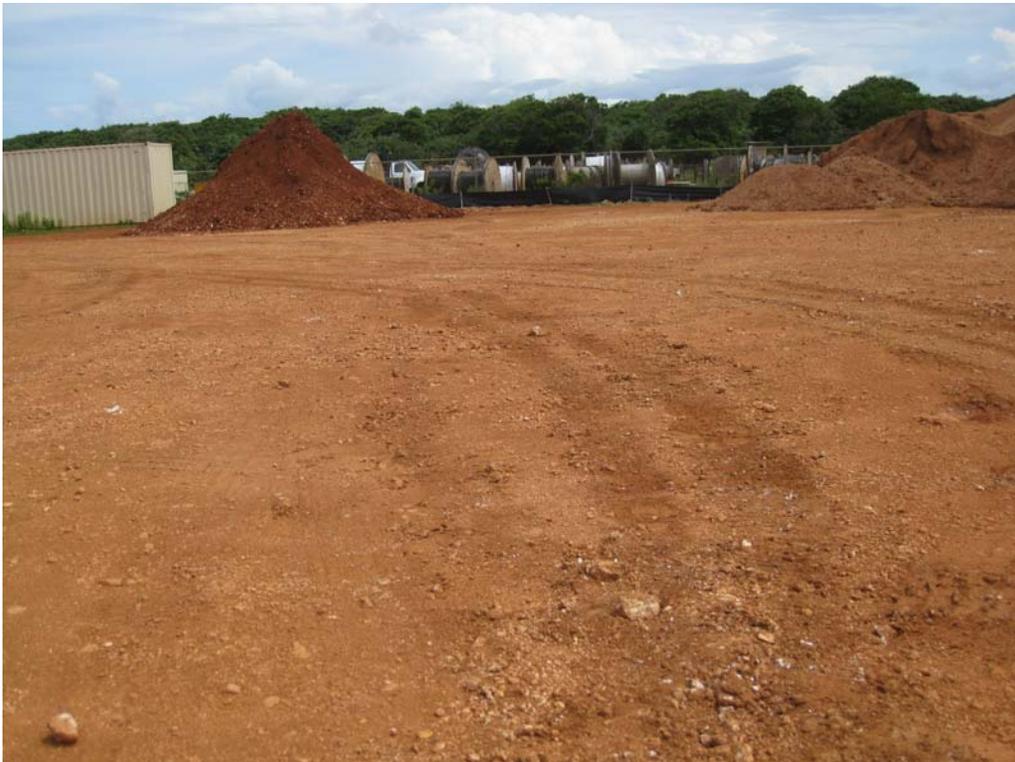
Photo 8 View from disturbed area northern part of Site 6 looking south.

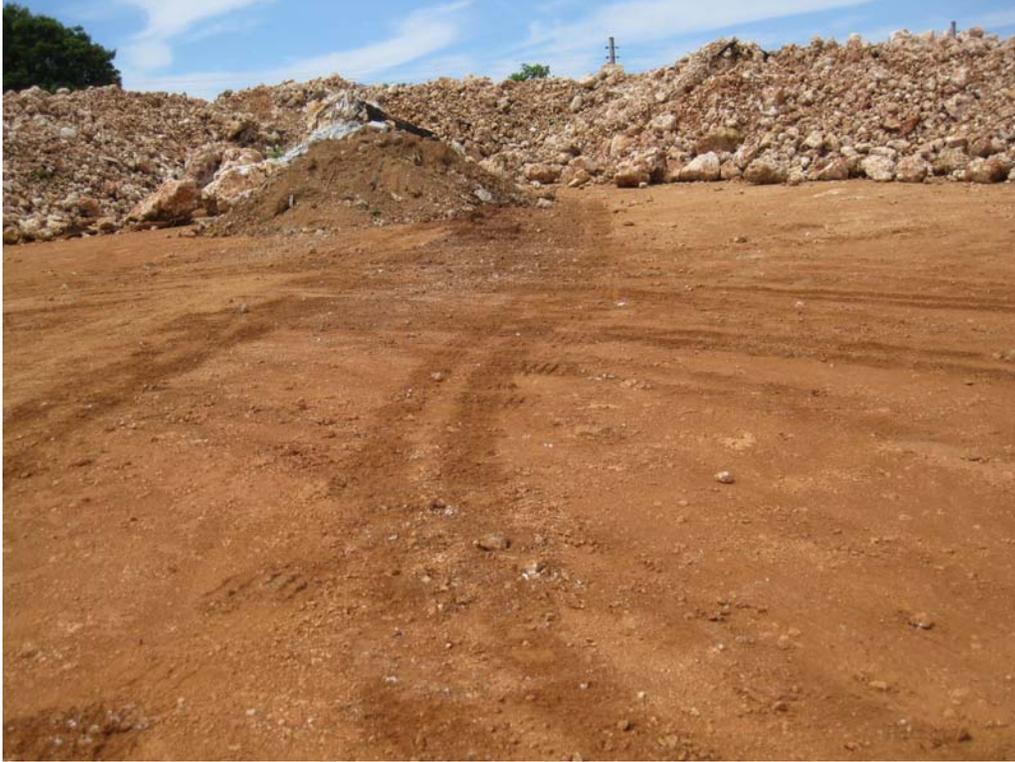
Photo 9 Soil stockpiles northern part of Site 6 looking north.

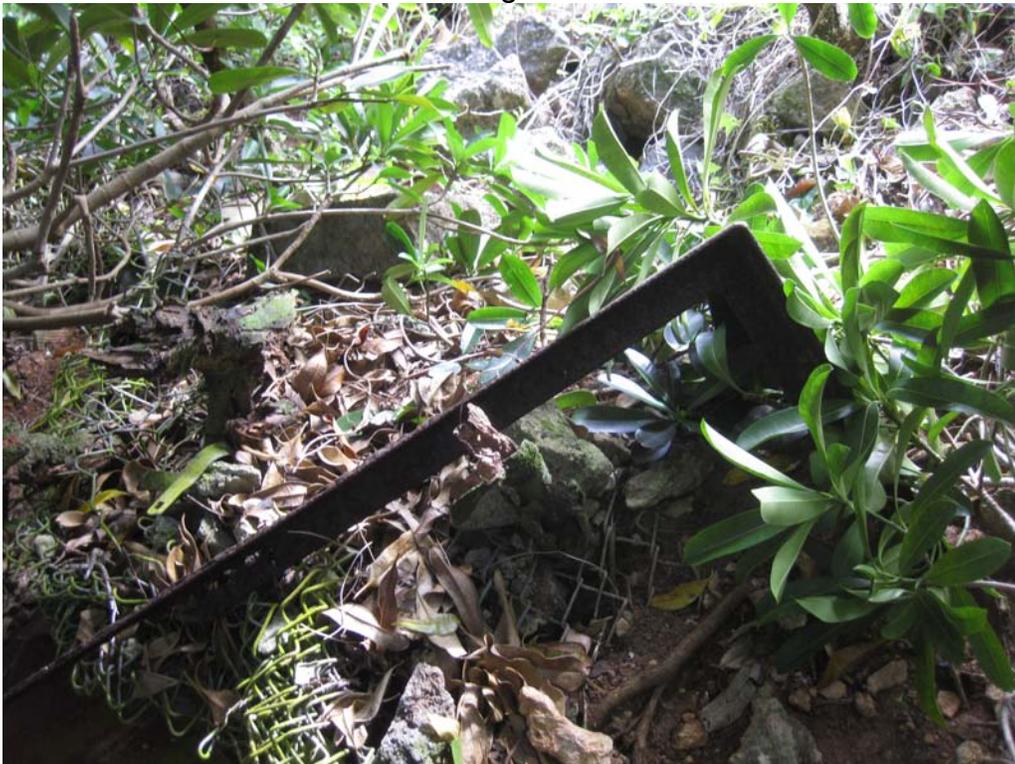
Photo 4 LUC Area 1 - Concrete and metal waste.

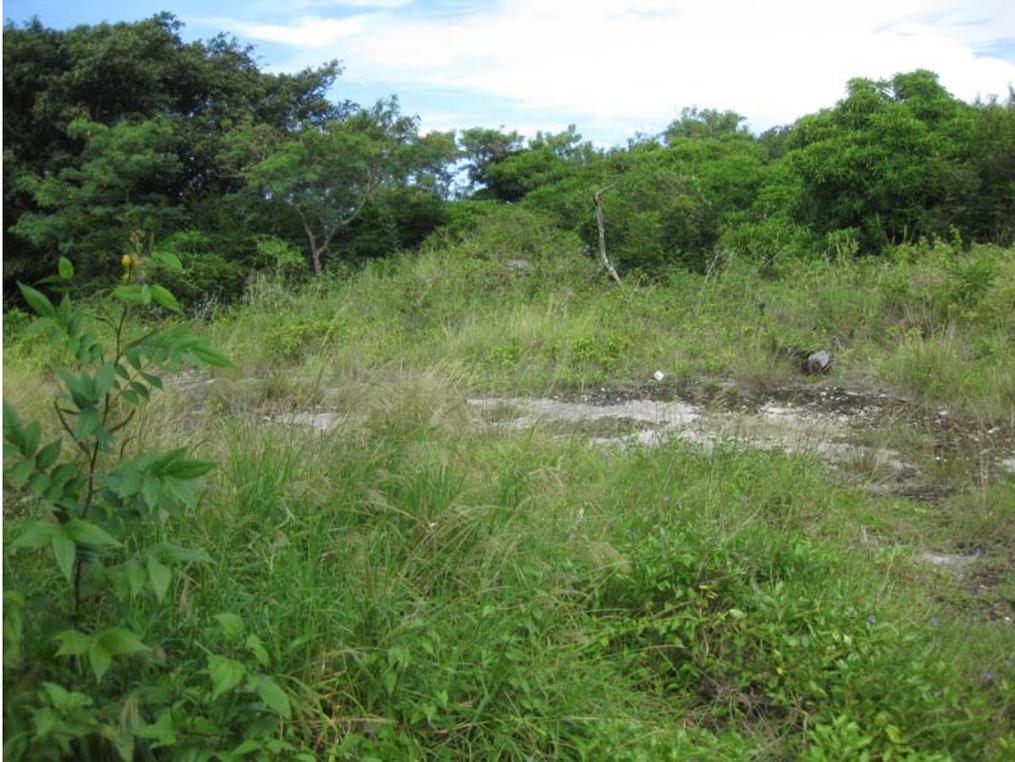
Photo 9 LUC Area 3 - View showing sparsely vegetated former access road within site.

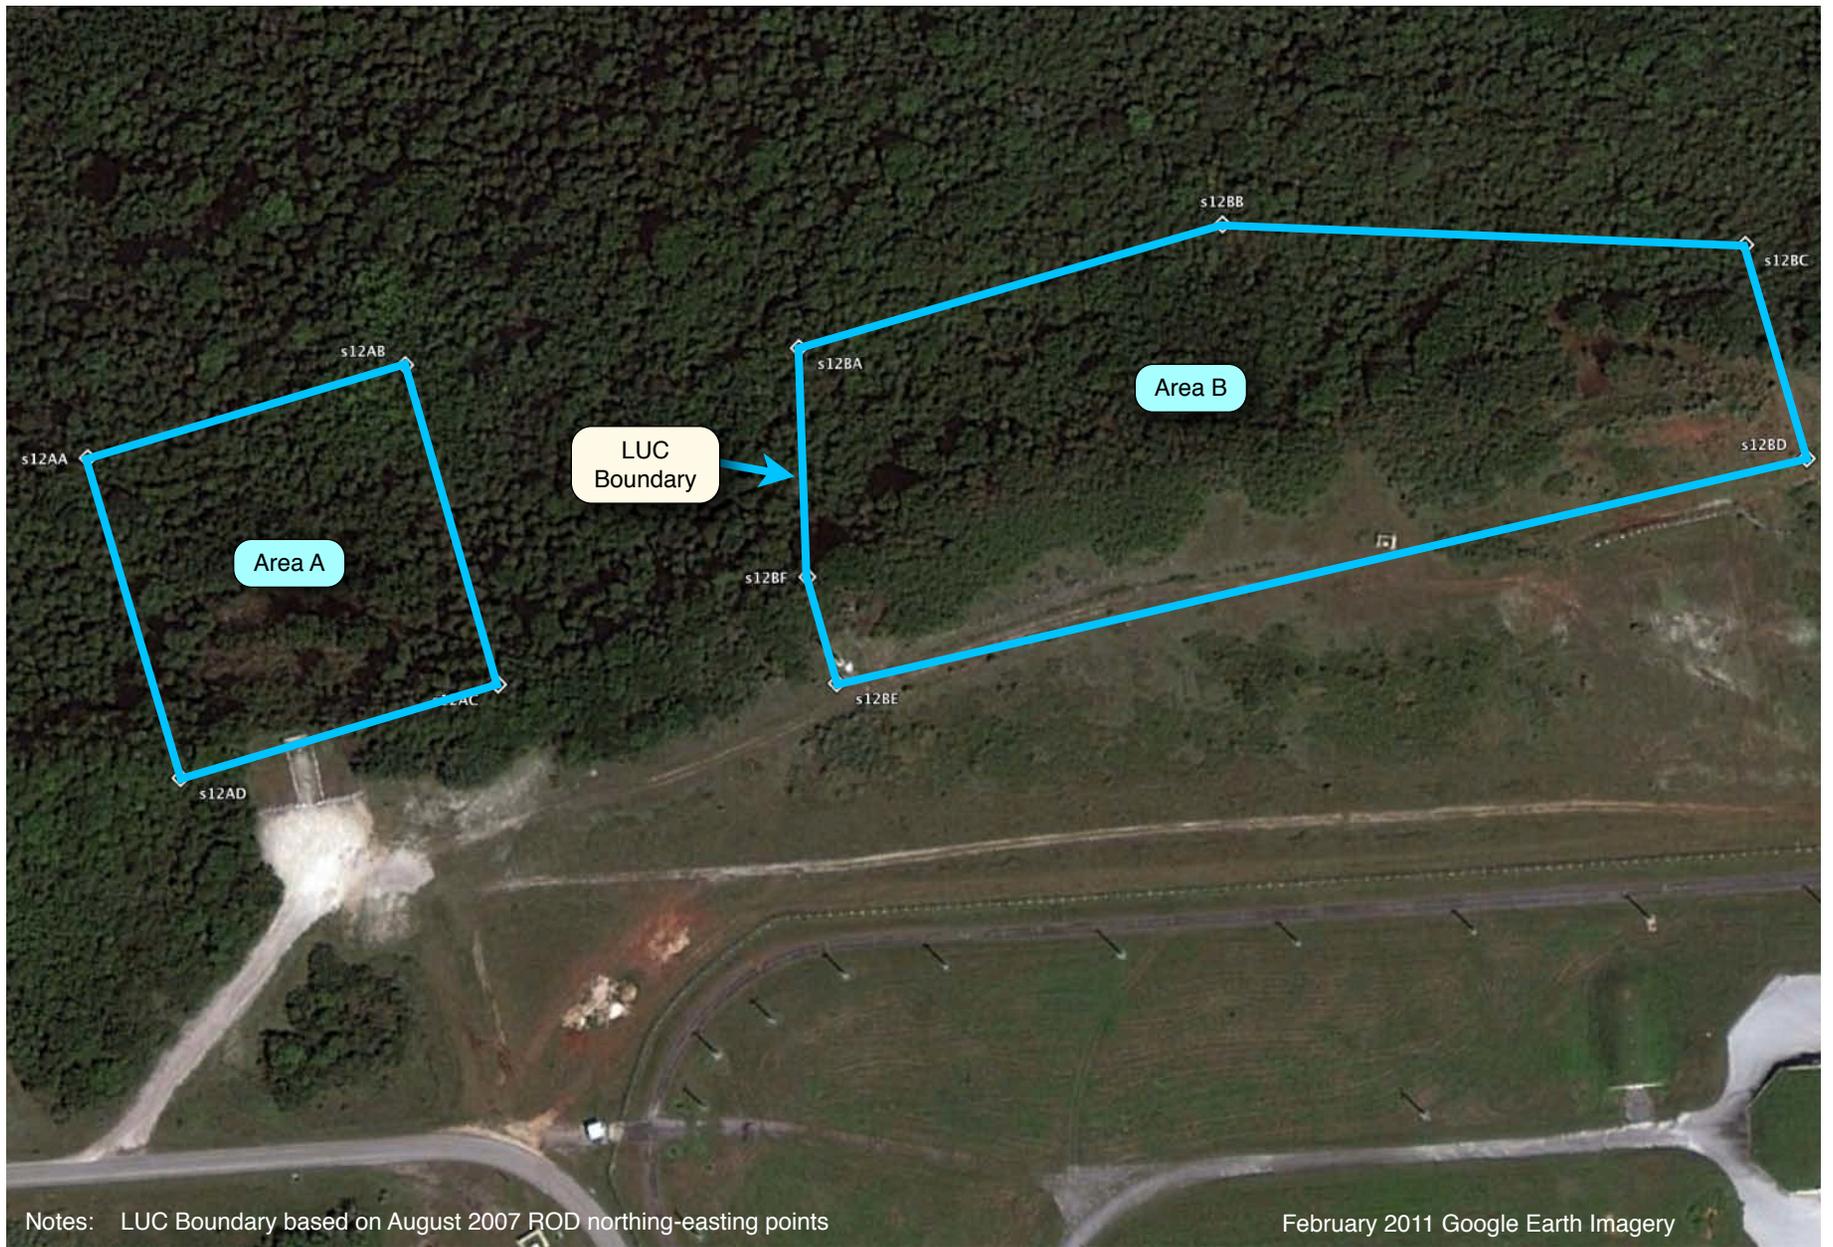
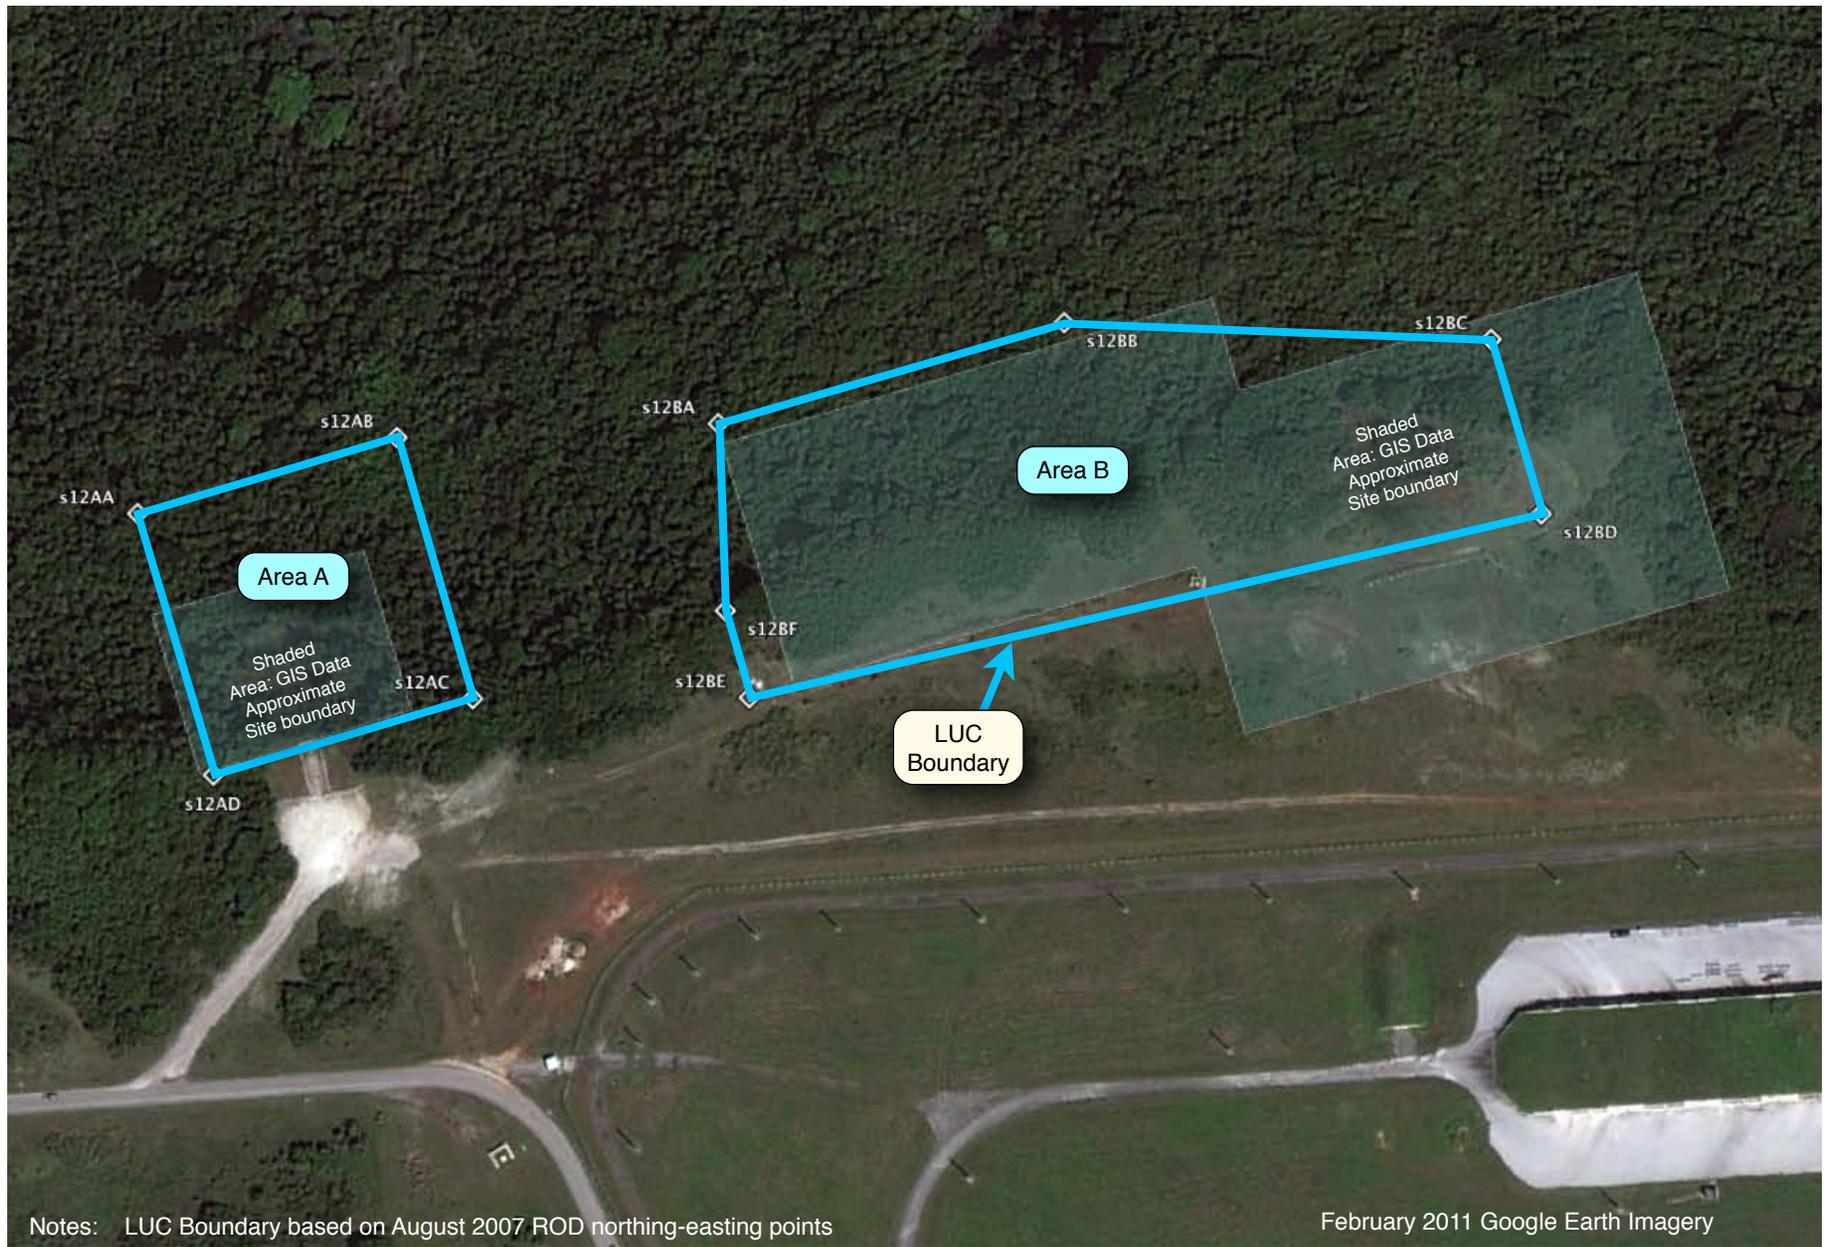
Annual Monitoring Checklist
 IRP Site 12 (Landfill 17)
 LUC Boundaries for Areas A and B

Fencing is not present at this site. Site 12 is comprised of 6 separate areas: A, B, C, D, E and F.

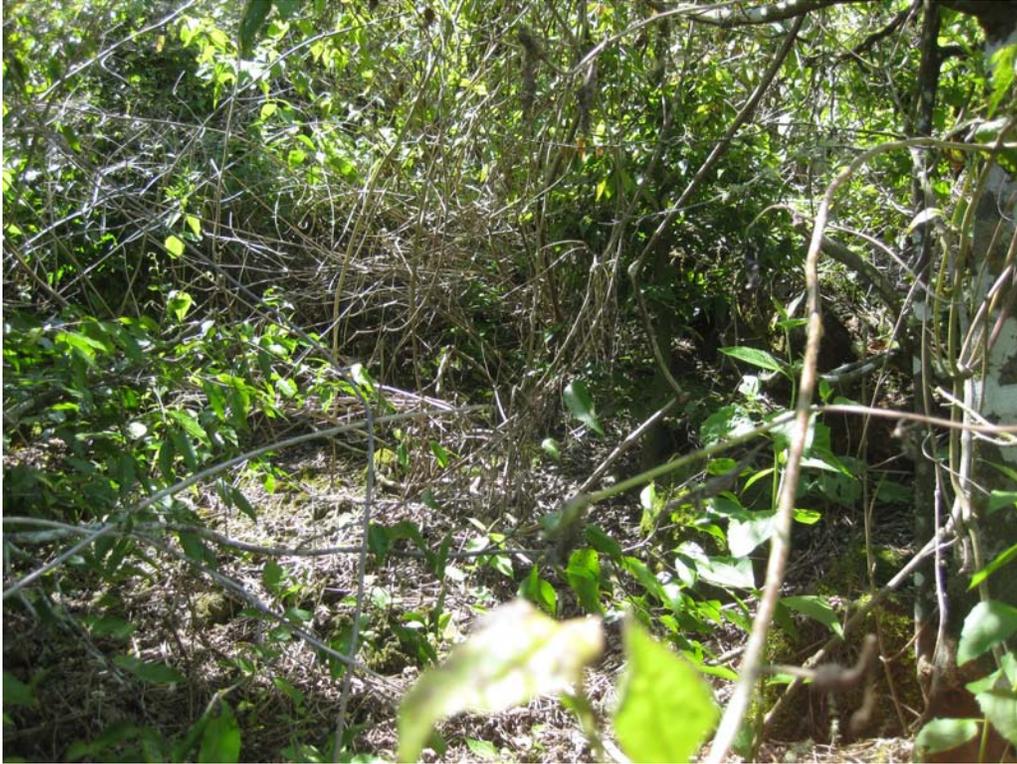
Photo 7 Area B: View of vegetation at site.

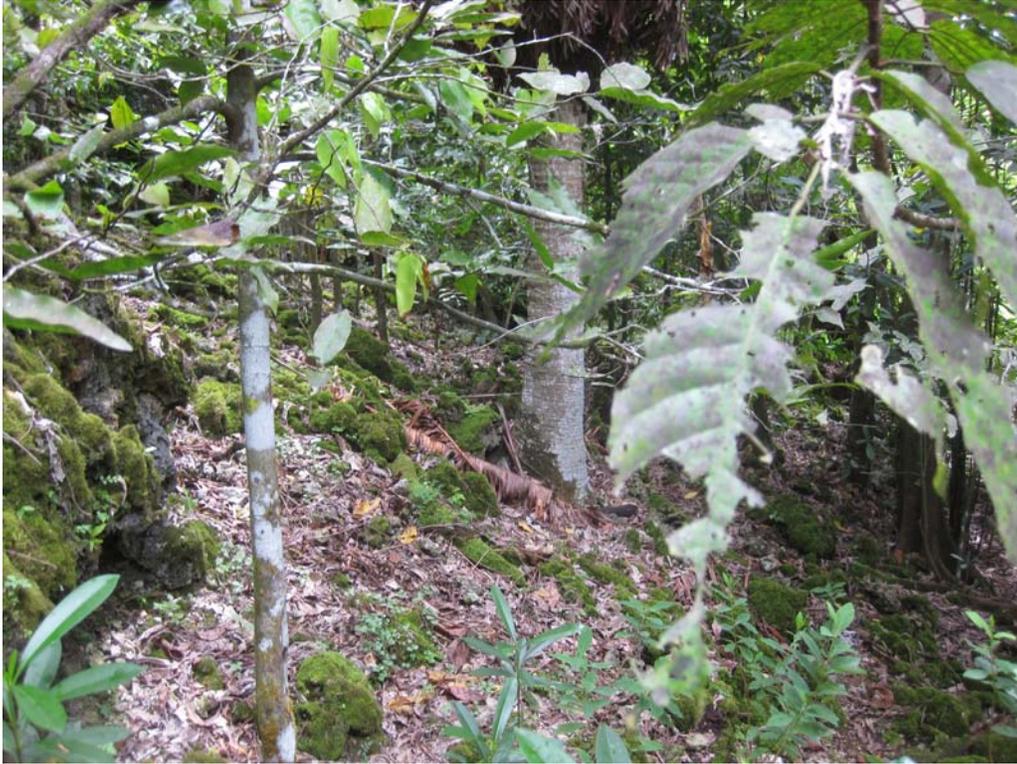
Photo 9 Area C: View of vegetation at site

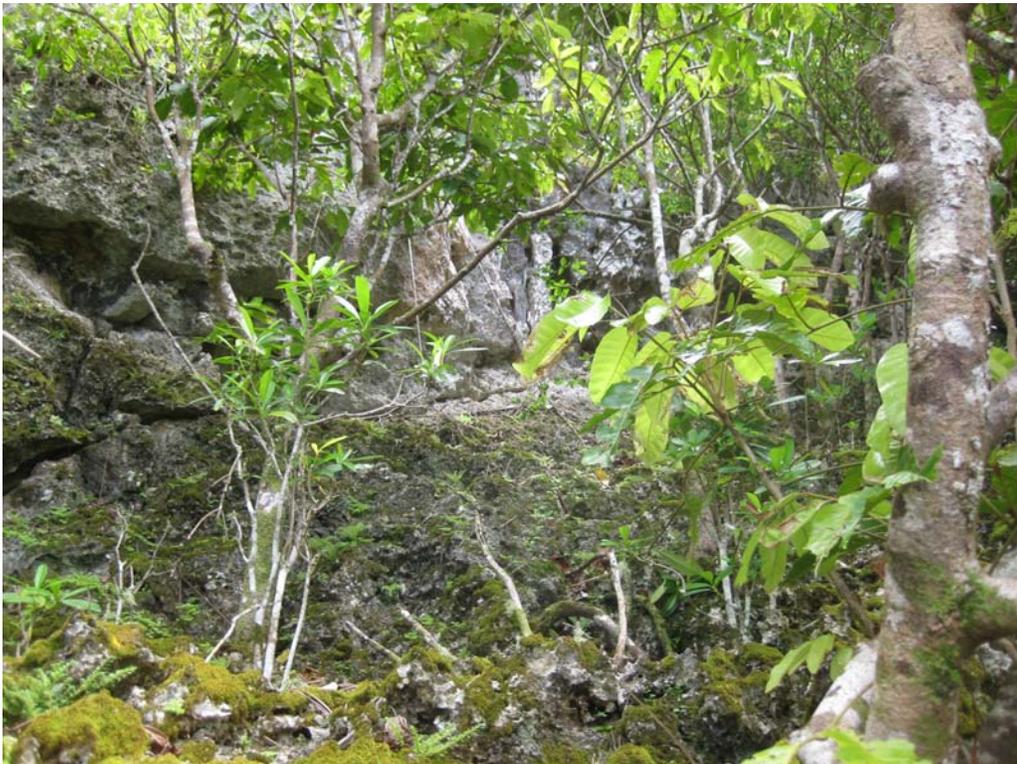
Photo 10 Area C: View of vegetation at site

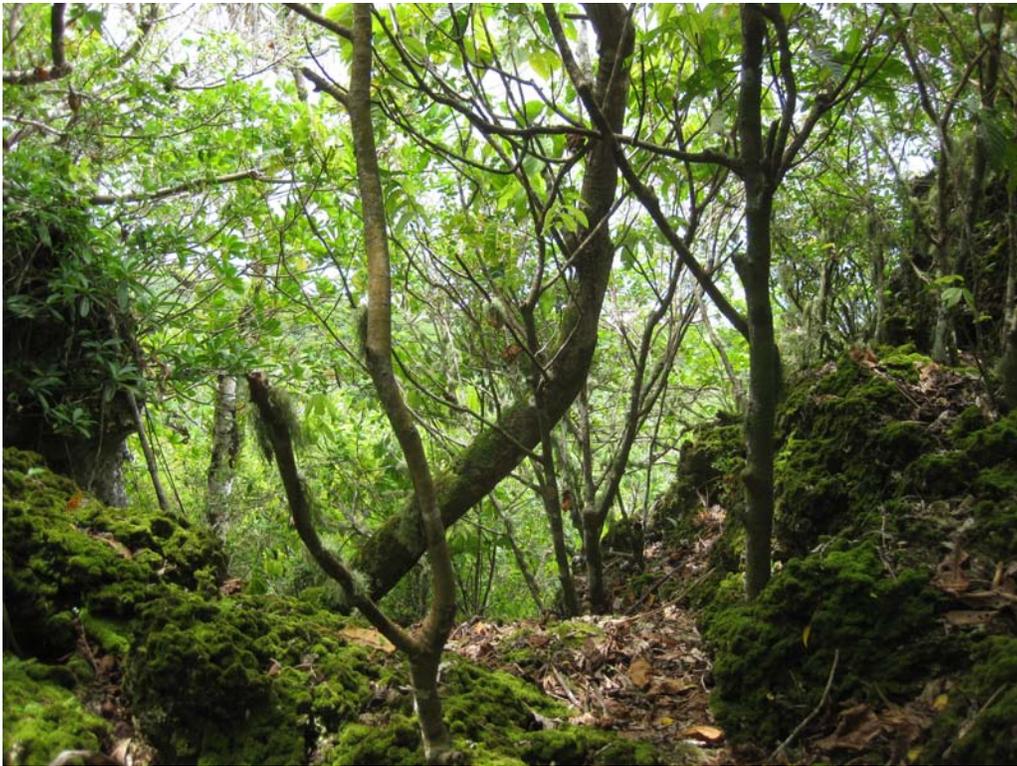
Photo 12 Area C: View of vegetation at site.

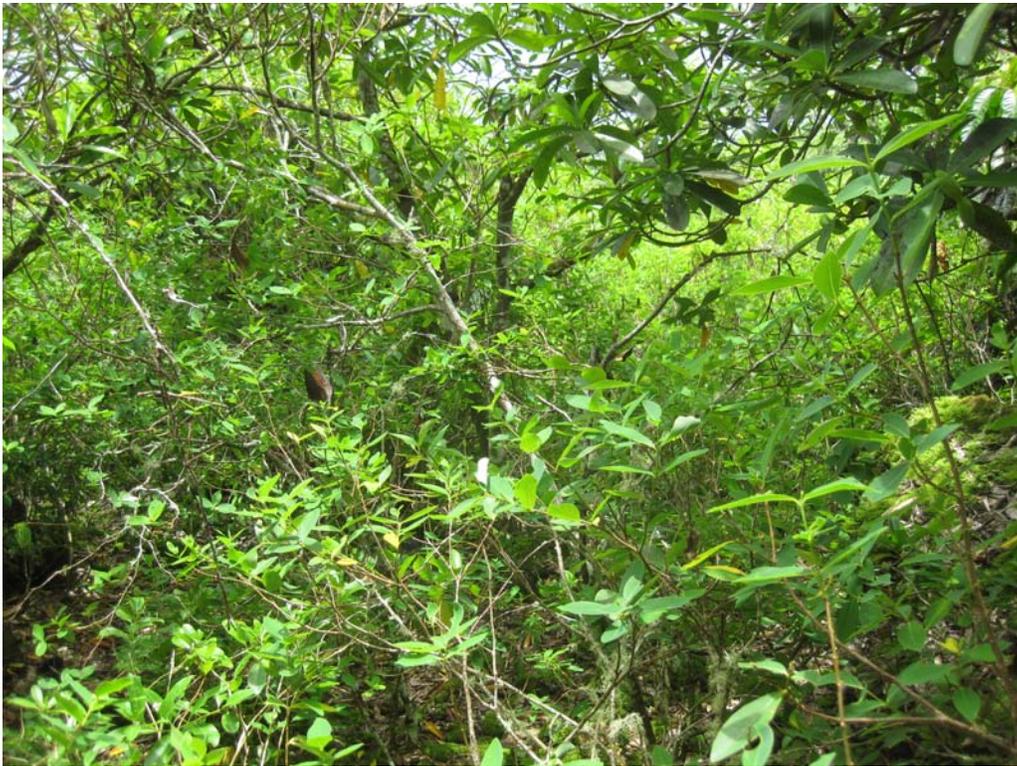
Photo 14 Area D: View of vegetation at site.

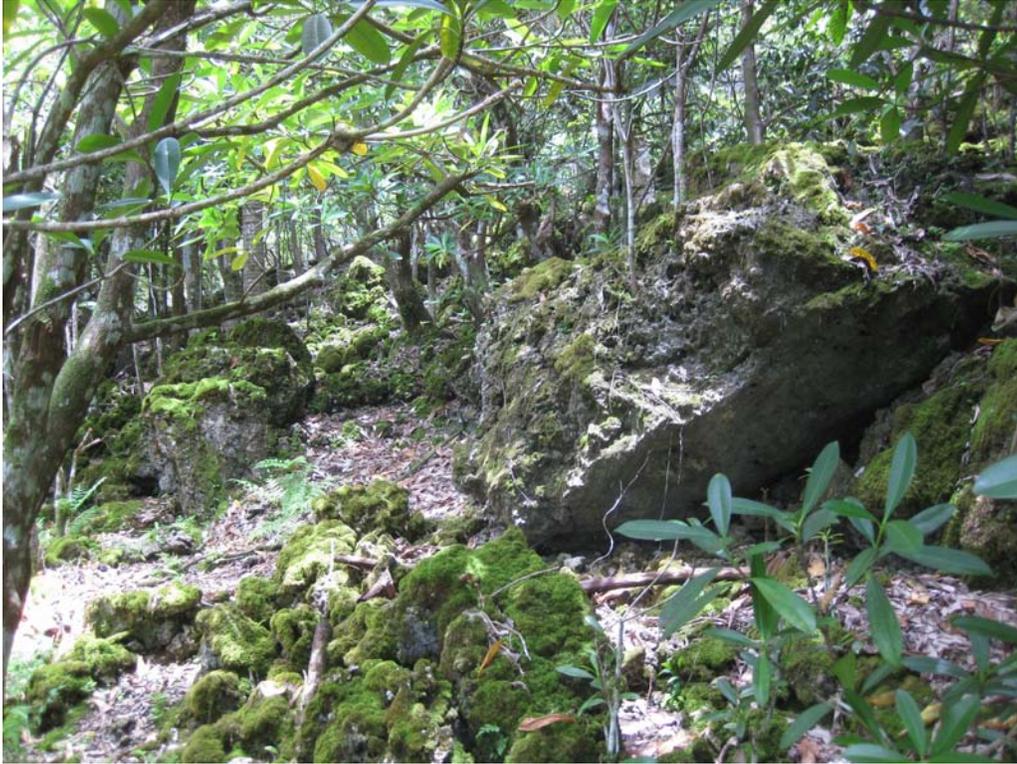
Photo 15 Area D: View of vegetation/boulders at site.

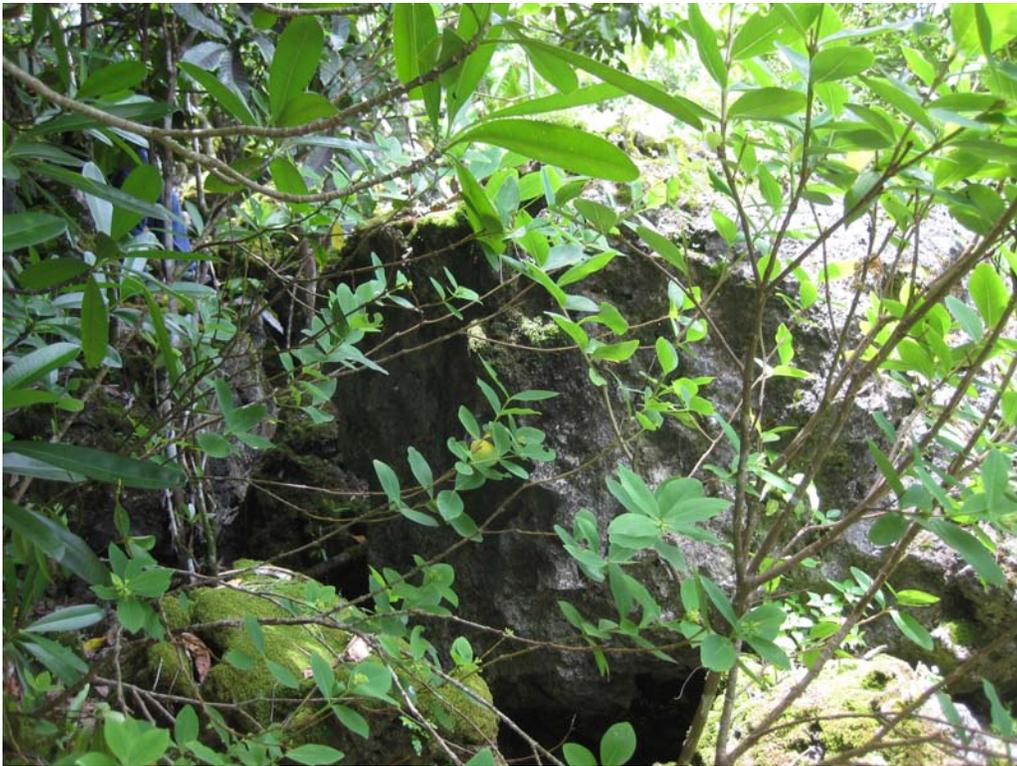
Photo 16 Area D: View of vegetation/boulders at site.

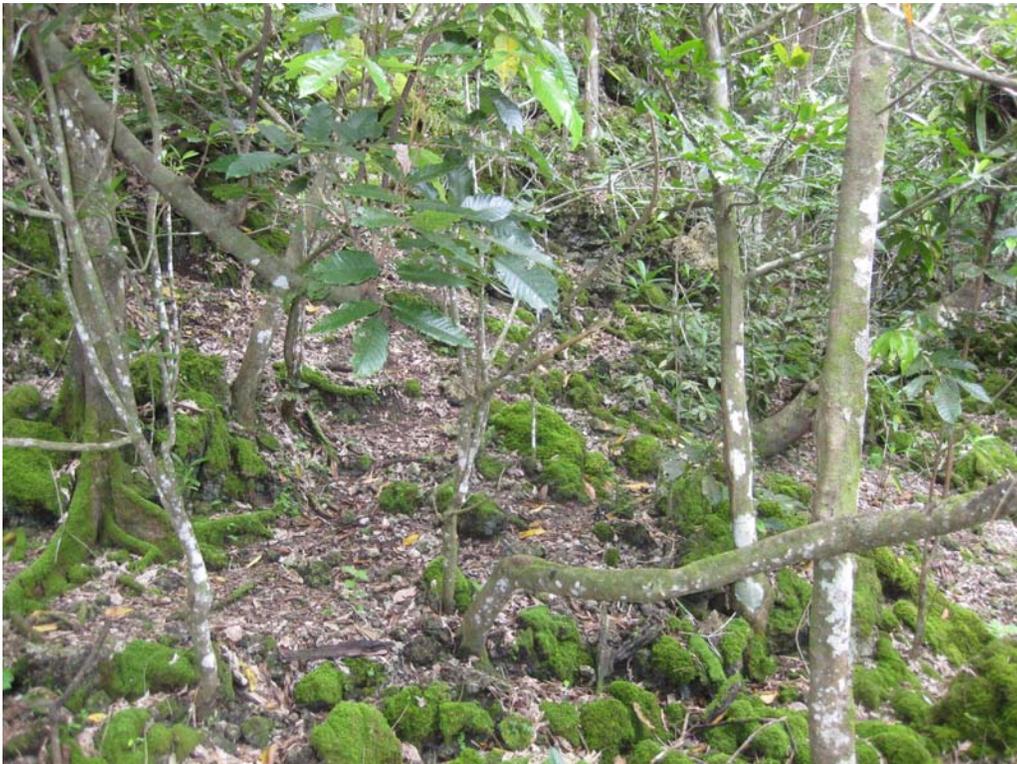
Photo 20 Area E: View of site vegetation.

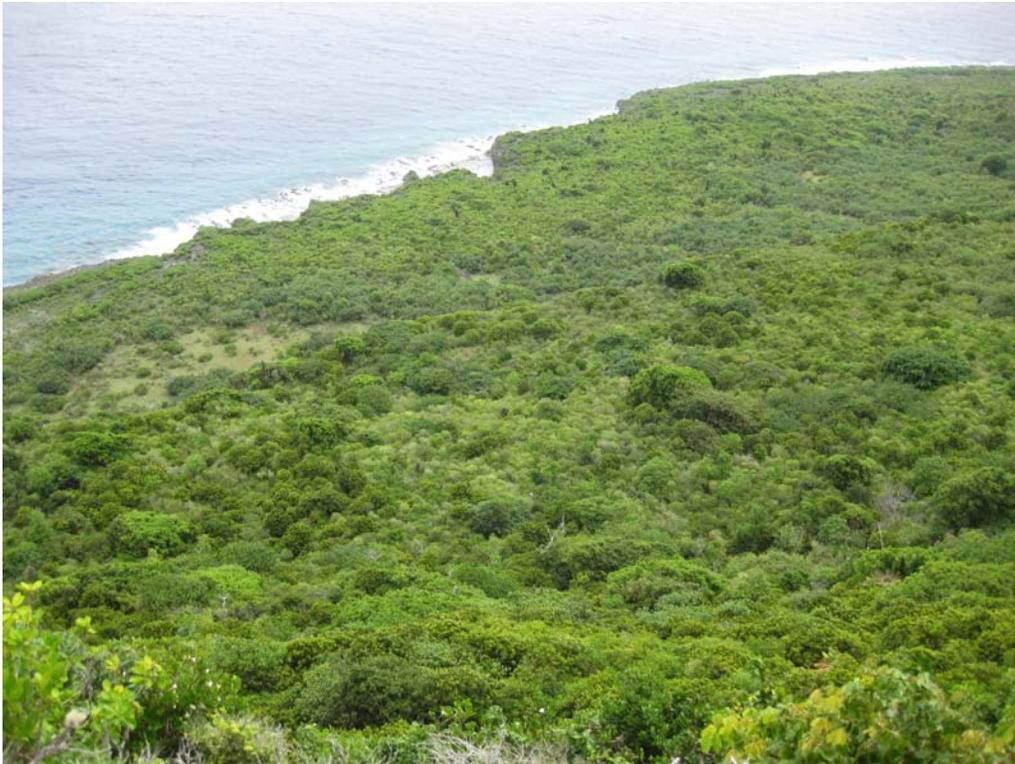
Photo 21 Area F: View of site from cliff line, looking northeast.
Site is in foreground.

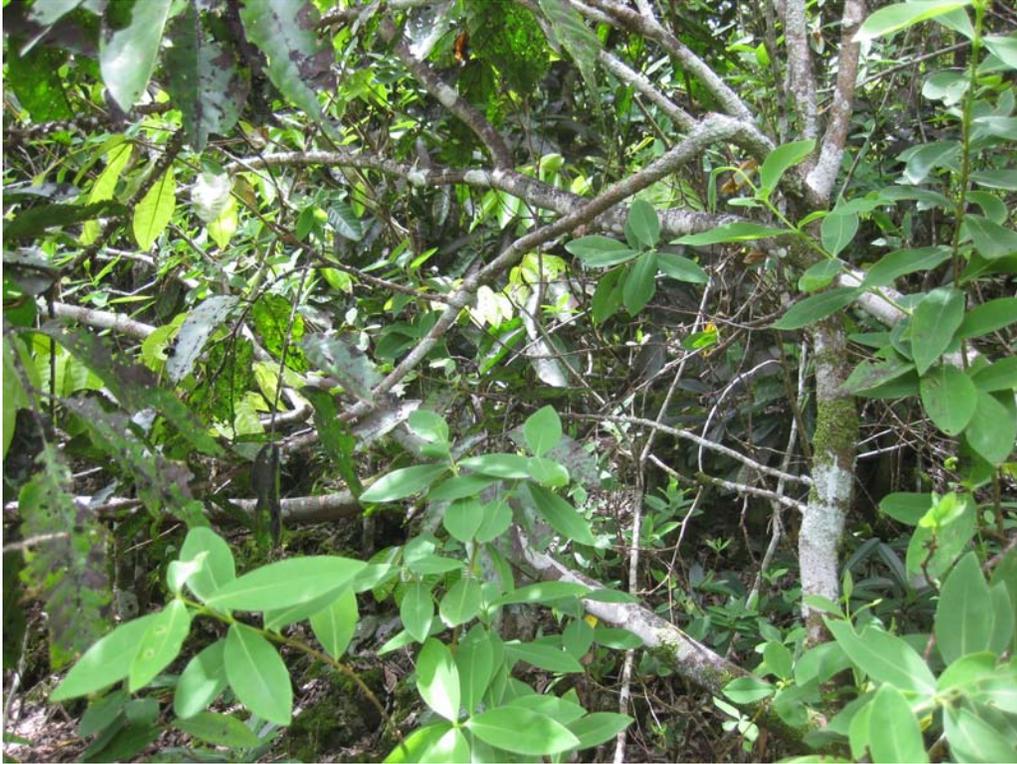
Photo 23 Area F: View of site vegetation.

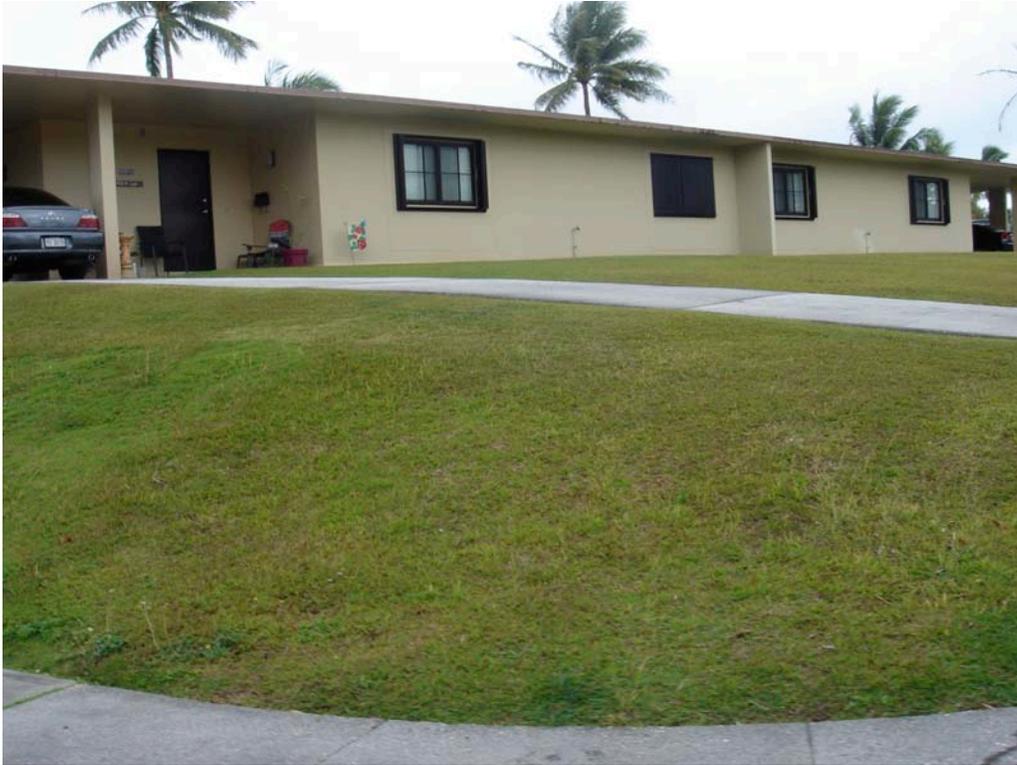
Photo 7 Site 5 (Landfill 7): View of housing area

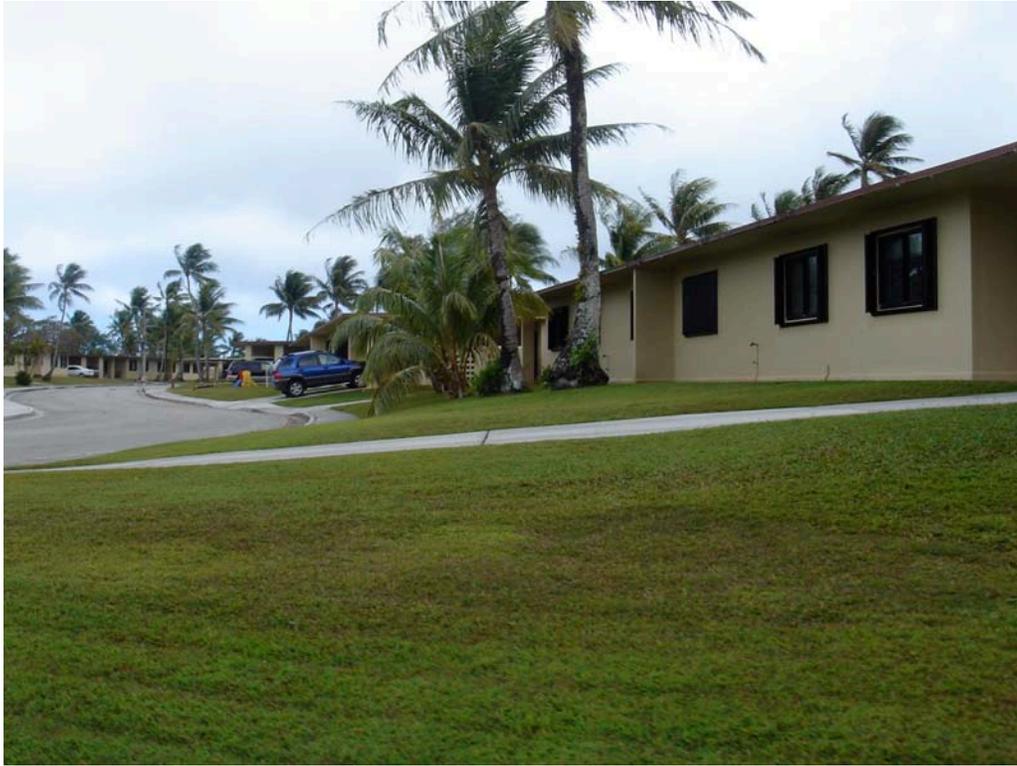
Photo 8 Site 5 (Landfill 7): View of housing area

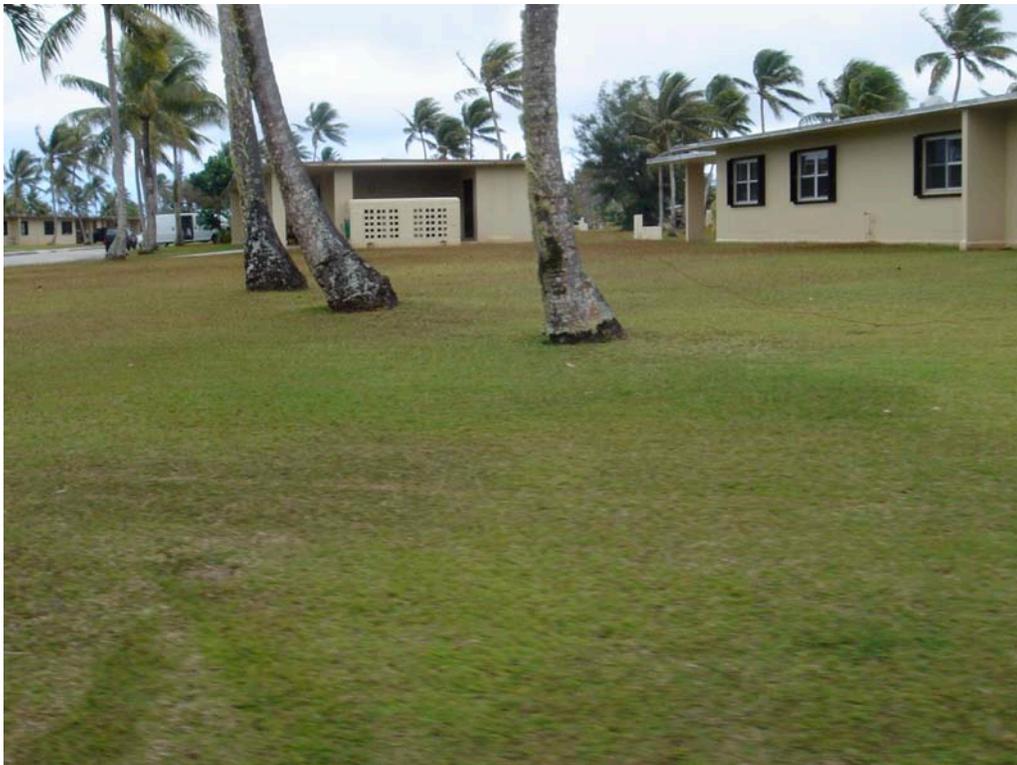
Photo 9 Site 5 (Landfill 7): View of housing area
