Annual Monitoring Checklist
IRP Site 5 (Landfill 7)
Andersen AFB, Guam
 N62742-09-D-1953 - Contract Task Order No. 009

**PHOTOGRAPHIC LOG – IRP SITE 5 (LANDFILL 7), ANDERSEN AFB, GUAM
N62742-09-D-1953 - CONTRACT TASK ORDER NO. 009 - JULY 8, 2011 INSPECTION**

3.0 Site 5 (Landfill 7) 2012 Annual LUC Monitoring Checklist

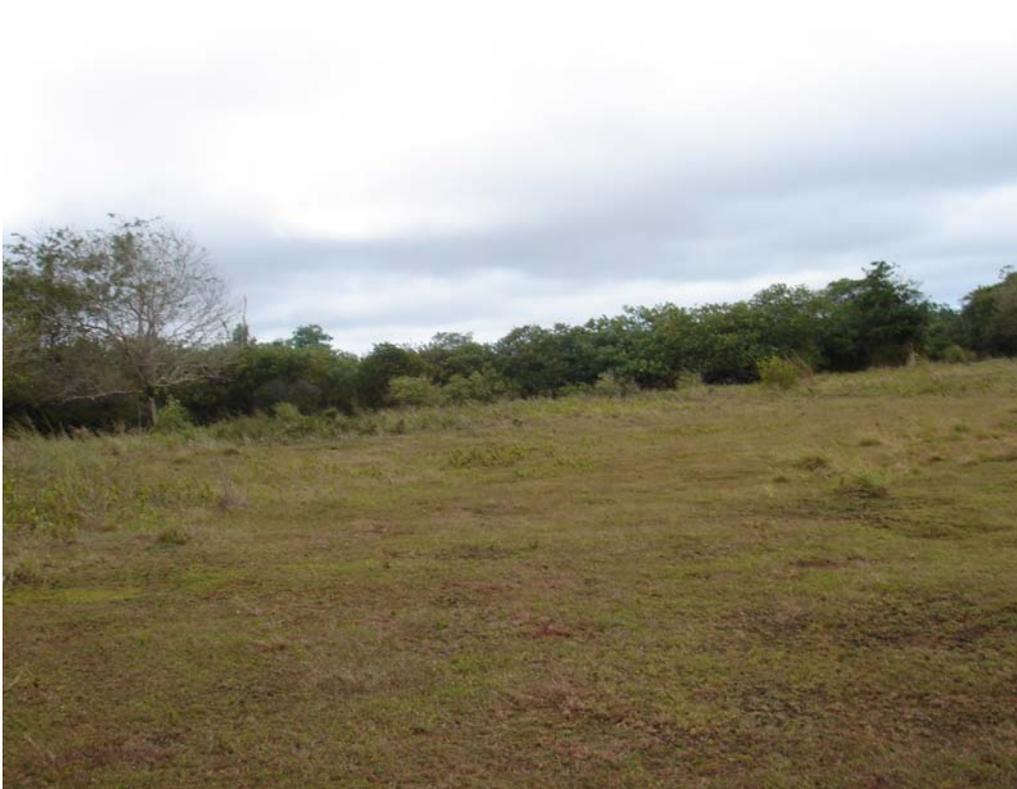
Photo 12 Site 6 (Landfill 8): View of southern section of site.

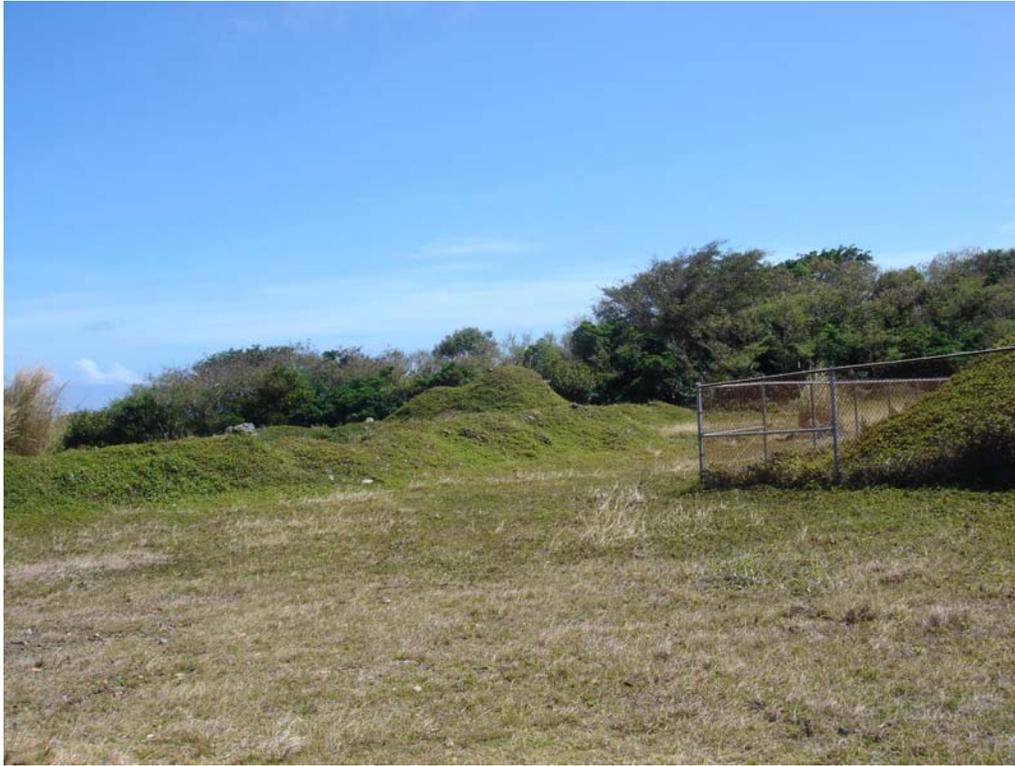
Photo 14 Site 8 (Landfill 10): Maintained area within site.

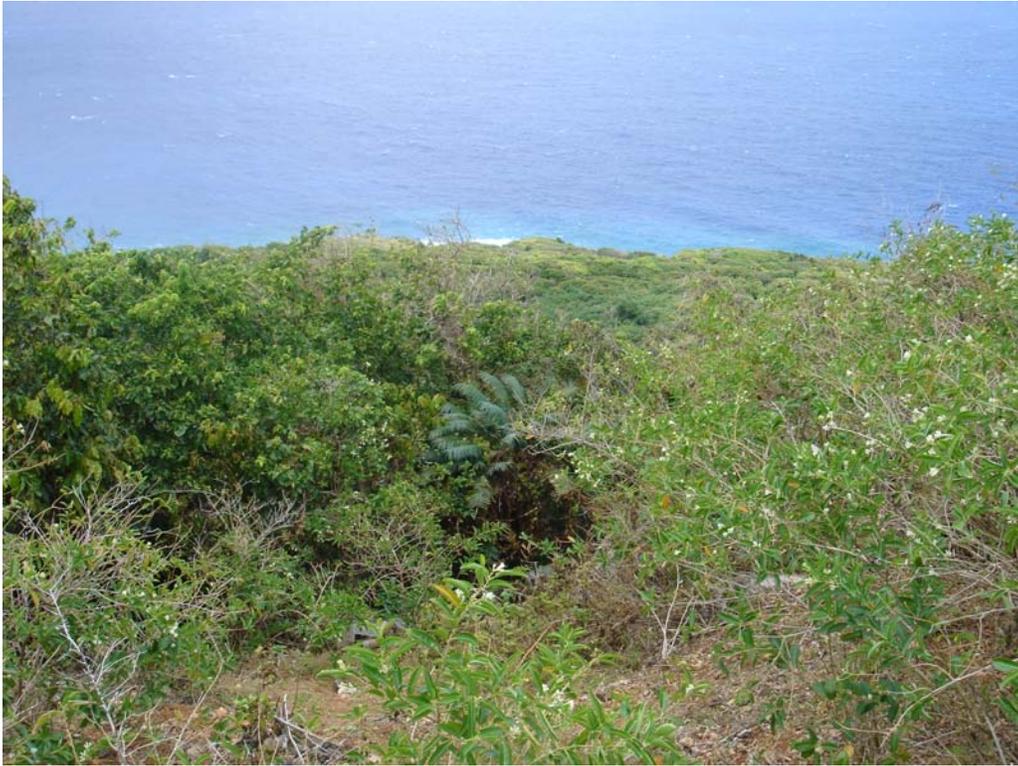
Photo 17 Site 12 (Landfill 17): View of site from top of cliff looking north.

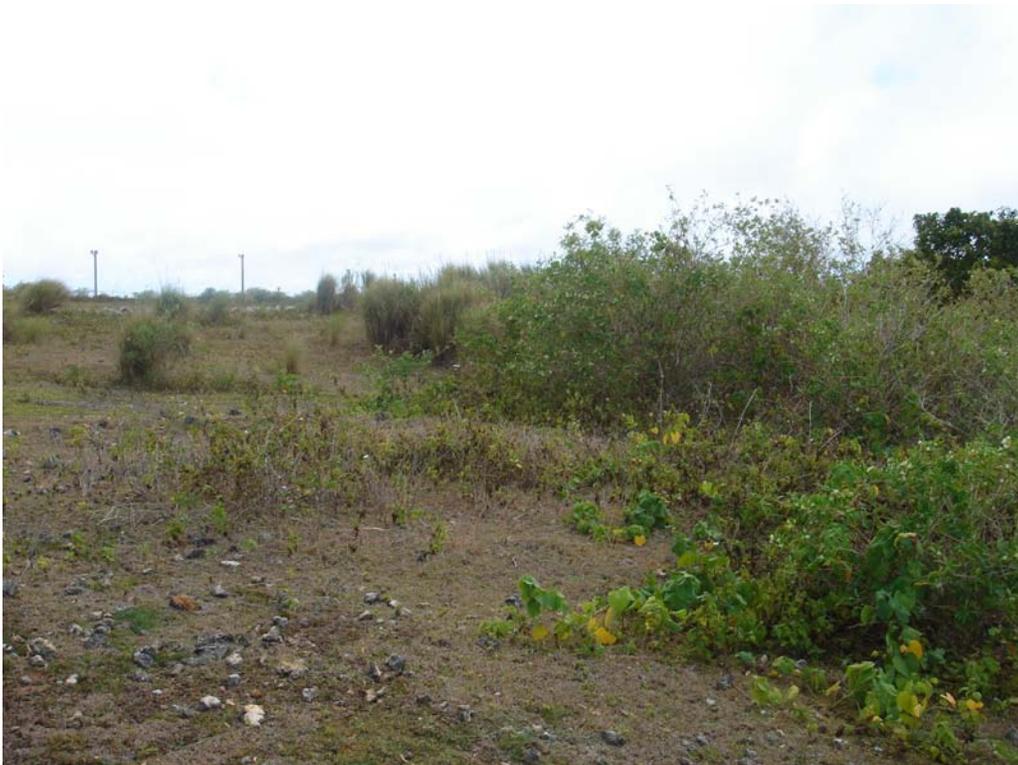
Photo 18 Site 12 (Landfill 17): View of area at top of cliff.

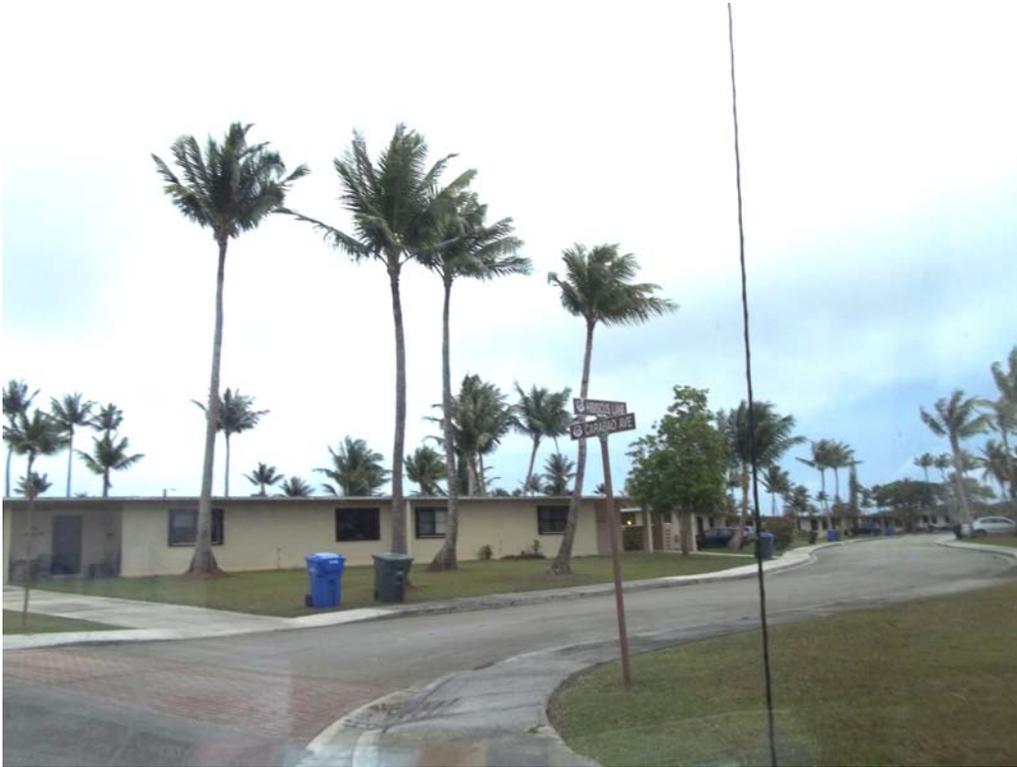
Photo 7 Site 5 (Landfill 7): View of housing area

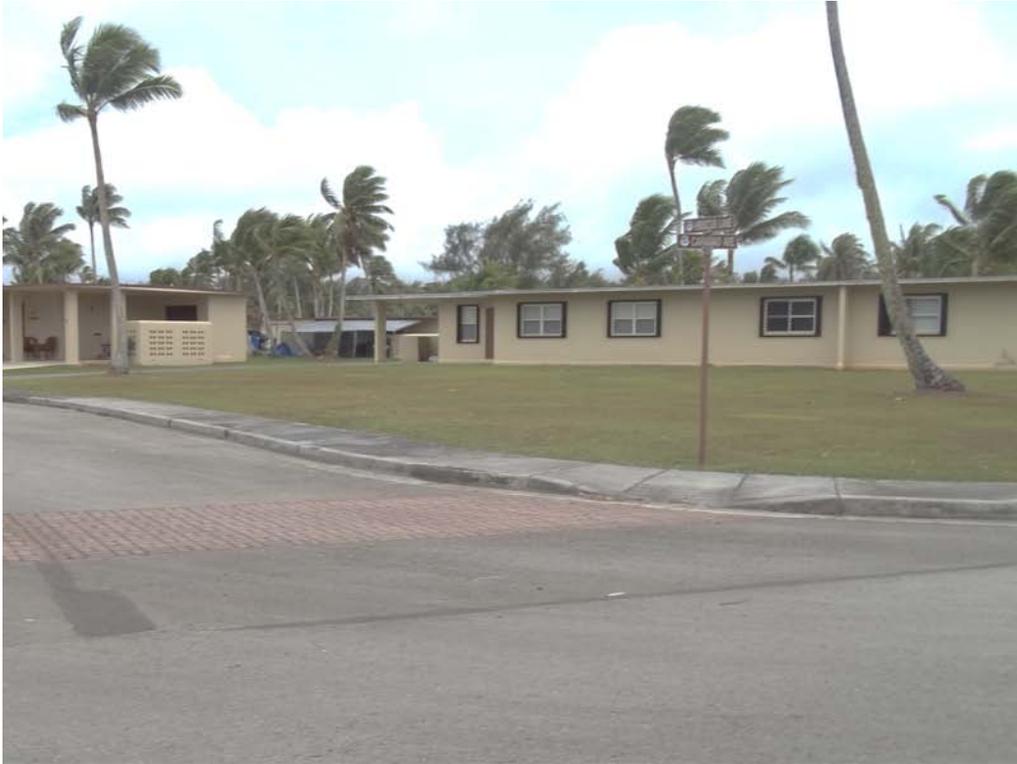
Photo 8 Site 5 (Landfill 7): View of housing area

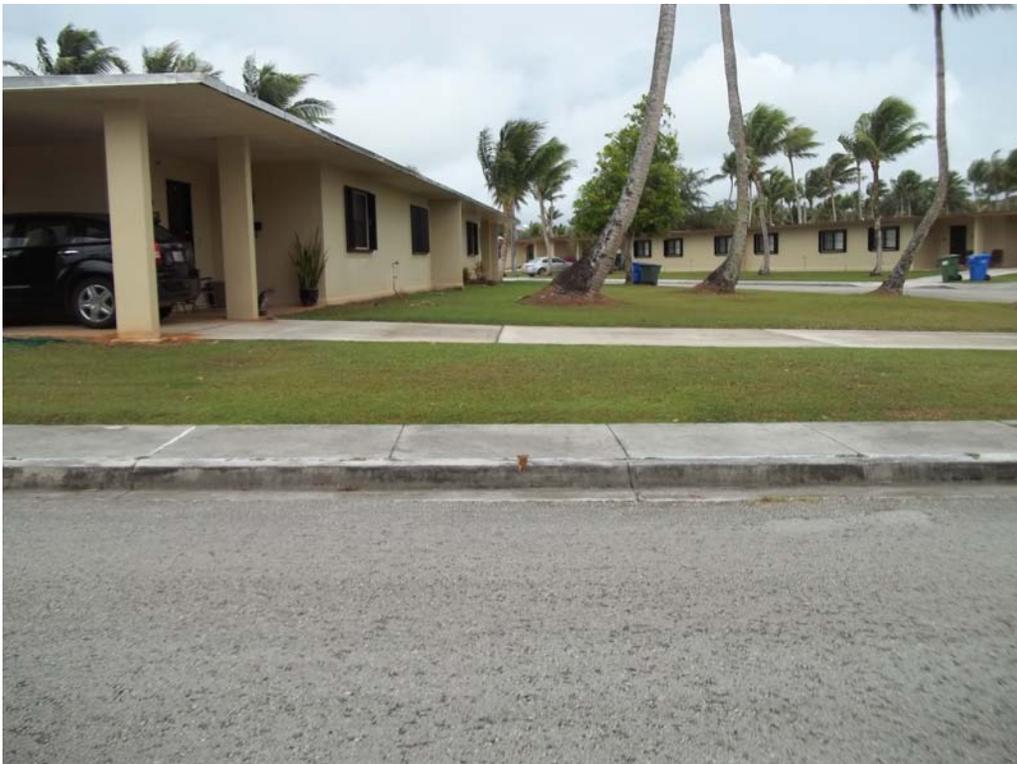
Photo 9 Site 5 (Landfill 7): View of housing area

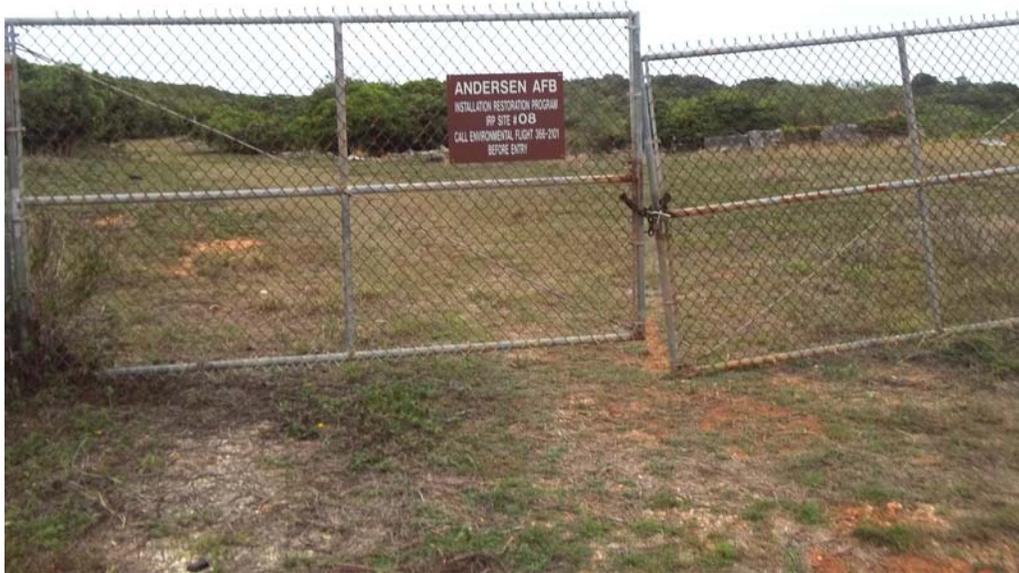
Photo 14 Site 8 (Landfill 10): Entrance to fenced/restricted area within site.

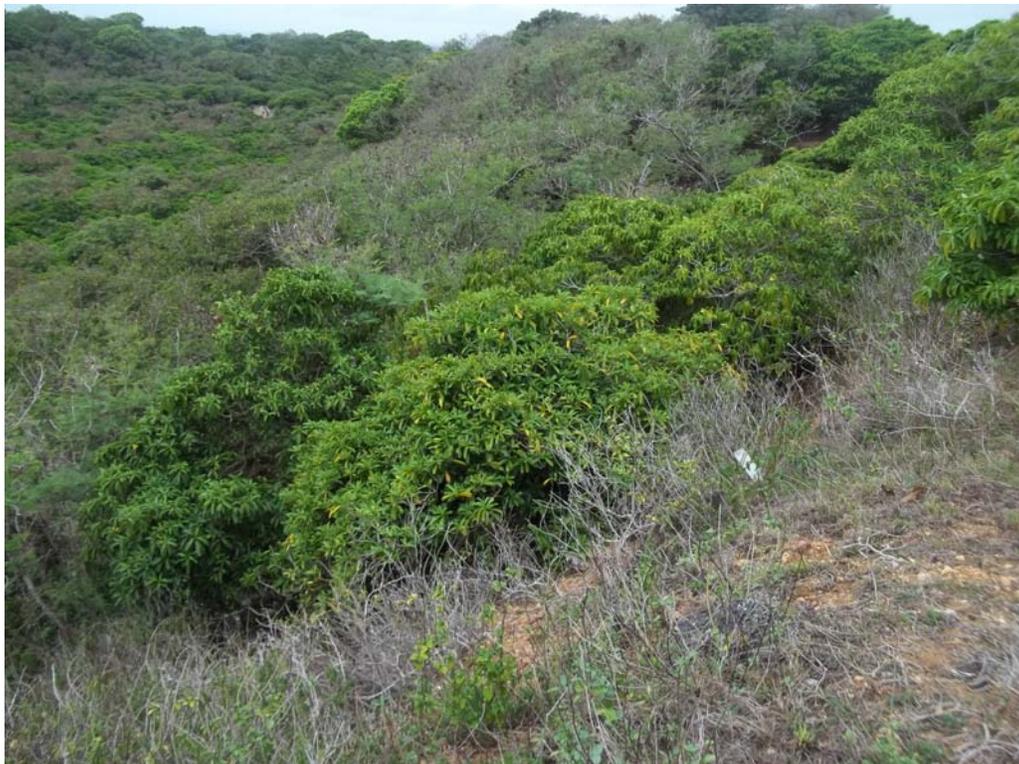
Photo 15 Site 8 (Landfill 10): View of interior of site.

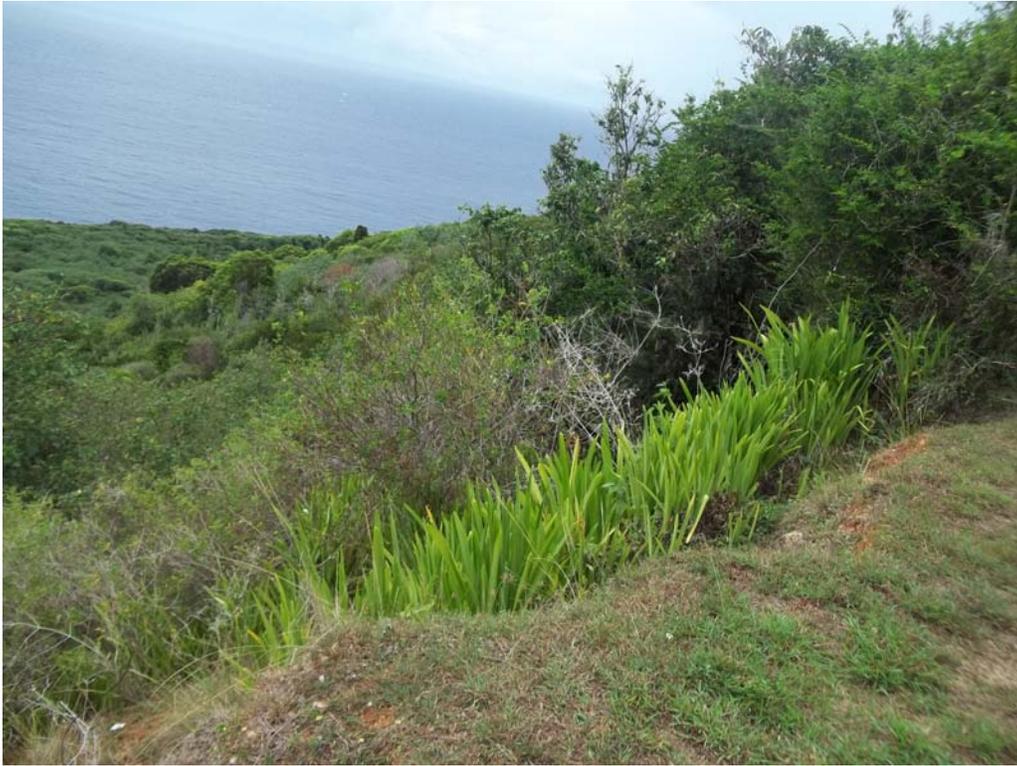
Photo 17 Site 12 (Landfill 17): View of site from top of cliff looking northeast.

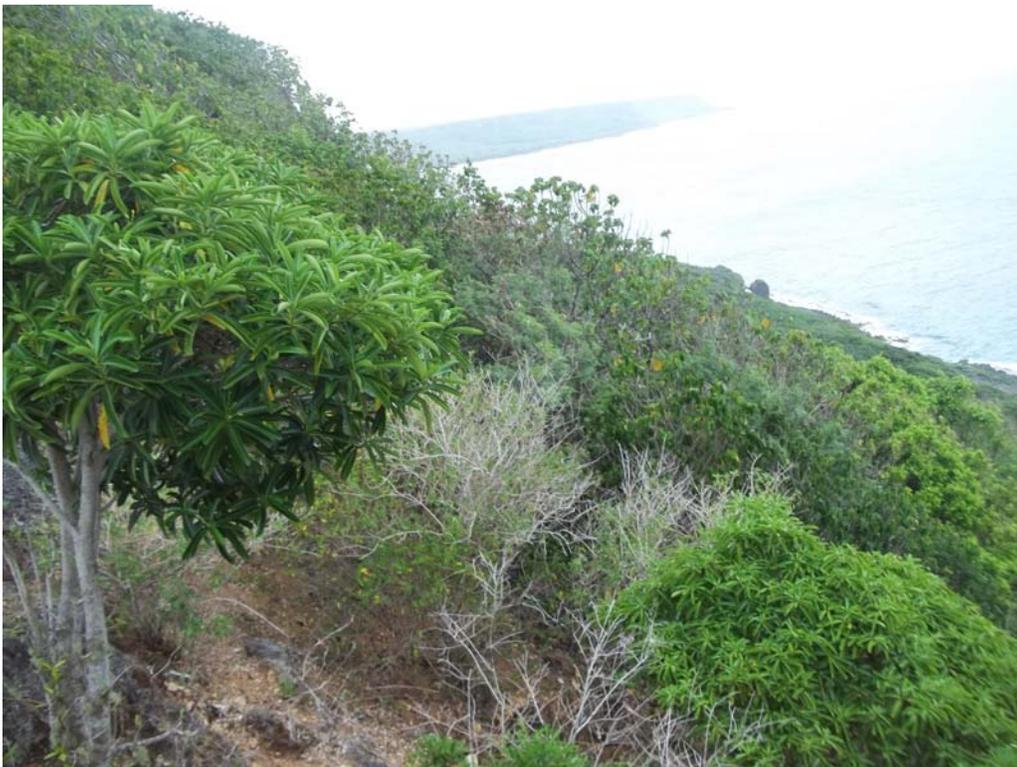
Photo 18 Site 12 (Landfill 17): View of site from top of cliff looking west.
